**Prüfbericht - Nr.: 16004796 001**  
Test Report No.:

## 6 Photographs of the Test Set-Up

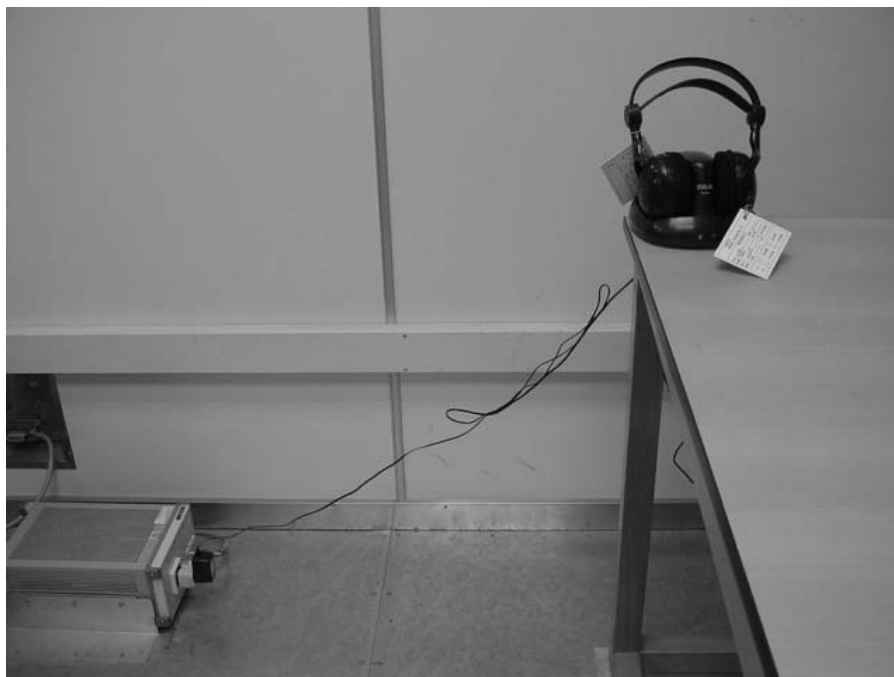
**Photograph 1: Set up for Conducted Emission on AC Mains of AC/DC adaptor of HP1391**

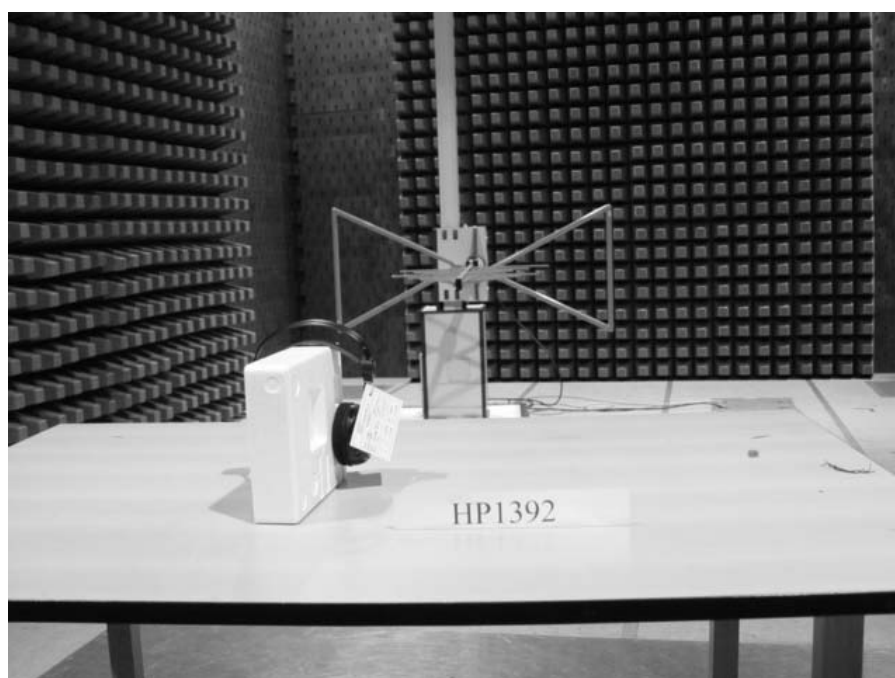
**Photograph 2: Set-up for Radiation Measurement Below 1GHz**

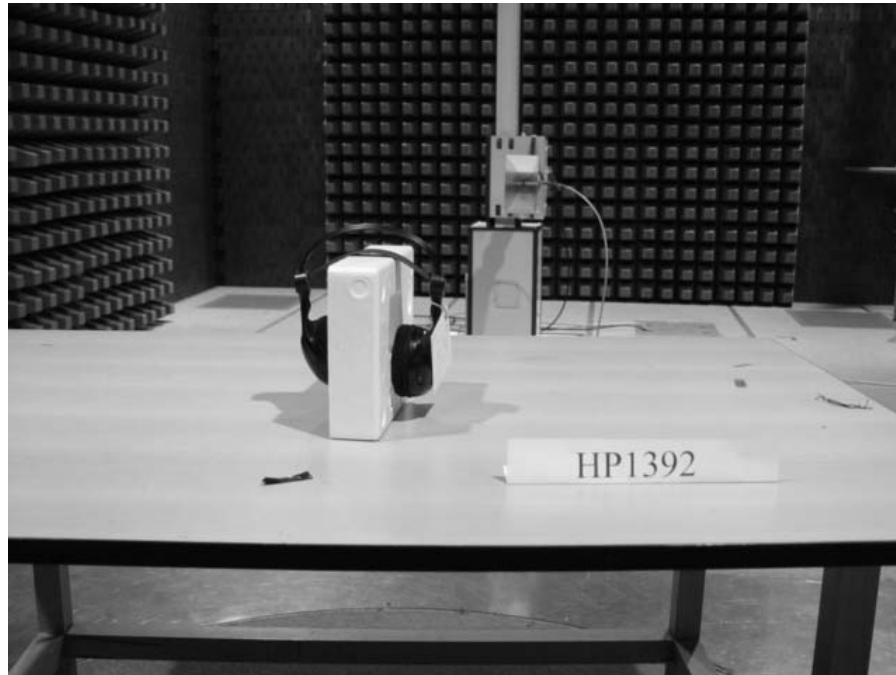
**Photograph 3: Set-up for Radiation Measurement Above 1GHz**
