**Prüfbericht - Nr.: 16004797 001**  
Test Report No.:

## 6 Photographs of the Test Set-Up

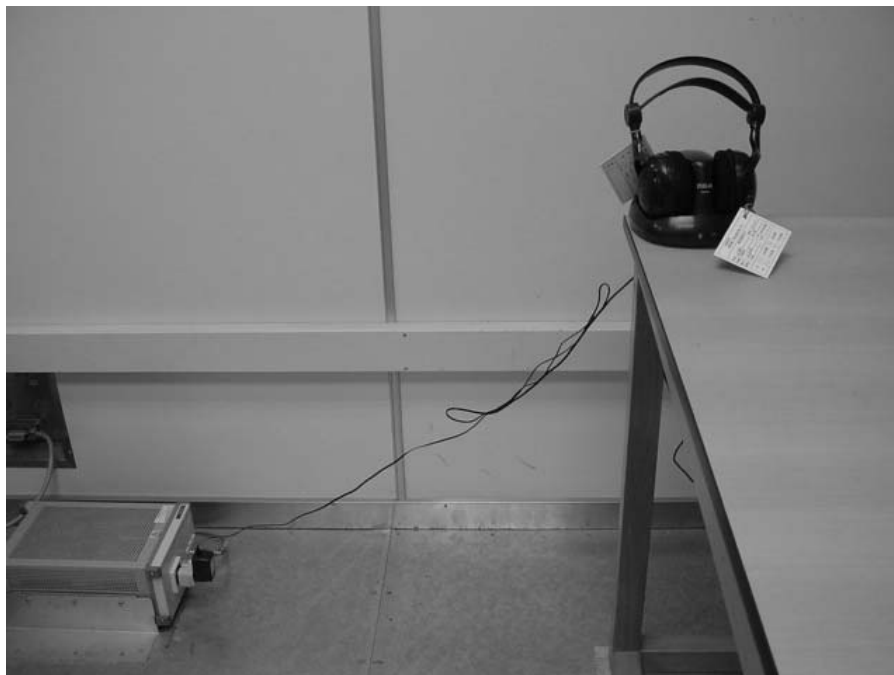
**Photograph 1: Set up for Conducted Emission on AC Mains of AC/DC adaptor of HP1391**

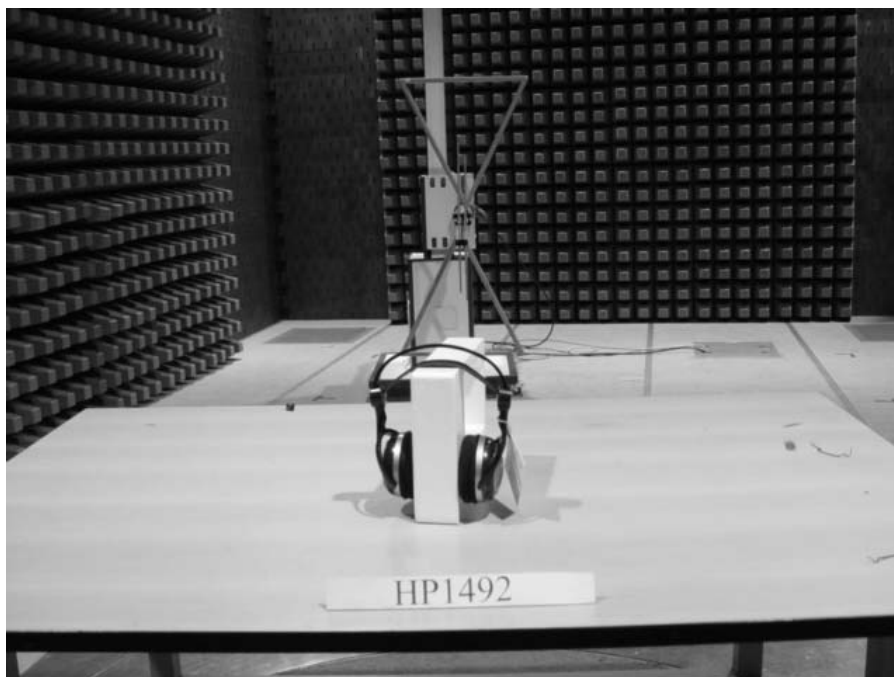
**Photograph 2: Set-up for Radiation Measurement Below 1GHz**

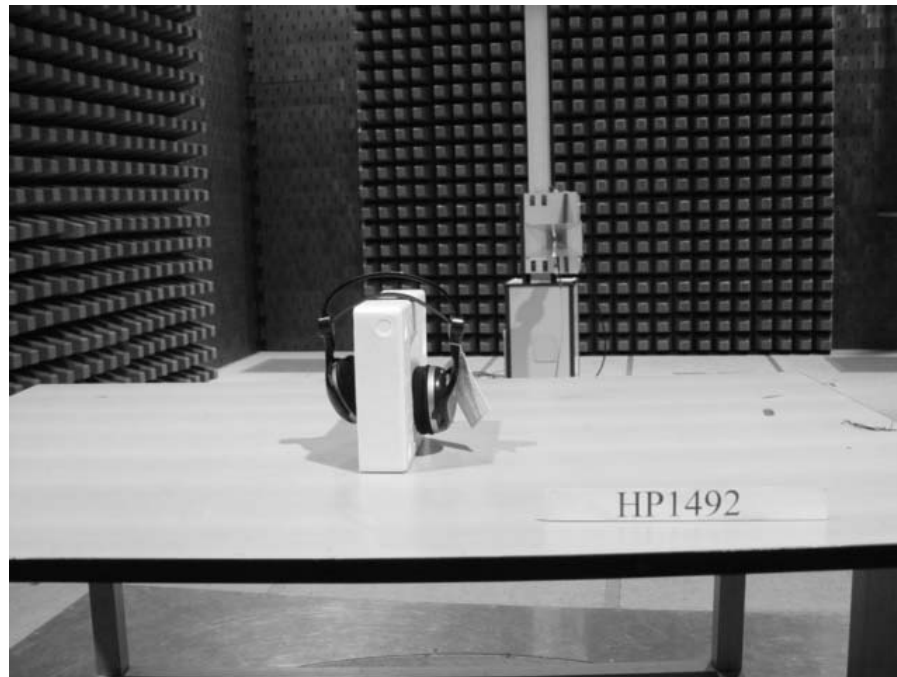
**Photograph 3: Set-up for Radiation Measurement Above 1GHz**
