# Intertek Testing Services

Report No.: 9906319

Mode: Charging

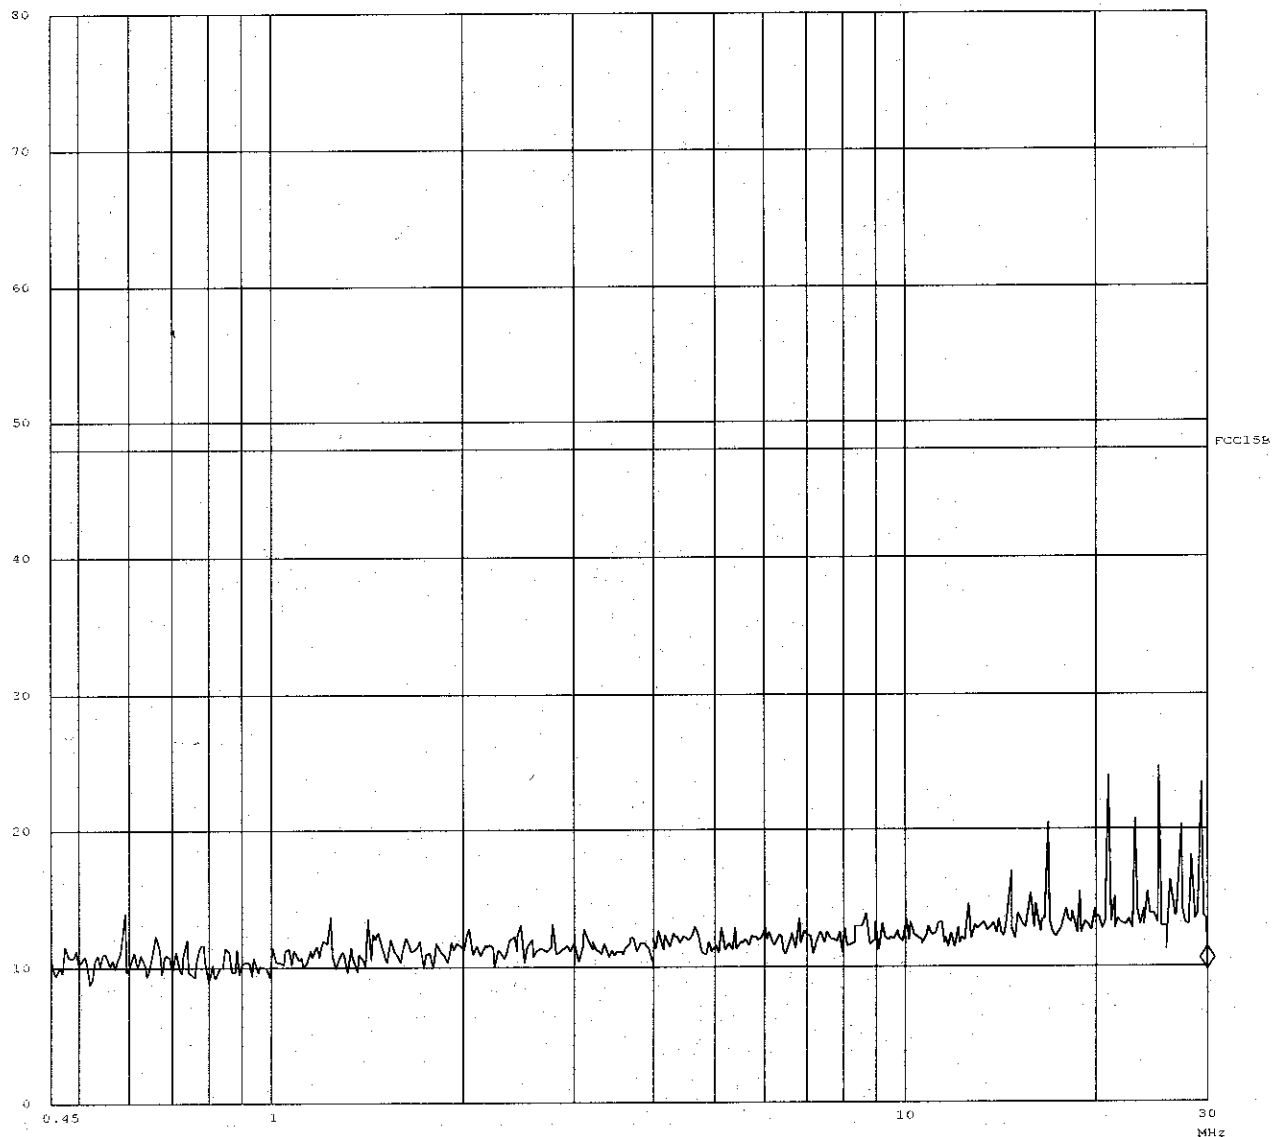
Scan Settings (1 Range)

| Start | Stop | Step | IF BW | Detector | M-Time | Atten | Preamp | OpRge |
|---|---|---|---|---|---|---|---|---|
| 450K | 30M | 5k | 10K | PK | 20ms | AMTO | LN OFF | 60dB |

dBuV Mkr : 30.00000MHz 9.7 dBuV

no Results

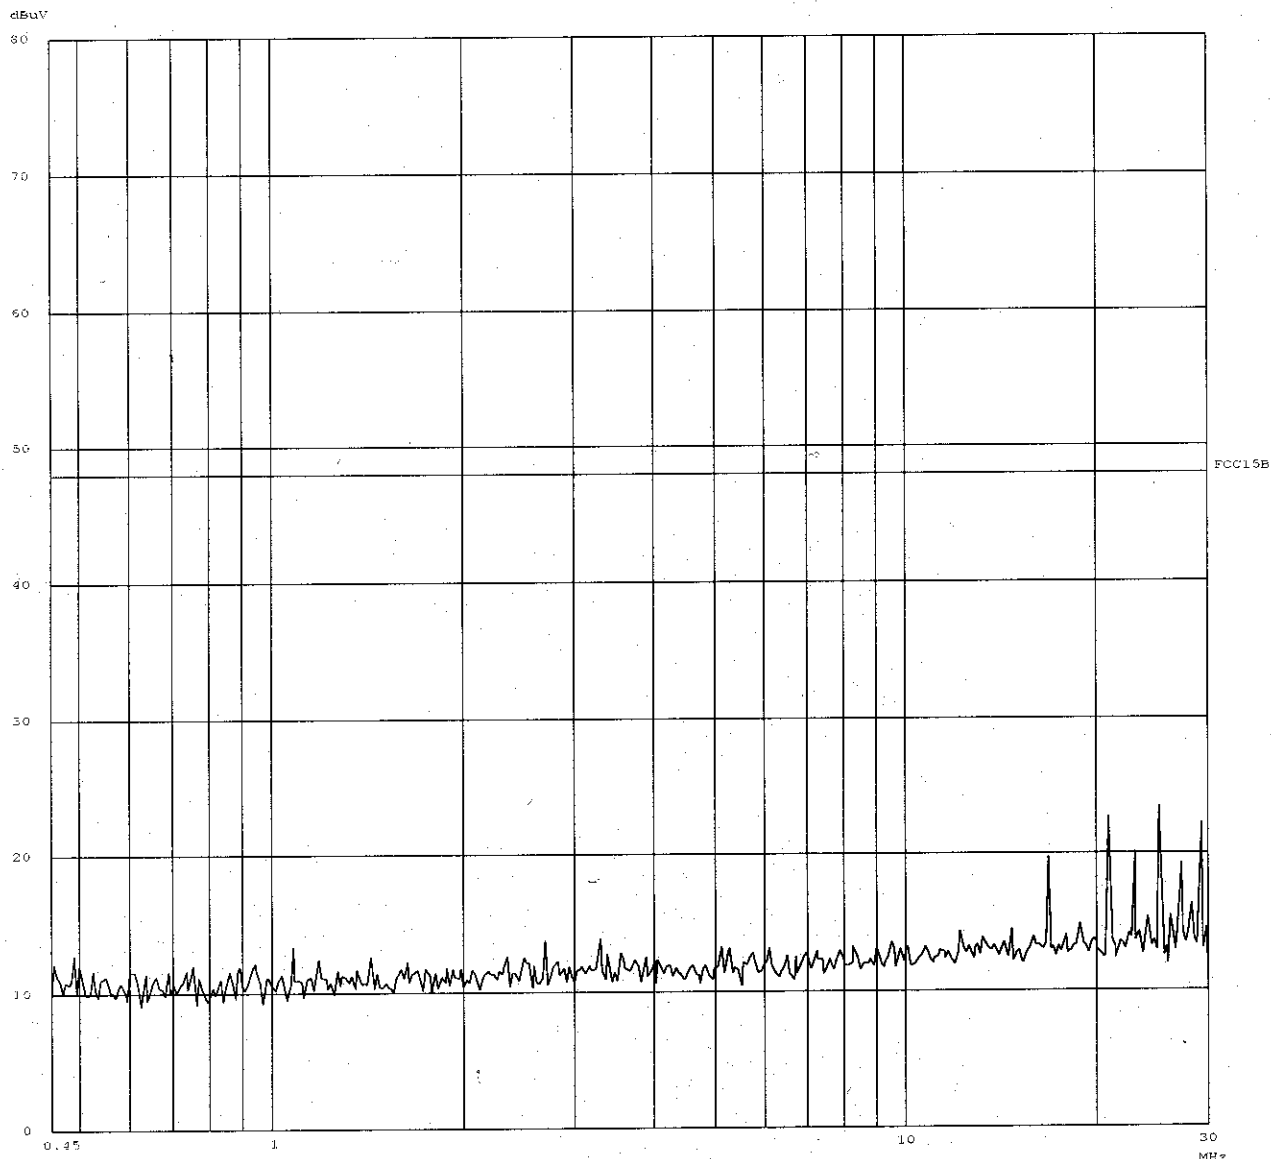
Mode: Standby

| Frequencies | | | Receiver Settings | | | | | |
| 450k | 30M | 5k | 10k | PK | 10ms | AUTO | LN OFF | 60dB |

no Results

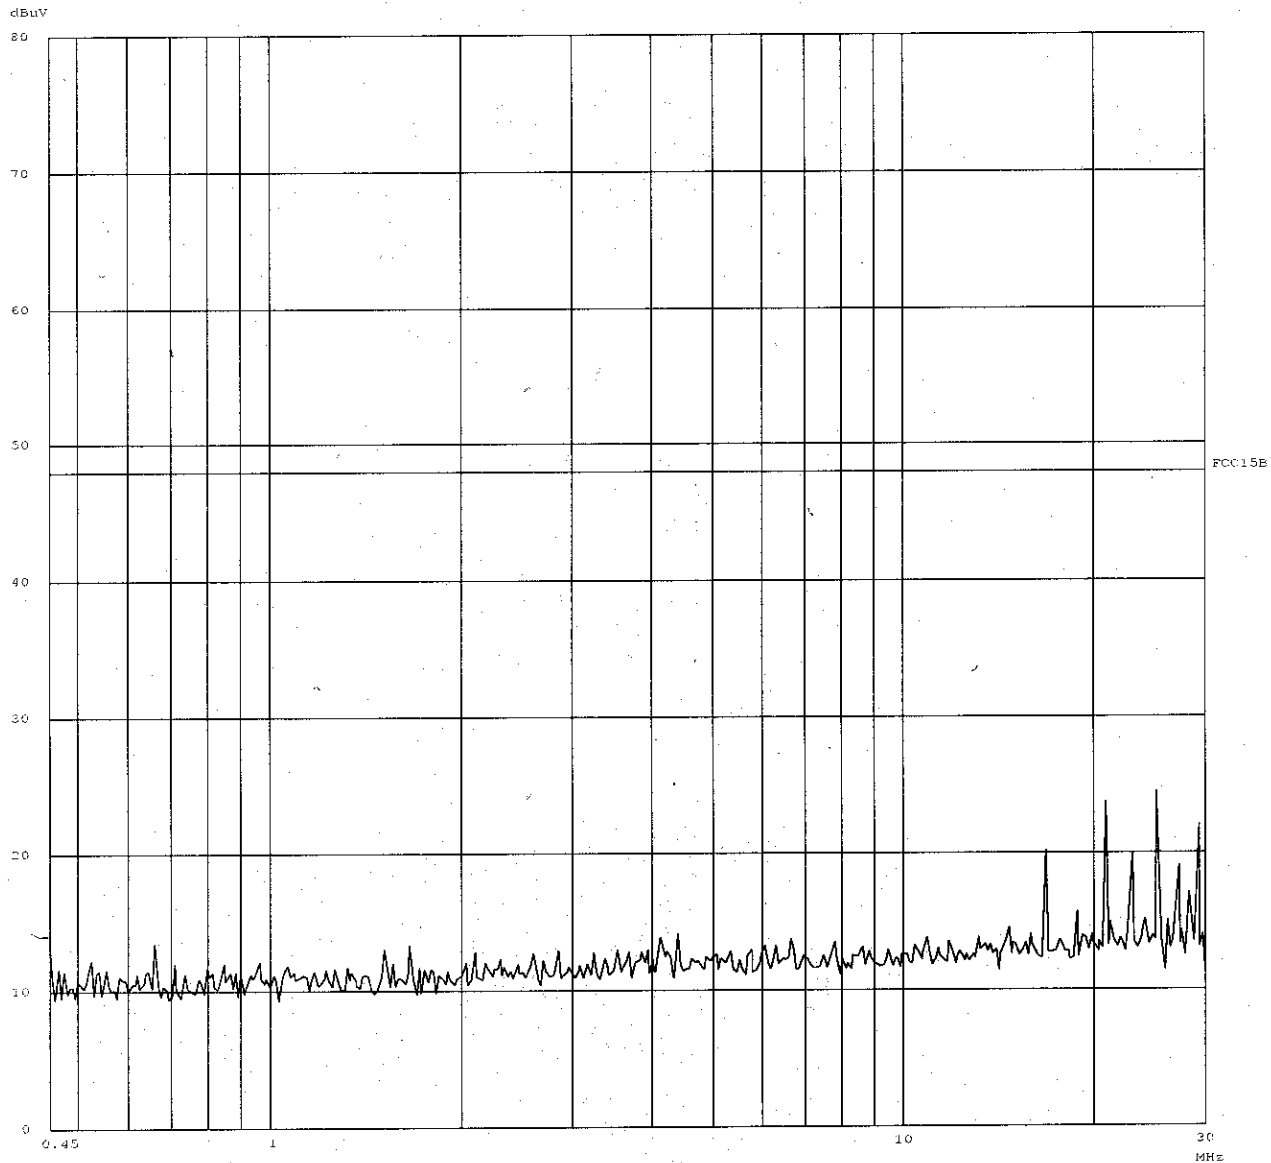
Mode: Transmission

Scan Settings (1 Range)

| Frequencies | | | Receiver Settings | | | | | |
|---|---|---|---|---|---|---|---|---|
| 450k | 30M | 5k | 10k | PK | 20ms | AUTO | LN OFF | 60dB |

no Results
