APPENDIX 1: Photographs of test setup

Radiated Emission
Door Antenna

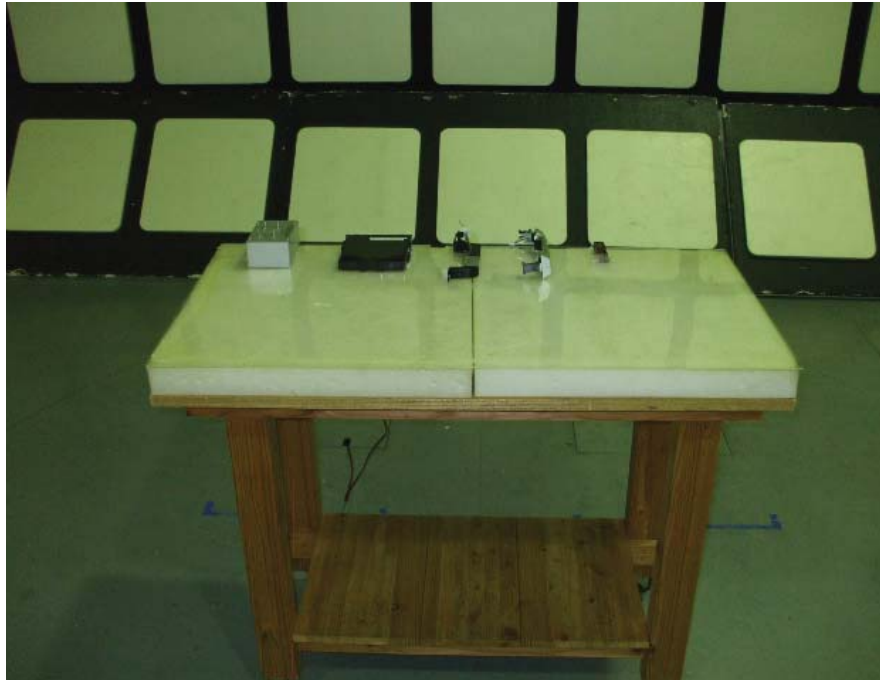
Photo 1

Radiated Emission
Trunk Antenna

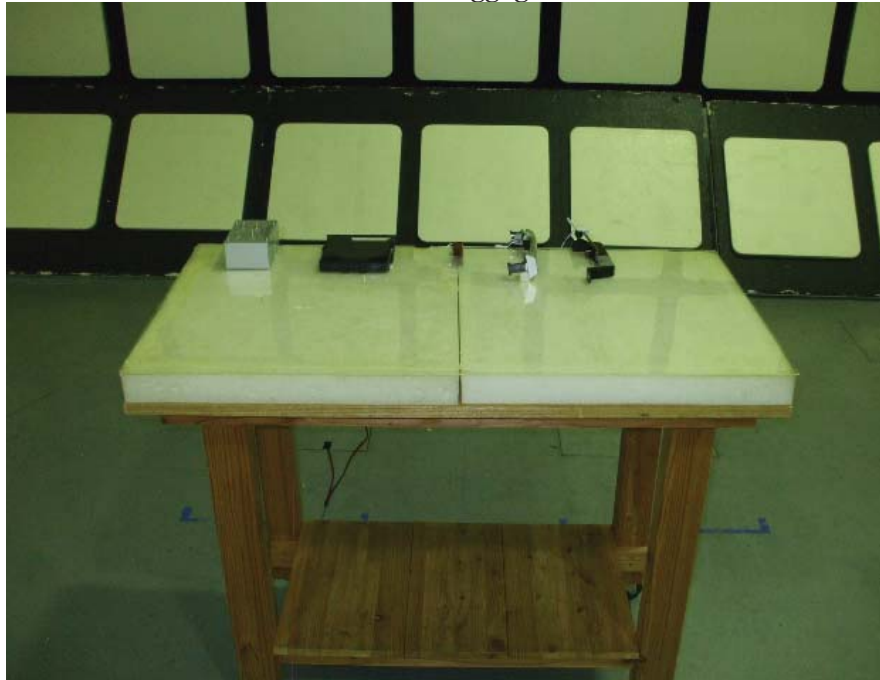
Photo 1

Radiated Emission
Room Antenna / Luggage Antenna

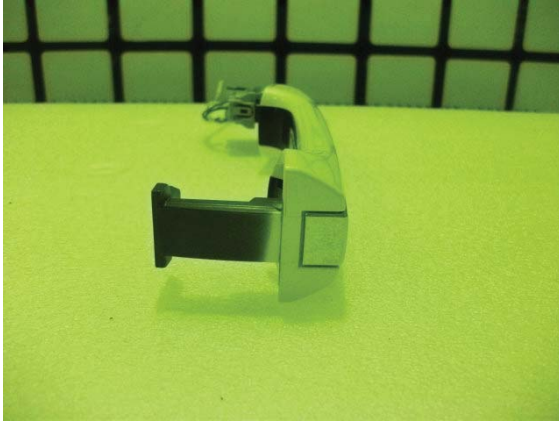
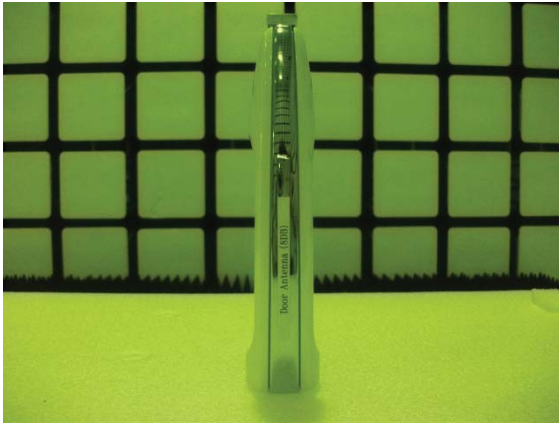
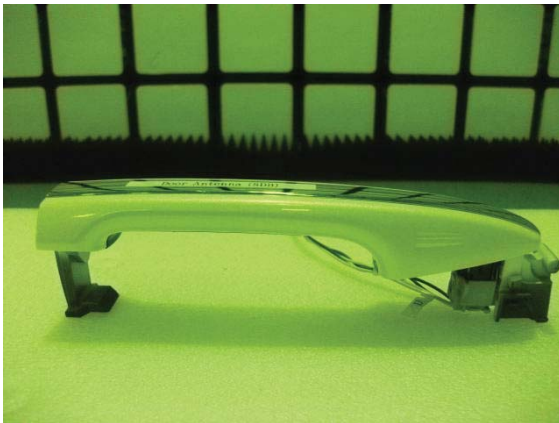
Door Antenna
Below 30MHz:X-axis
Above 30MHz(Hori:X-axis /Vert:X-axis)
X-axis

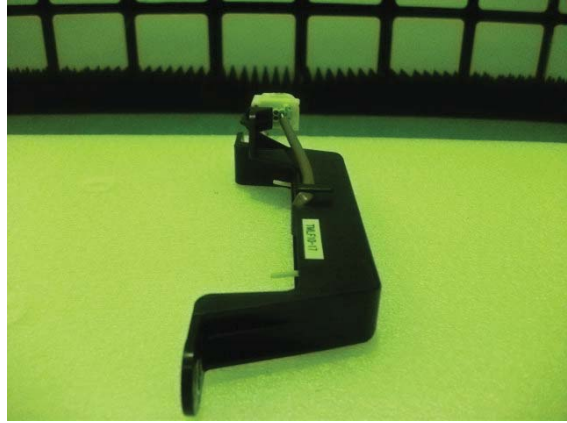
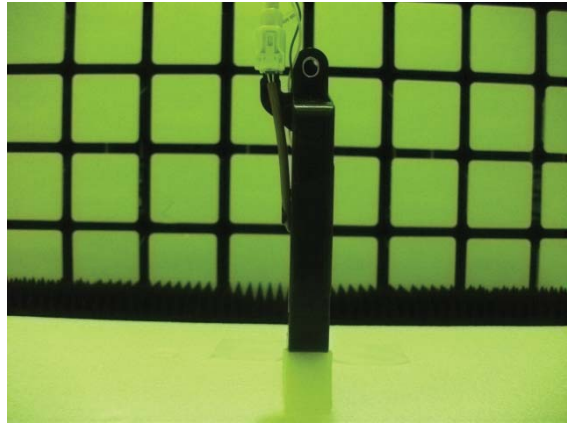
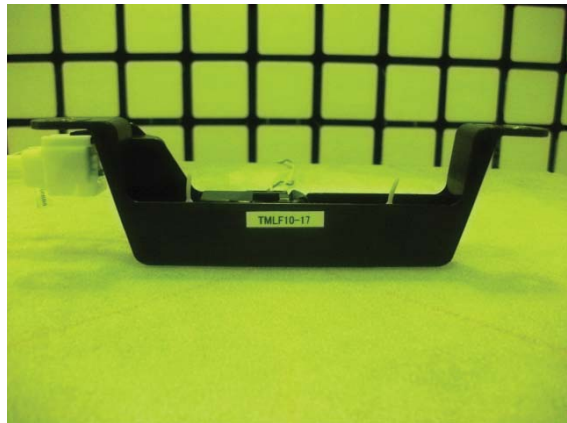
Trunk Antenna
Below 30MHz:X-axis
Above 30MHz(Hori:X-axis /Vert:X-axis)
X-axis

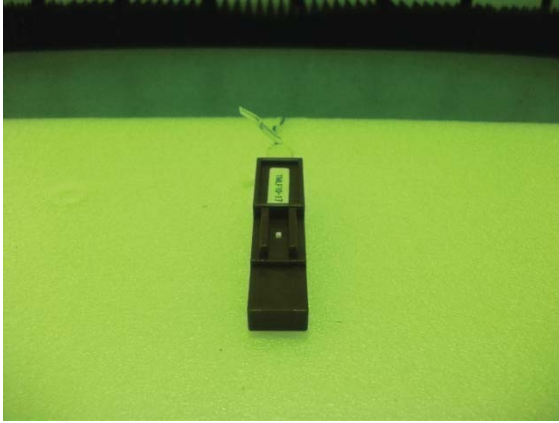
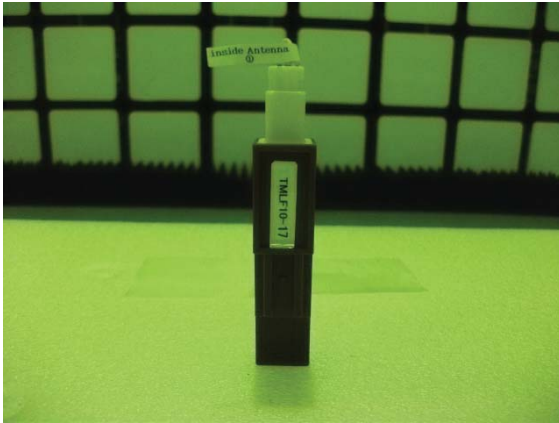
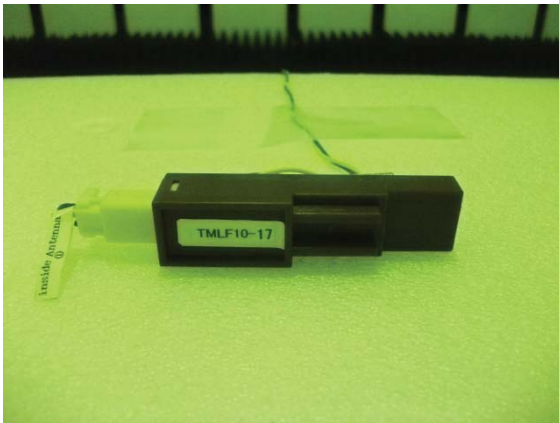
Room Antenna / Luggage Antenna
Below 30MHz:Z-axis
Above 30MHz(Hori:X-axis /Vert:X-axis)
X-axis

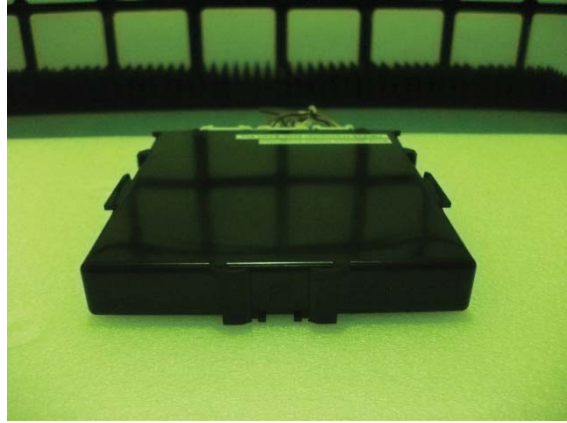
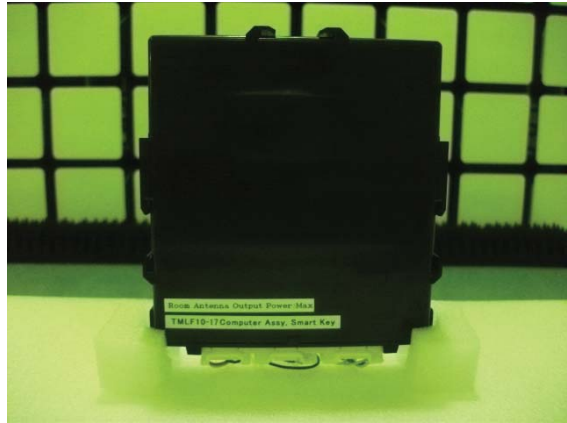
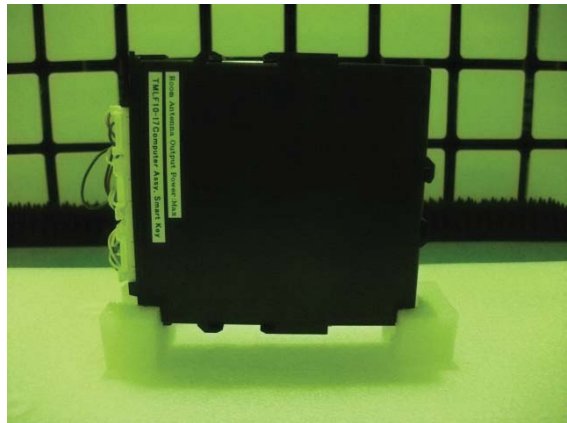
ECU
Below 30MHz:X-axis
Above 30MHz(Hori:X-axis /Vert:X-axis)
X-axis
