ANNEX 1 - PHOTOGRAPHS OF RADIATED EMISSIONS MEASUREMENTS
Siemens Milltronics SITRANS LR, Model No: 7ML5420 & 7ML5421

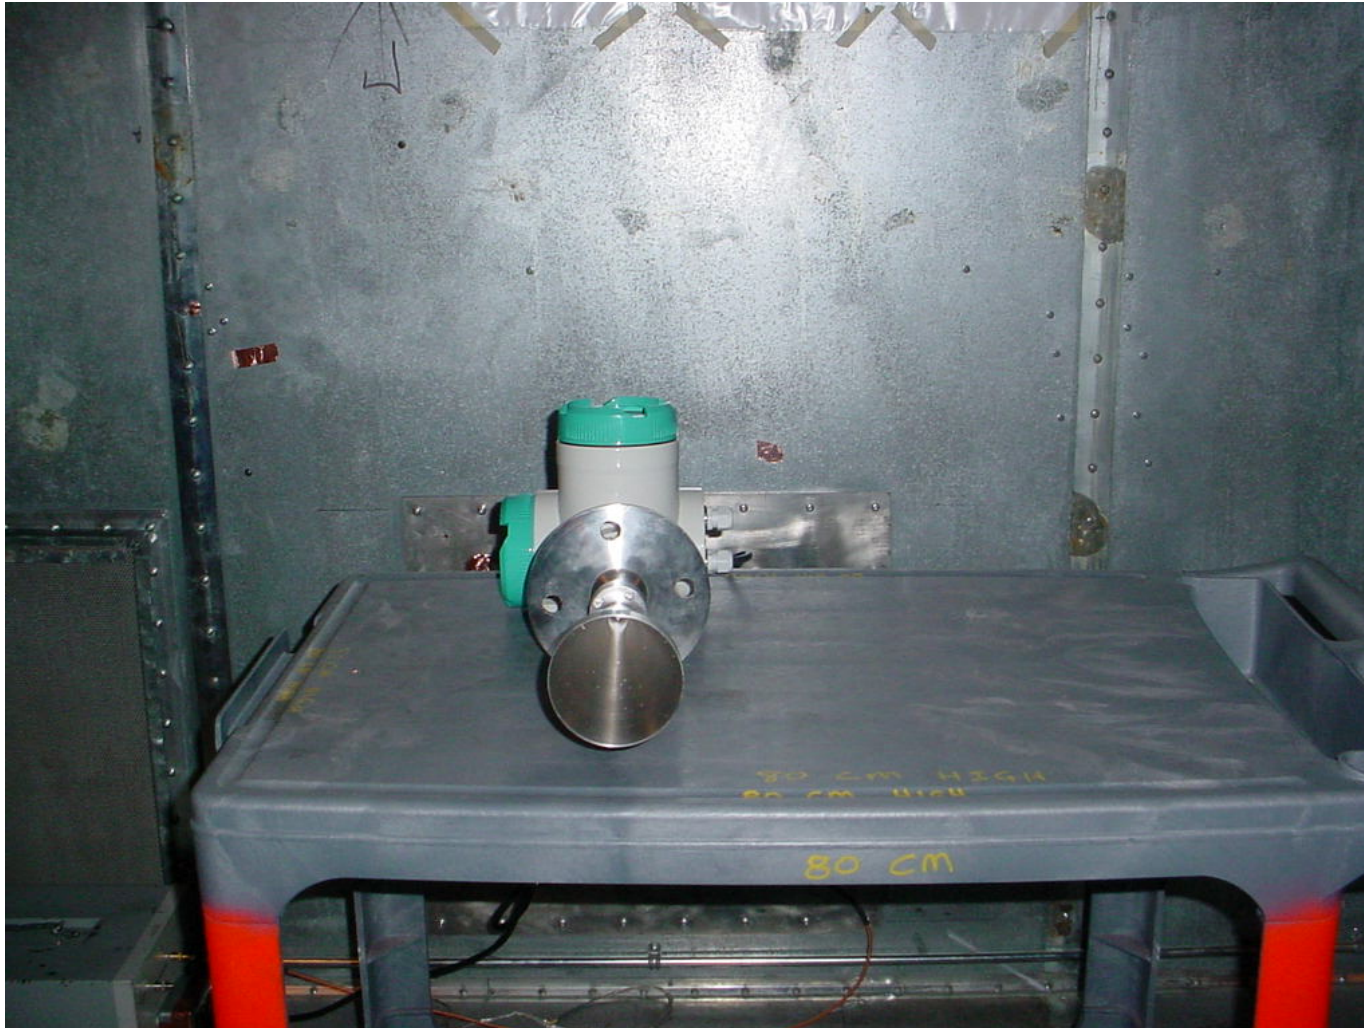
PHOTO # 1
FCC ID: NJA-LR400-1

AC/DC Power Line Conducted Emissions Test Setup

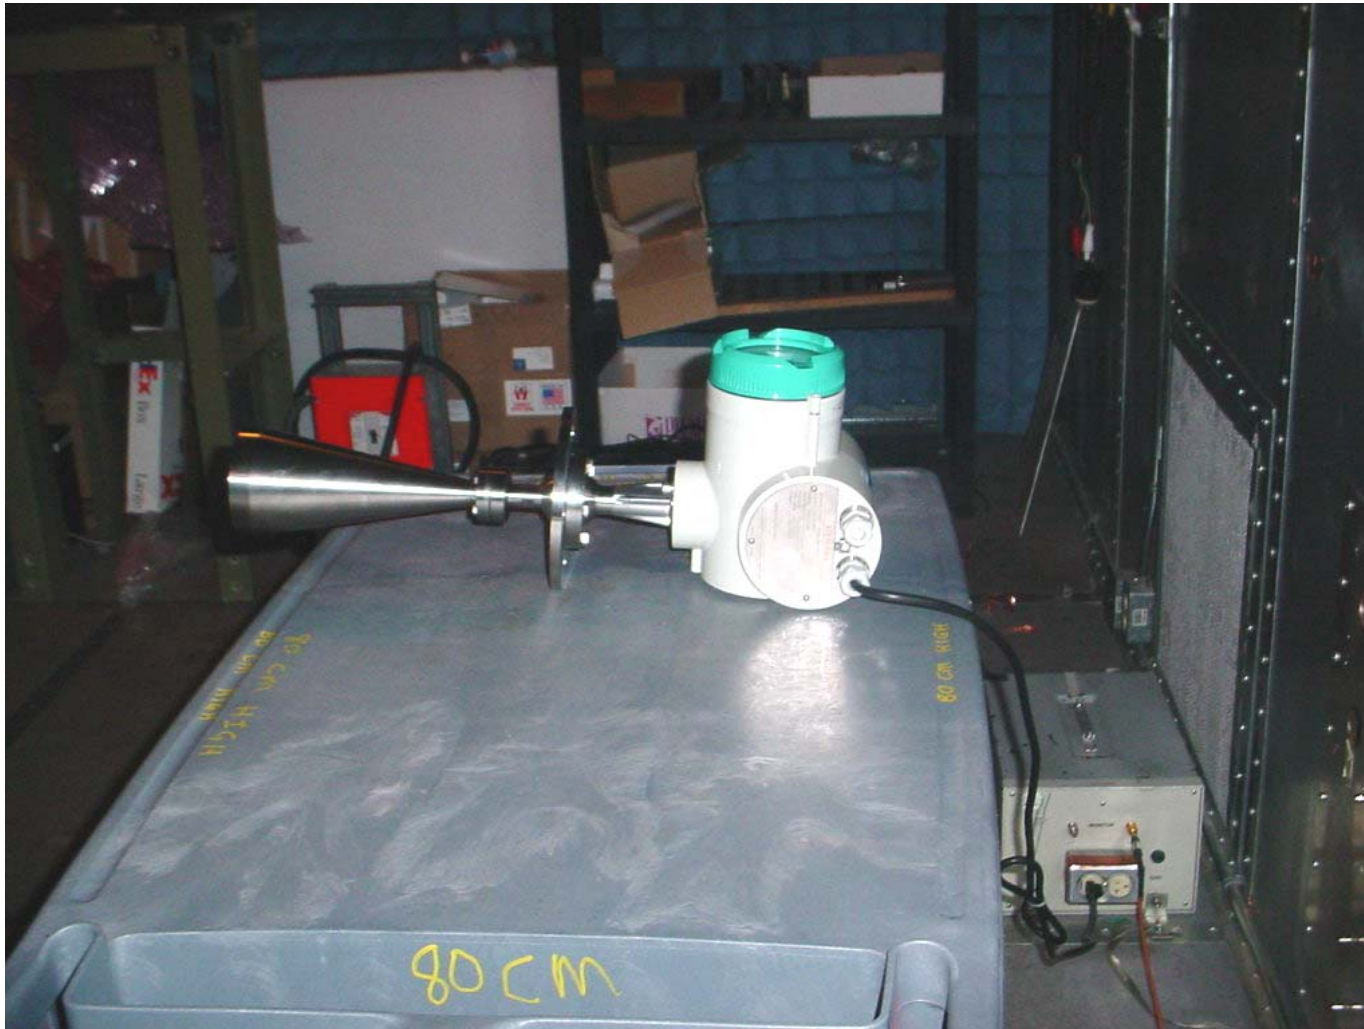
**PHOTO # 2
FCC ID: NJA-LR400-1**

AC/DC Power Line Conducted Emissions Test Setup

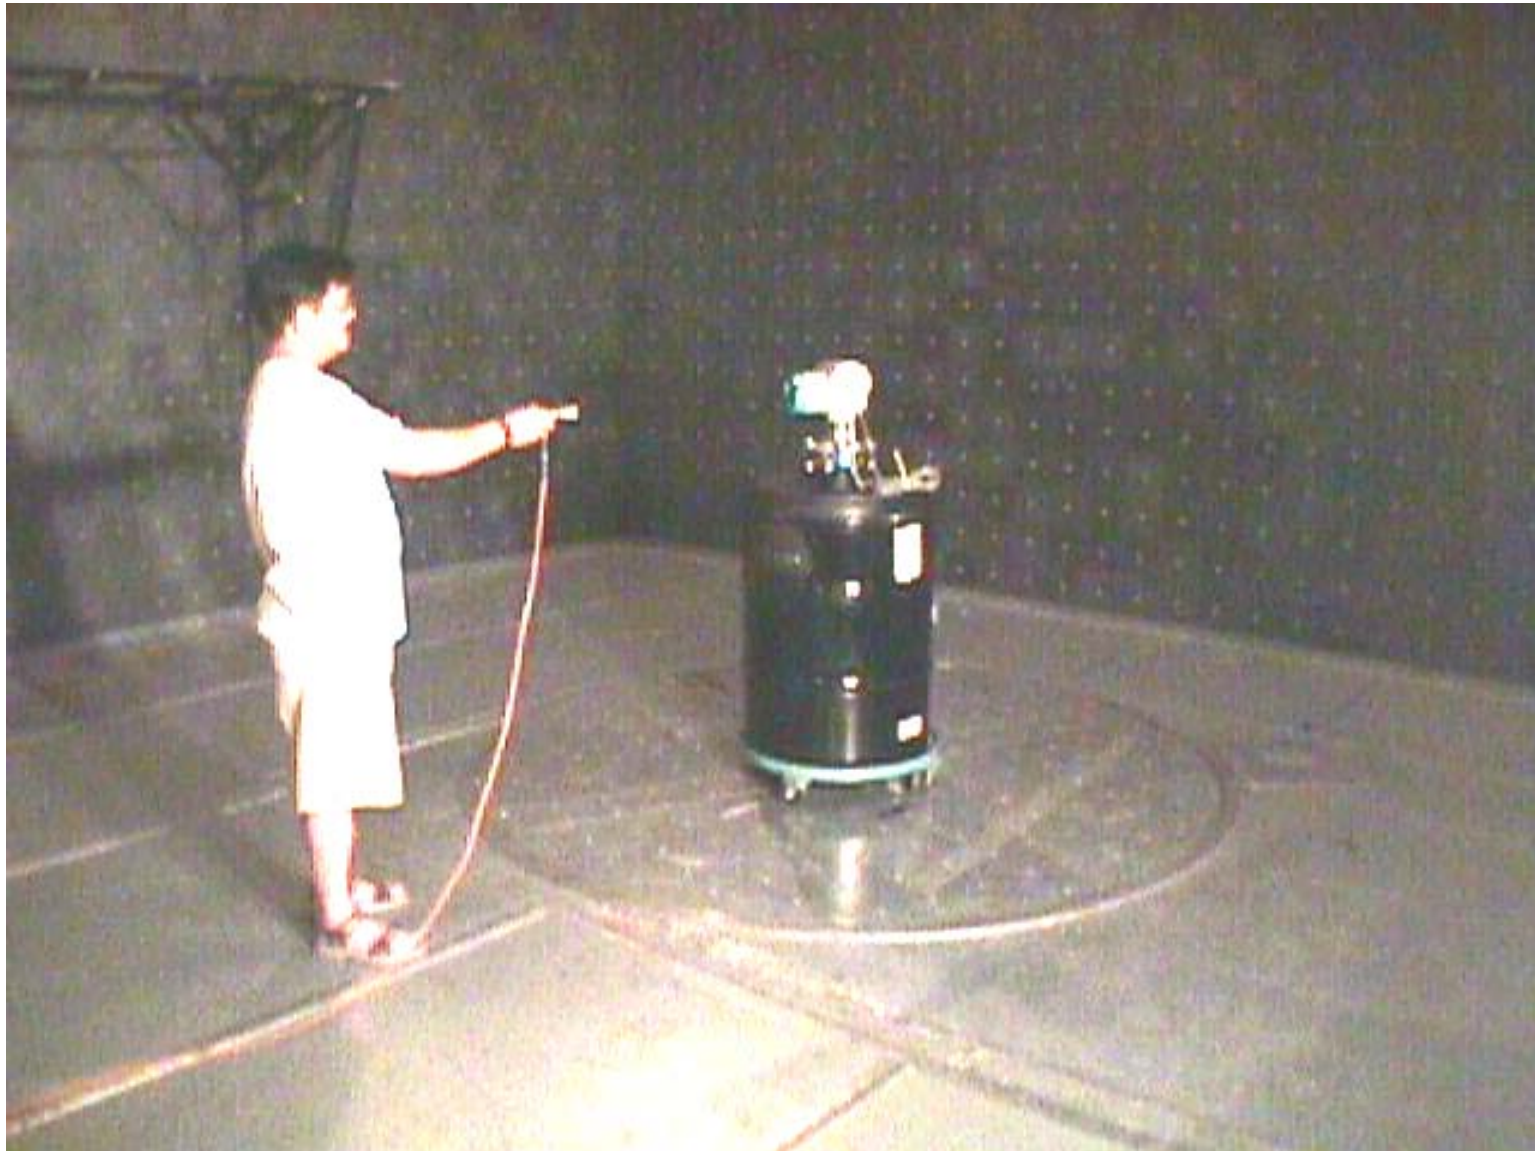
PHOTO # 3
FCC ID: NJA-LR400-1

Carrier and spurious/harmonic emissions from the Siemens Milltronics SITRANS LR, which was mounted on top of the metal tank without ventilation, were scanned using a horn antenna at 0.2, 0.5, 1.0 and 3 meters distances.

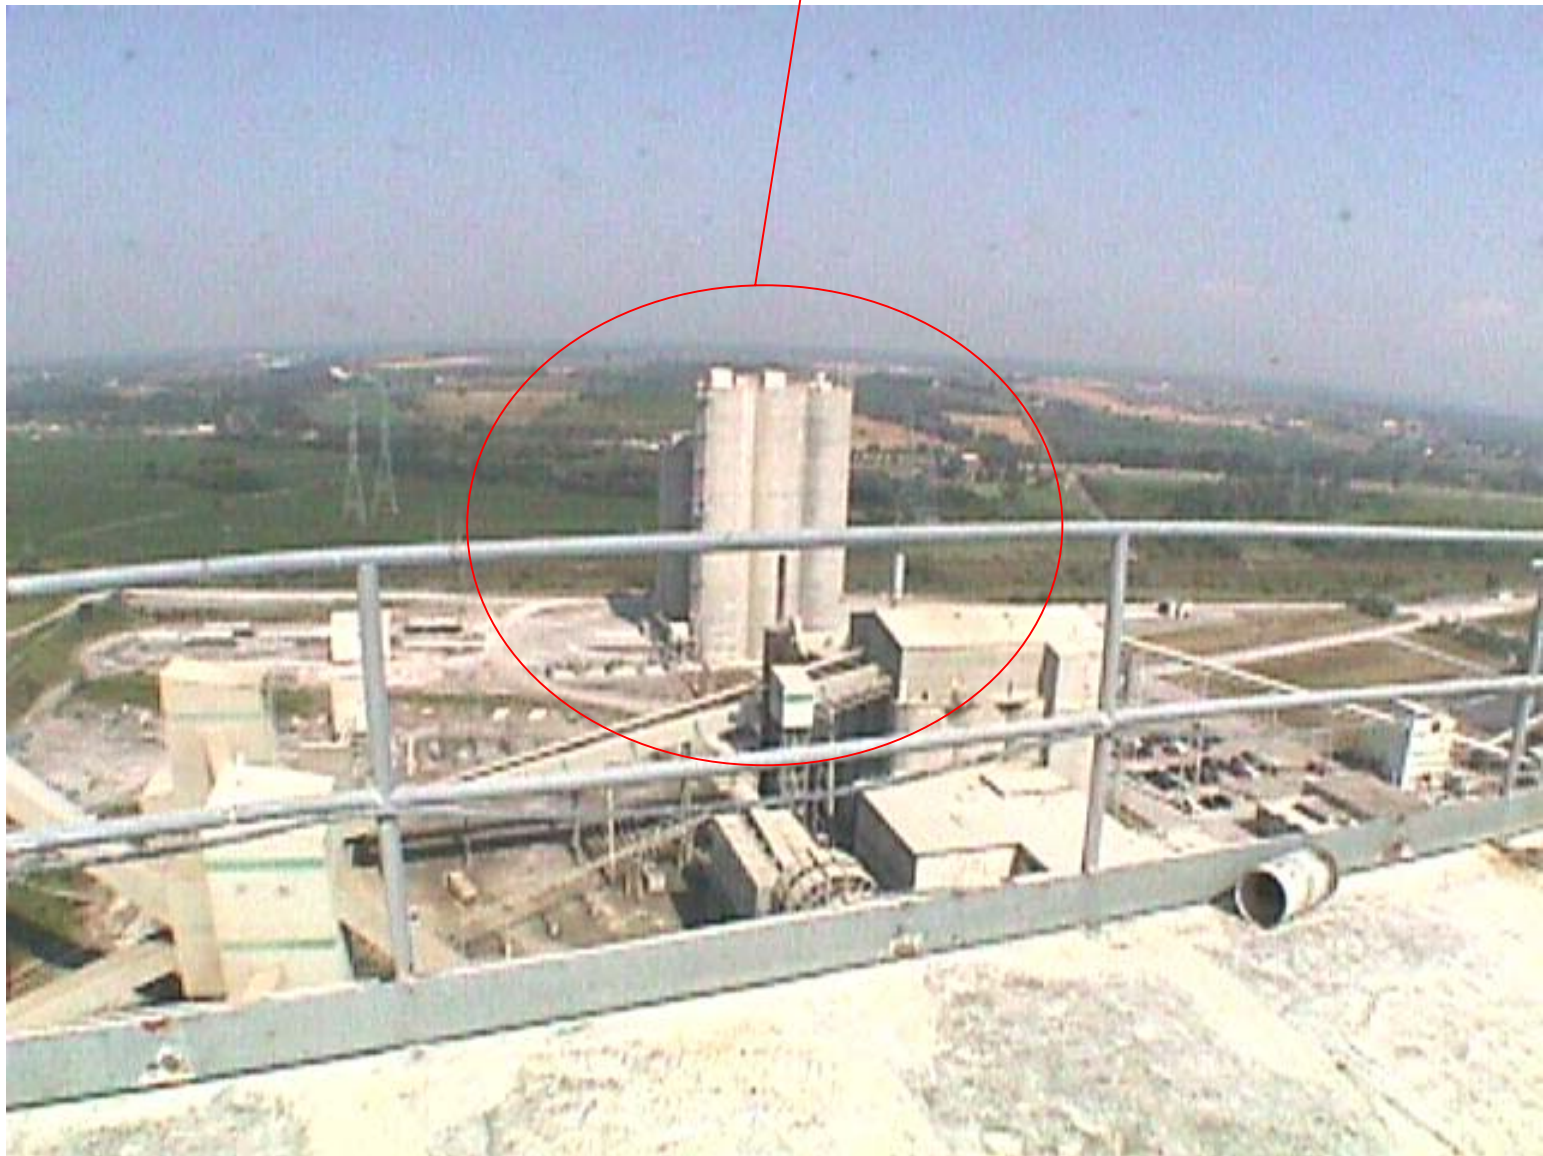
PHOTO # 4
FCC ID: NJA-LR400-1

Concrete cement tank contains cement

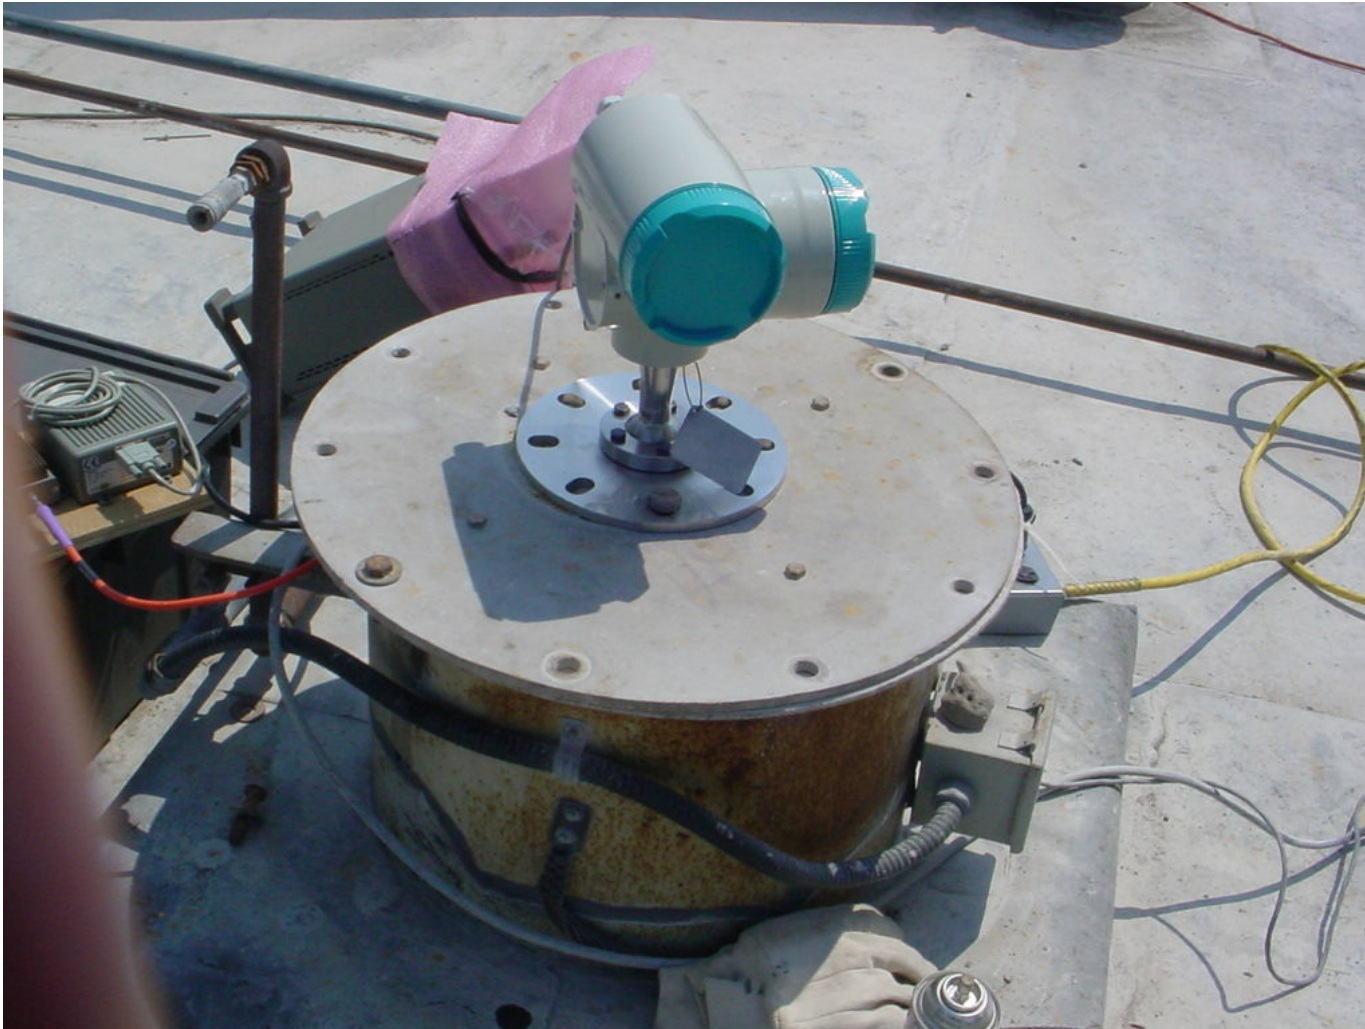
PHOTO # 5
FCC ID: NJA-LR400-1

The Siemens Milltronics SITRANS LR mounted on top of the mouth of the Concrete Tank

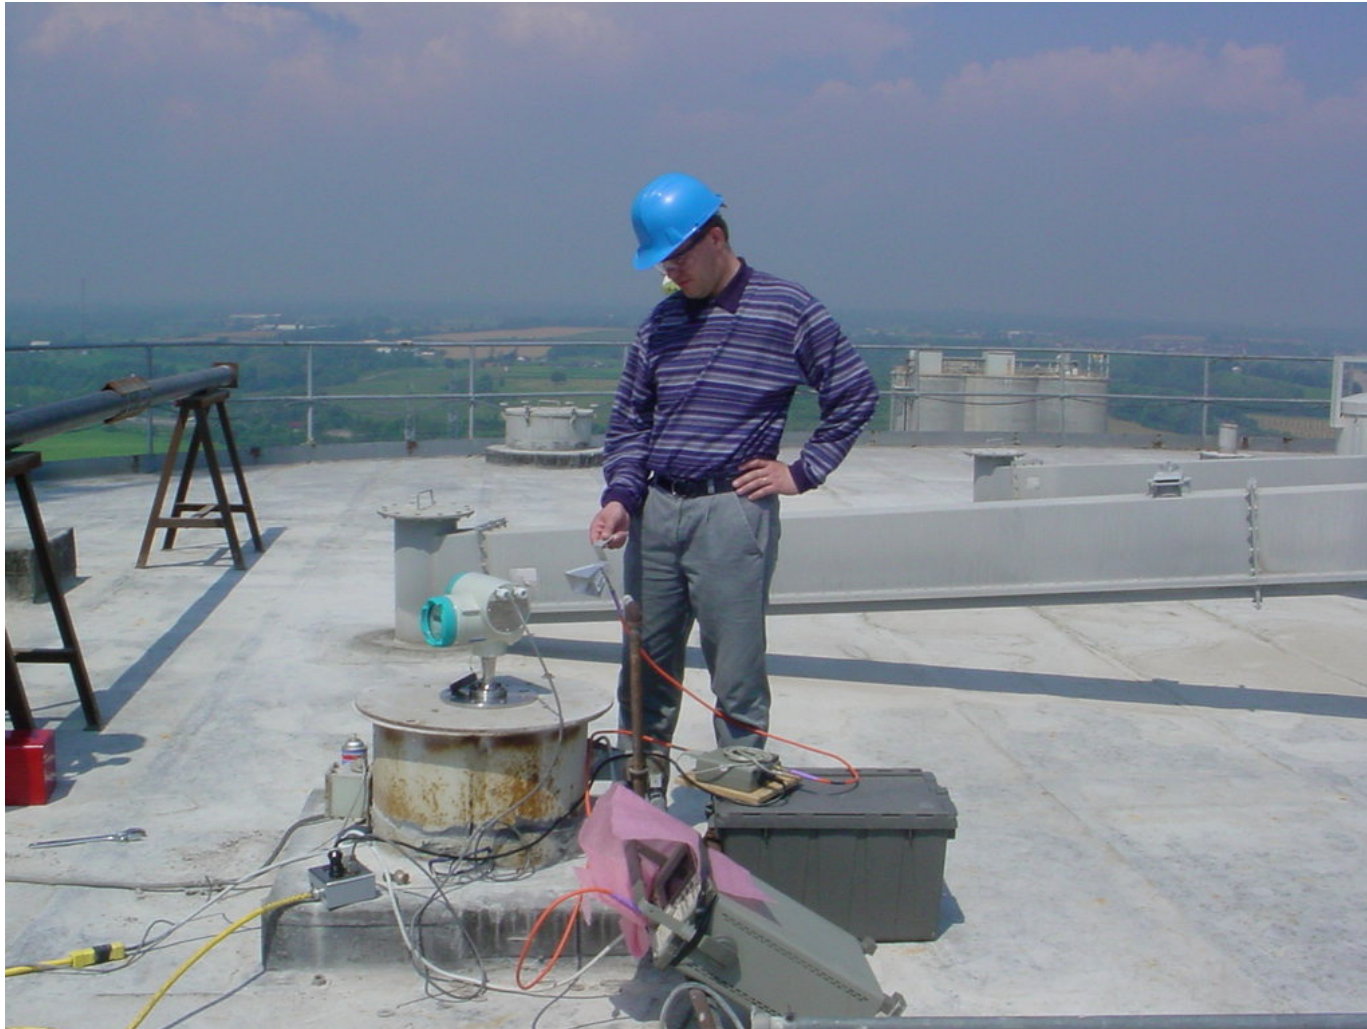
PHOTO # 6
FCC ID: NJA-LR400-1

Carrier and spurious/harmonic emissions from the Siemens Milltronics SITRANS LR , which was mounted on top of the concrete tank, were scanned using a horn antenna at 0.2, 0.5, 1.0 and 3 meters distances.
