## APPENDIX

### 10. Photographs of Test Setup

## 11. Photographs of the EUT

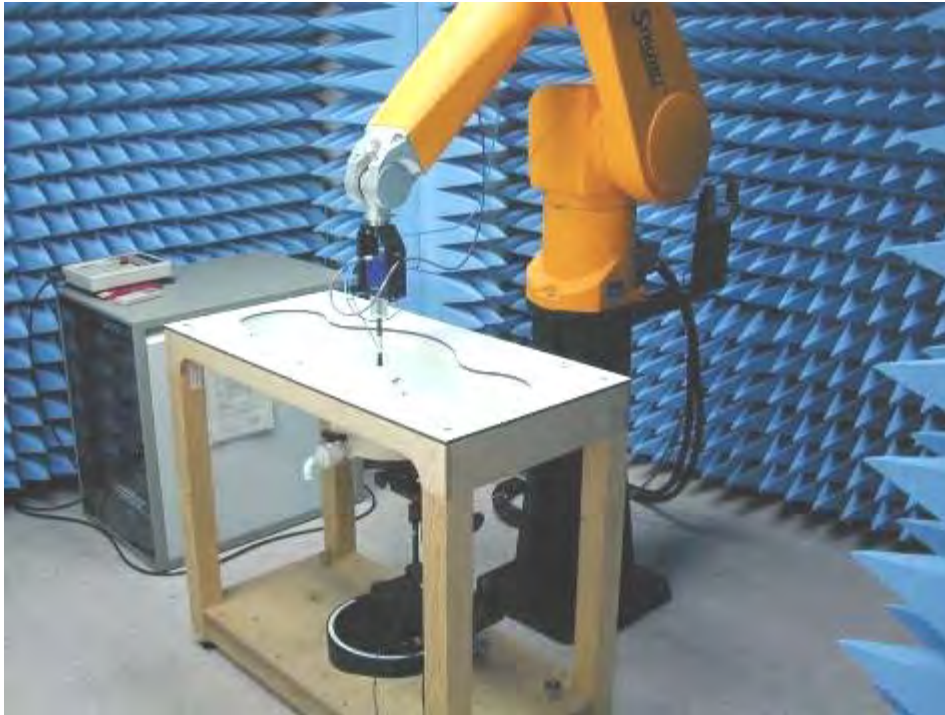
Fig.1 Photograph of the SAR measurement System

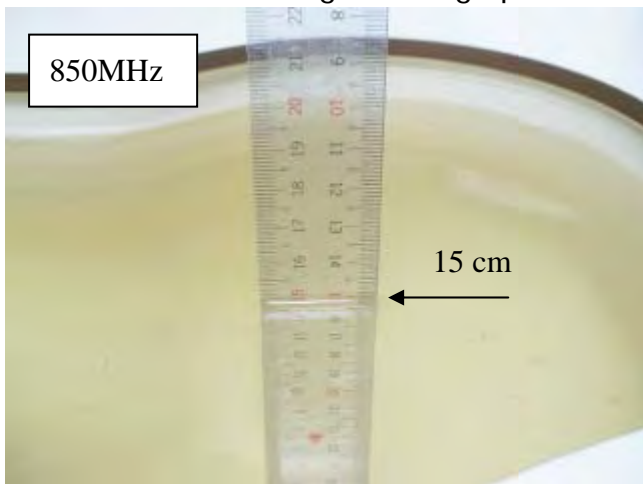
Fig.2.1 Photograph of the Tissue Simulant Fluid liquid depth 15cm for Left-head Side

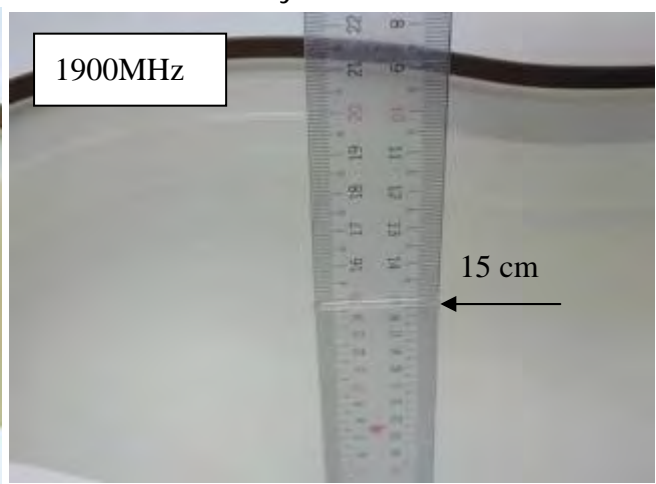
Fig.2.2 Photograph of the Tissue Simulant Fluid liquid depth 15cm for Right-head Side

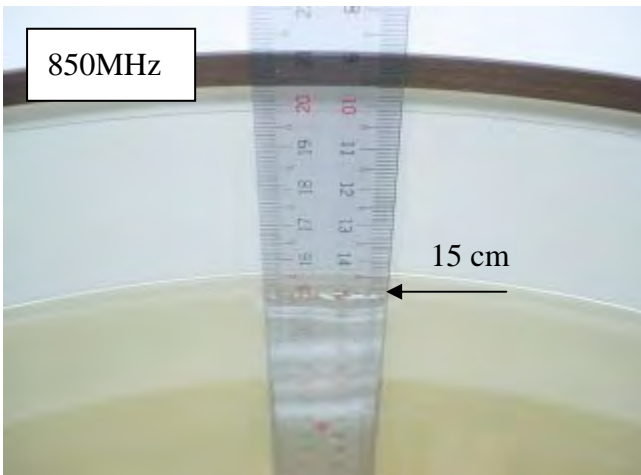
Fig.2.3 Photograph of the Tissue Simulant Fluid liquid depth 15cm for Flat (Body)

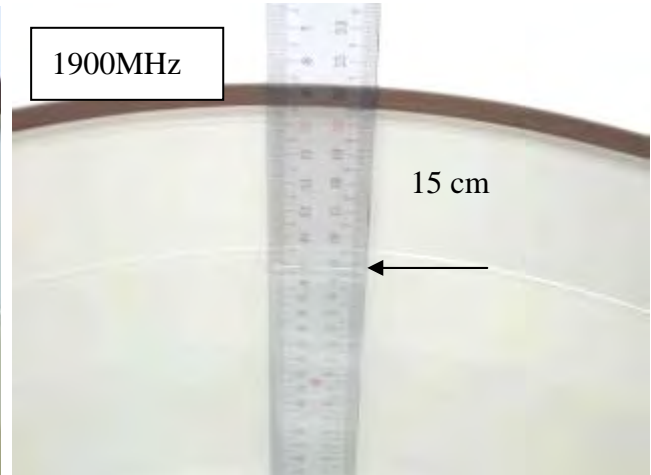
Fig.2.4 Photograph of the Tissue Simulant Fluid liquid depth 15cm for Flat (Body)

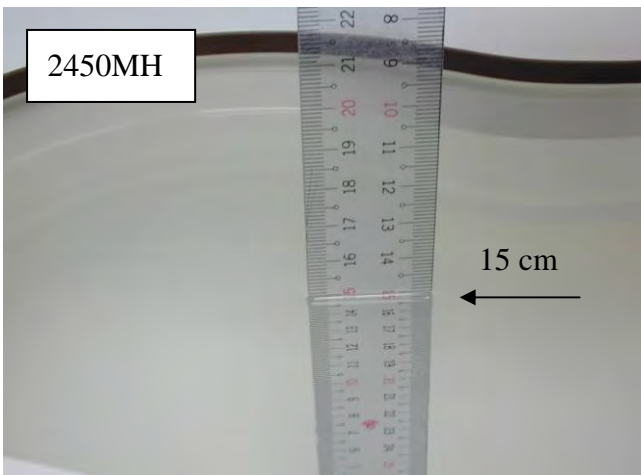
Fig.2.5 Photograph of the Tissue Simulant Fluid liquid depth 15cm for Left-head Side

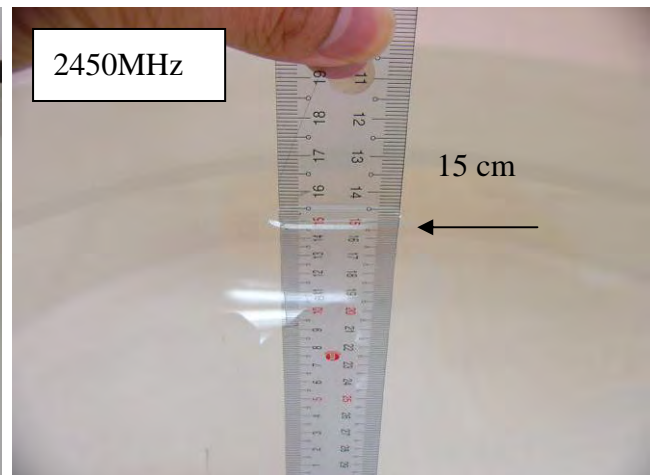
Fig.2.6 Photograph of the Tissue Simulant Fluid liquid depth 15cm for Flat (Body)

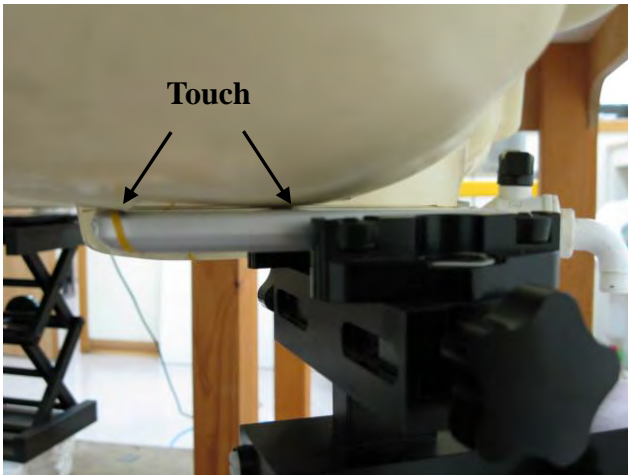
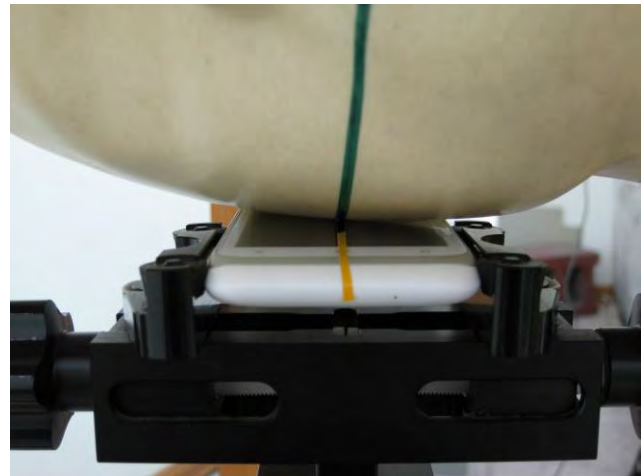
Fig.3 Right Head Section / Cheek-Touch Position

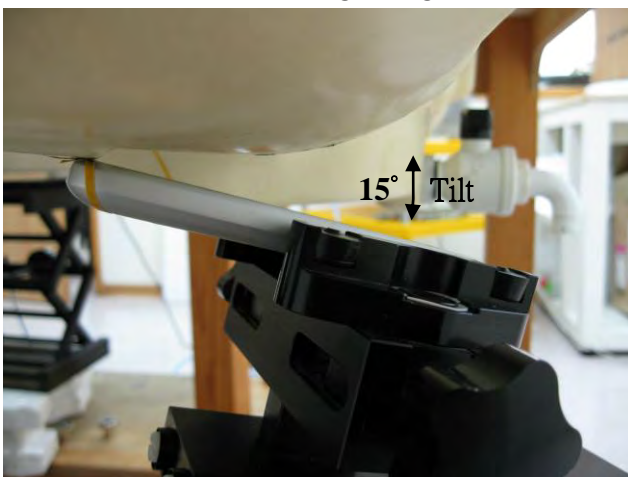
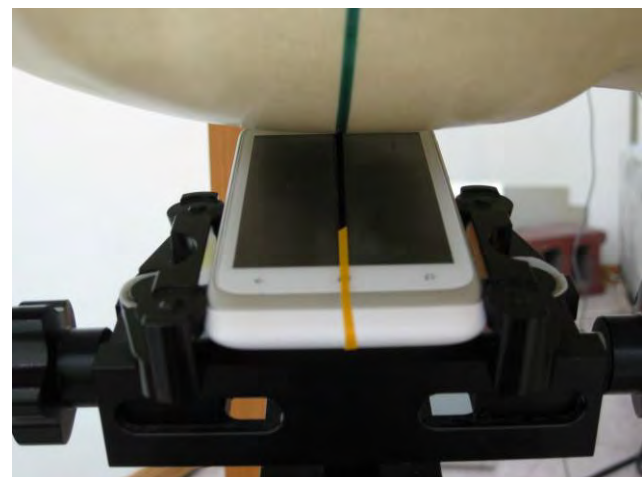
Fig.4 Right Head Section / Ear-Tilt Position(15°)

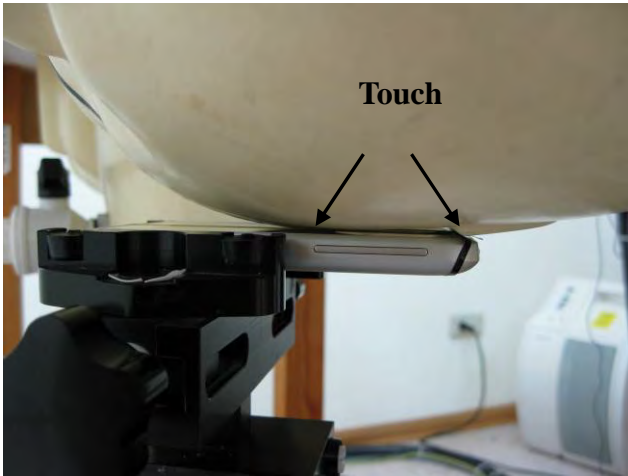
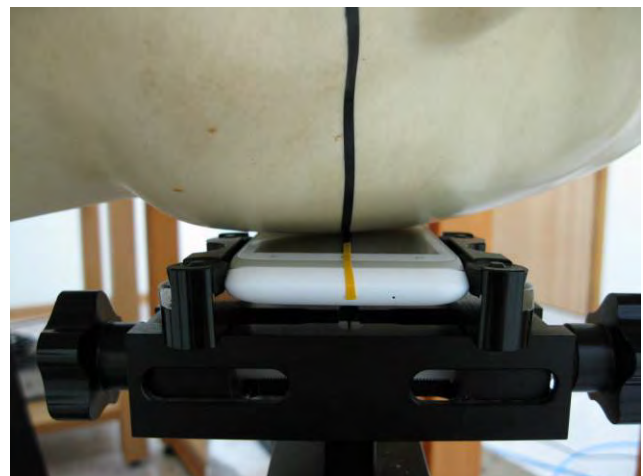
Fig.5 Left Head Section / Cheek-Touch Position

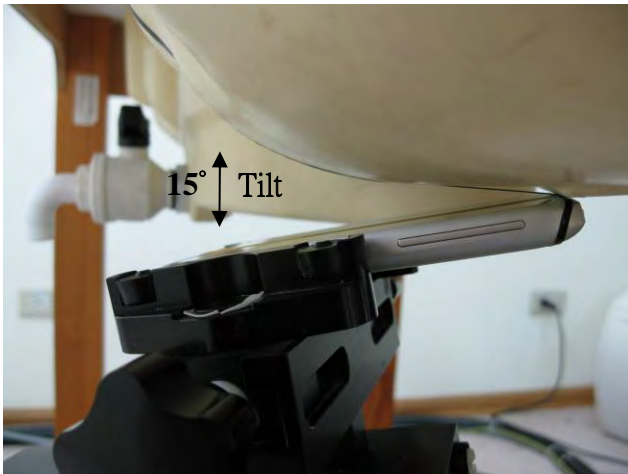
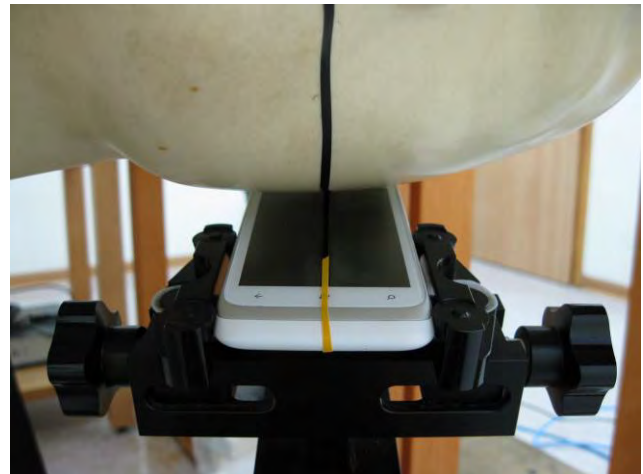
Fig.6 Left Head Section / Ear-Tilt Position(15°)

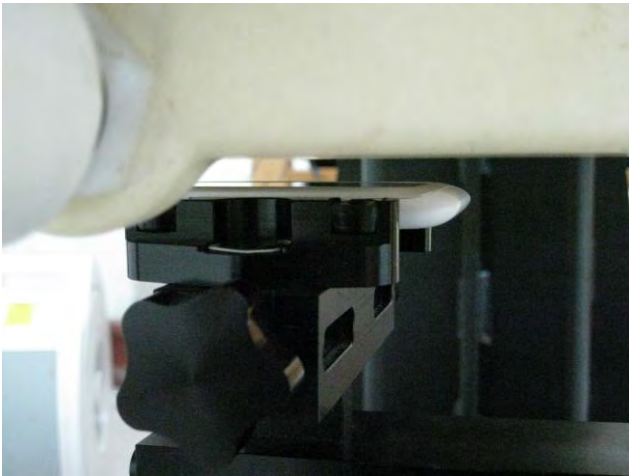
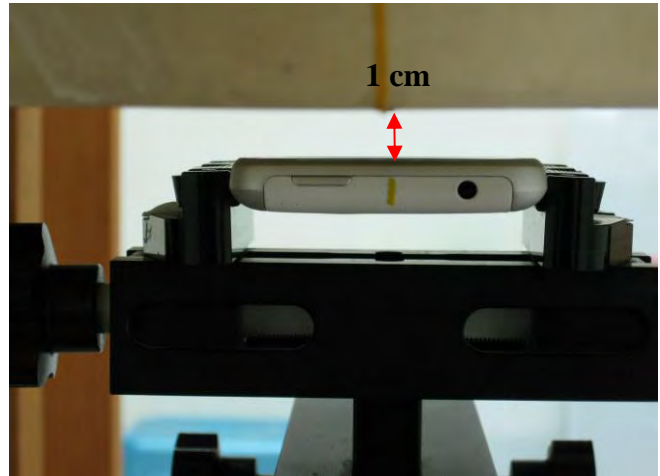
Fig.7 Hotspot mode- EUT front to flat phantom and distance between flat phantom and mobile phone is 1 cm.

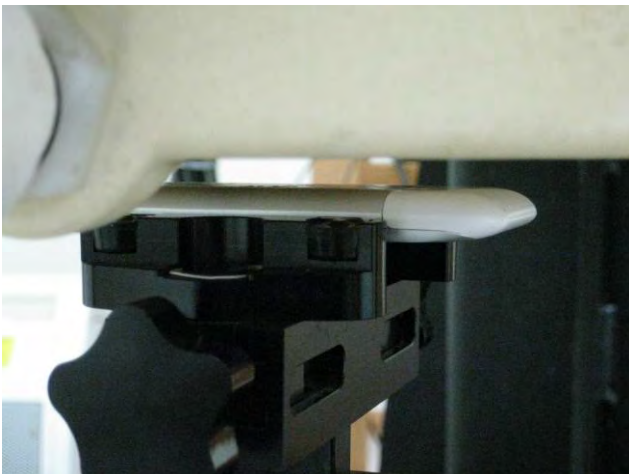
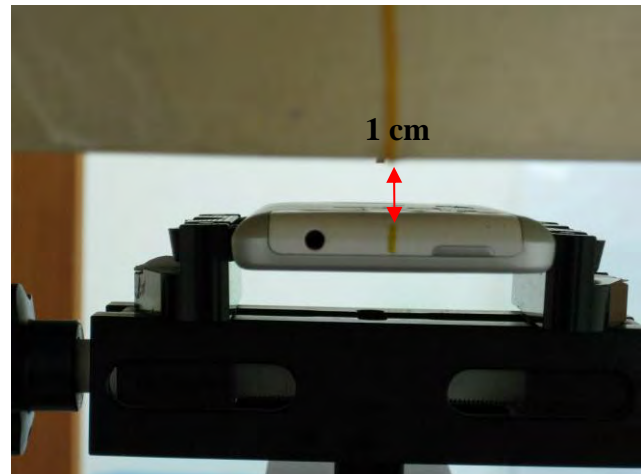
Fig.8 Hotspot mode- EUT back to flat phantom and distance between flat phantom and mobile phone is 1 cm.

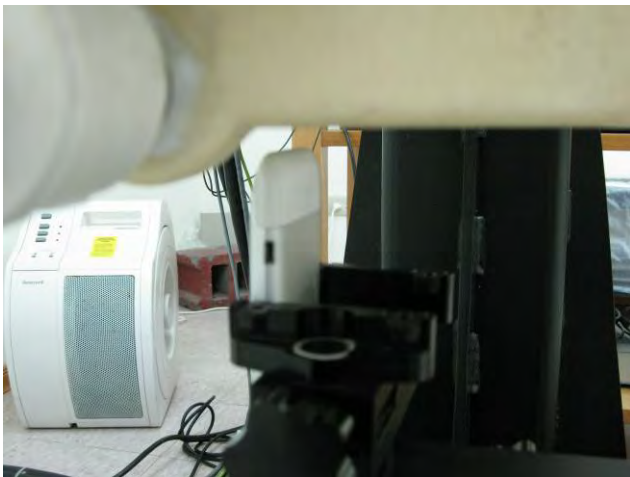
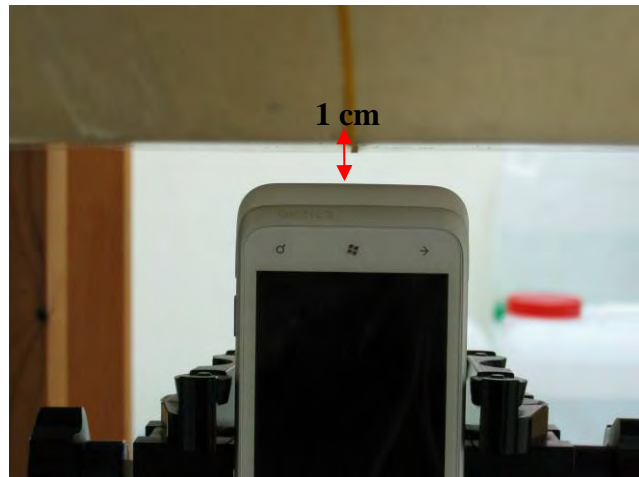
Fig.9 Hotspot mode- EUT Bottom to flat phantom and distance between flat phantom and mobile phone is 1 cm.

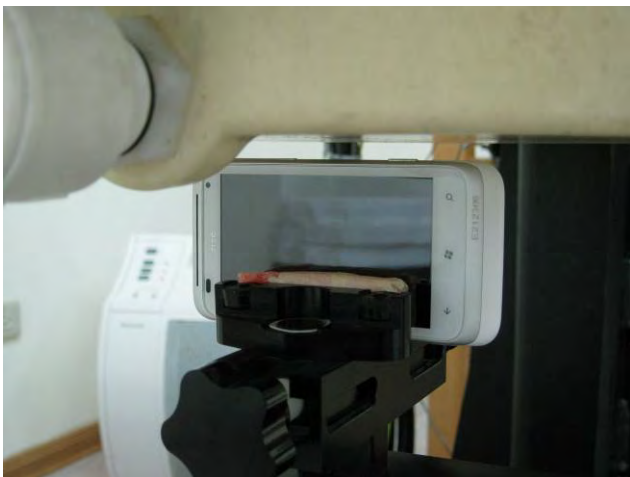
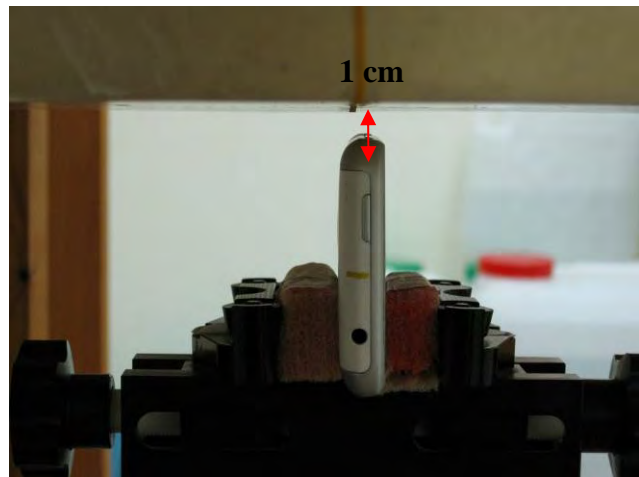
Fig.11 Hotspot mode- EUT Right to flat phantom and distance between flat phantom and mobile phone is 1 cm.

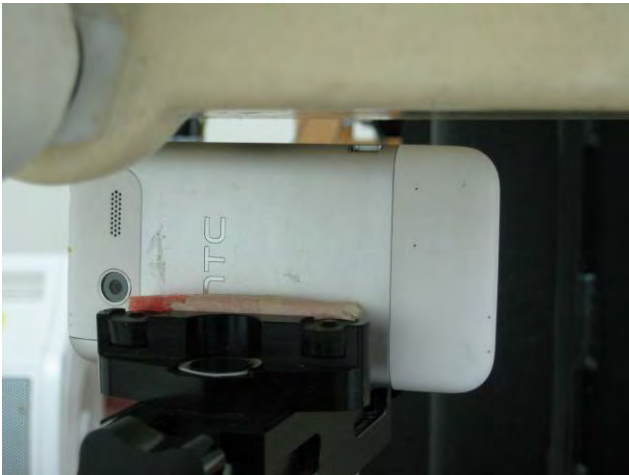
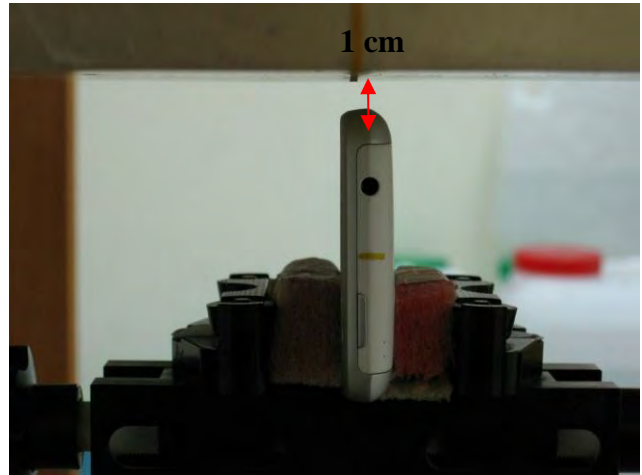
Fig.11 Hotspot mode- EUT Left to flat phantom and distance between flat phantom and mobile phone is 1 cm.

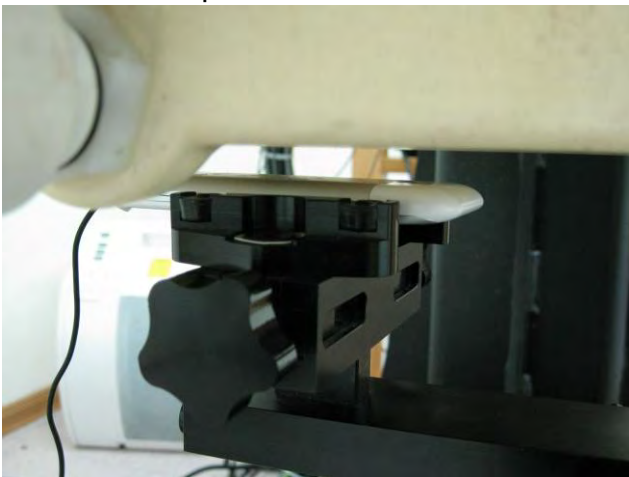
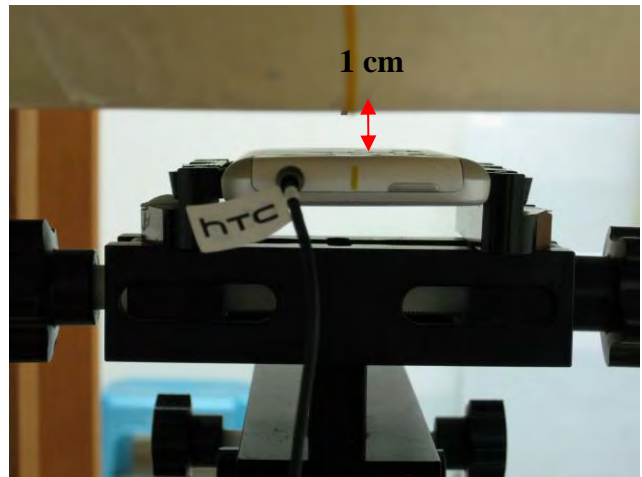
Fig.12 Hotspot mode- EUT Back to flat phantom and distance between flat phantom and mobile phone is 1 cm\_ repeated with Headset.

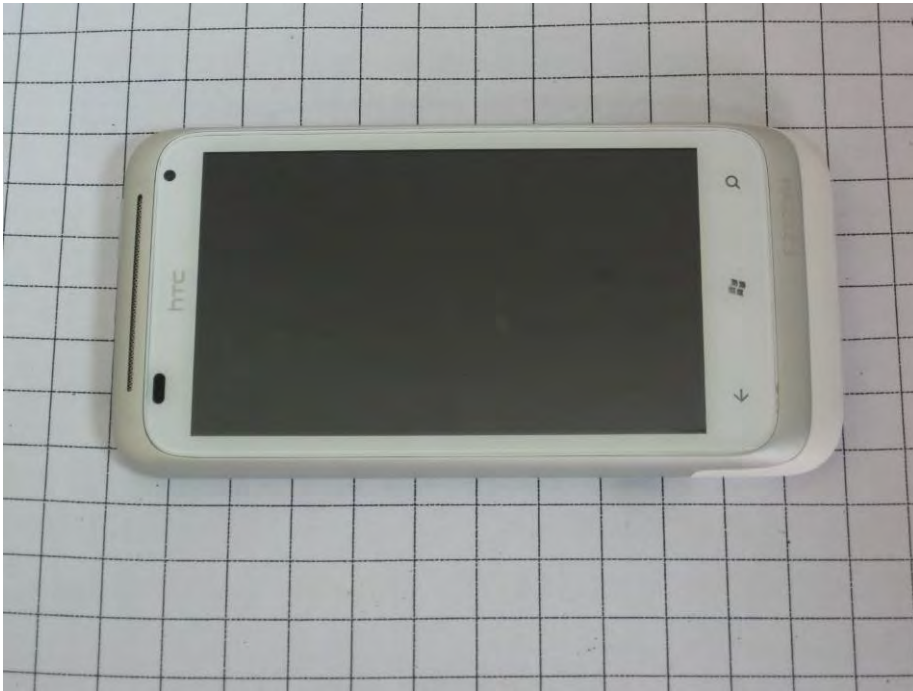
Fig.13 Front view of device

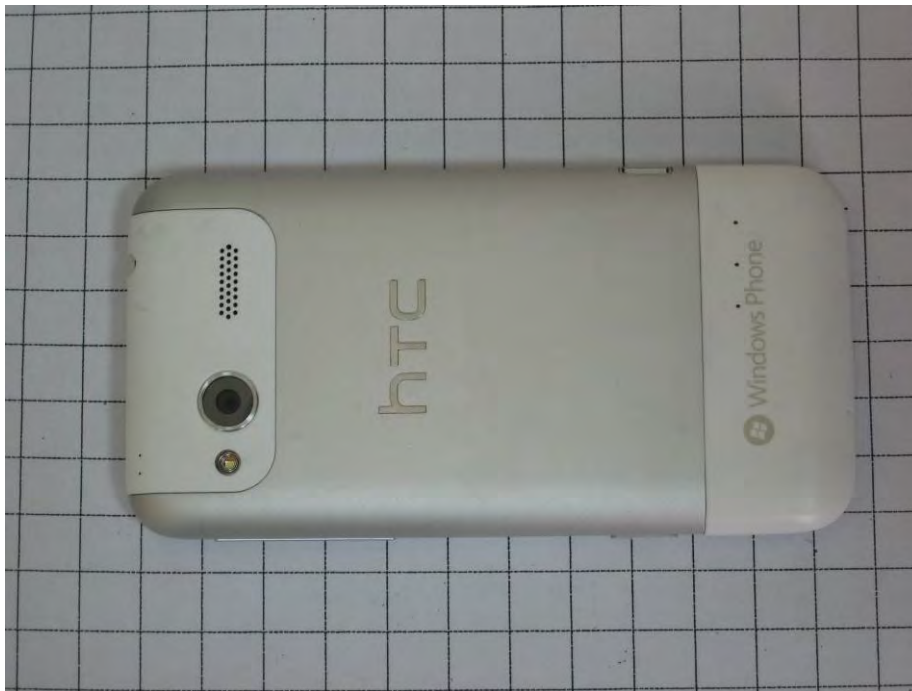
Fig.14 Back view of device

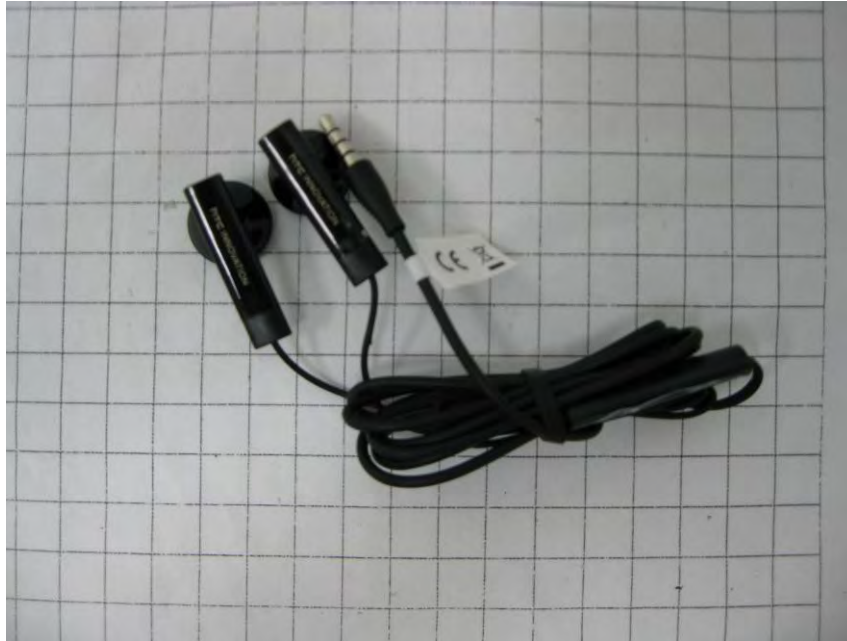
Fig.15 Headset  
(Supplier name : Cotron Model name : HS G400 )

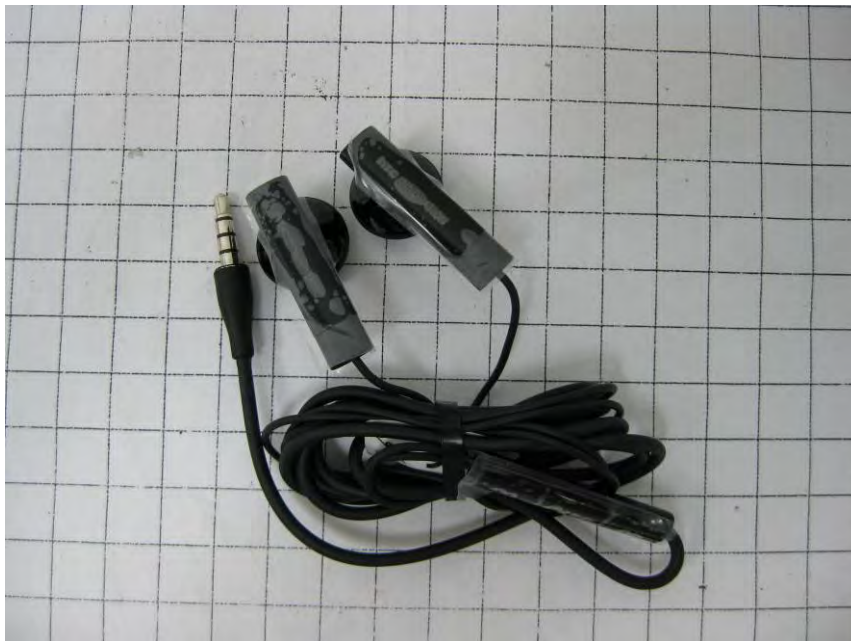
Fig.16 Headset  
(Supplier name: Foste Model name: HS G400 )

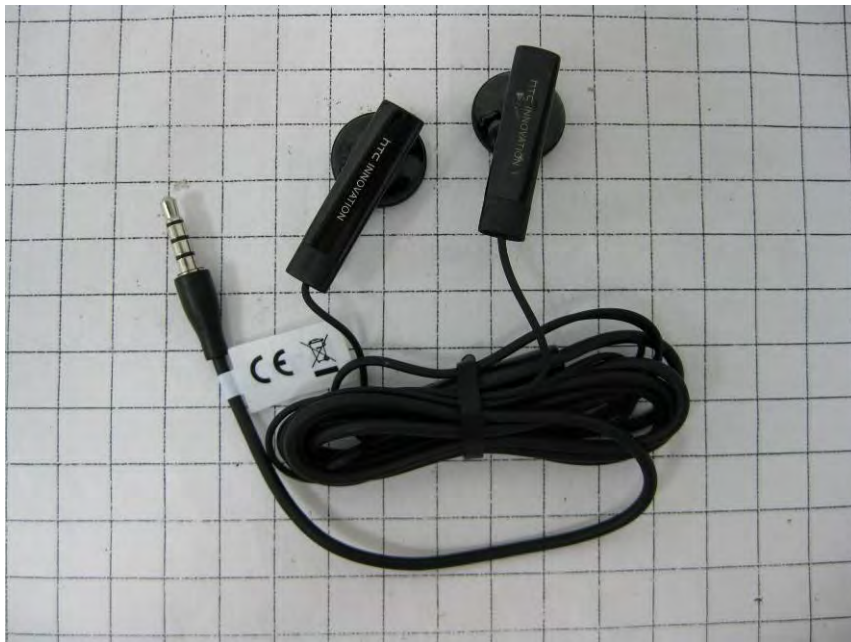
Fig.17 Headset  
(Supplier name : Merry Model name : HS G400 )

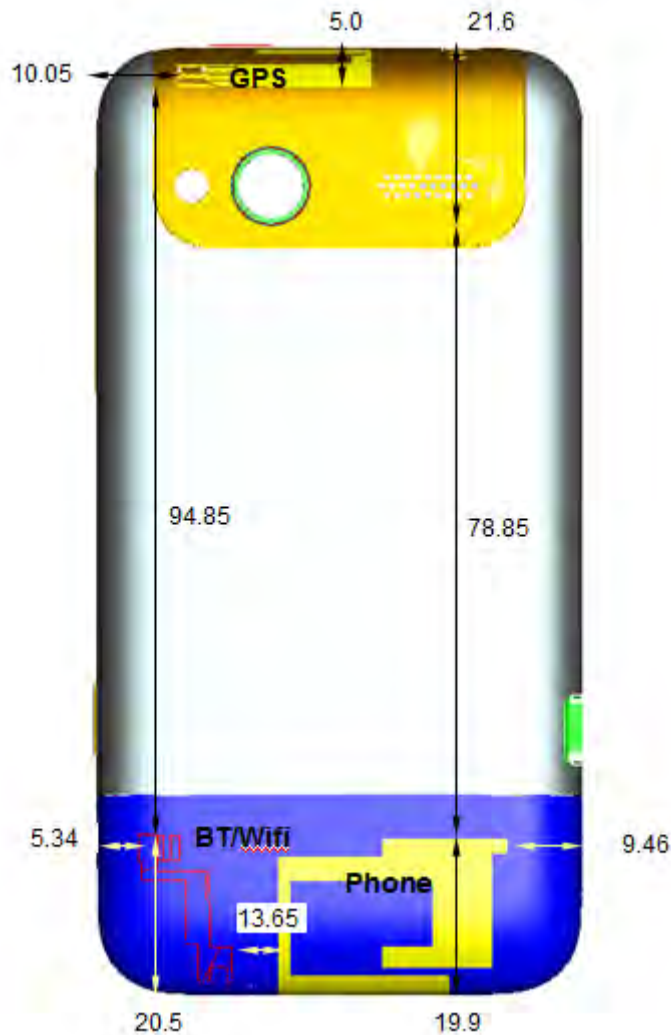
Fig.18 Antenna position of EUT (Unit: mm)
