# Intertek Testing Services

Mode = TX

Report No.: 9809825

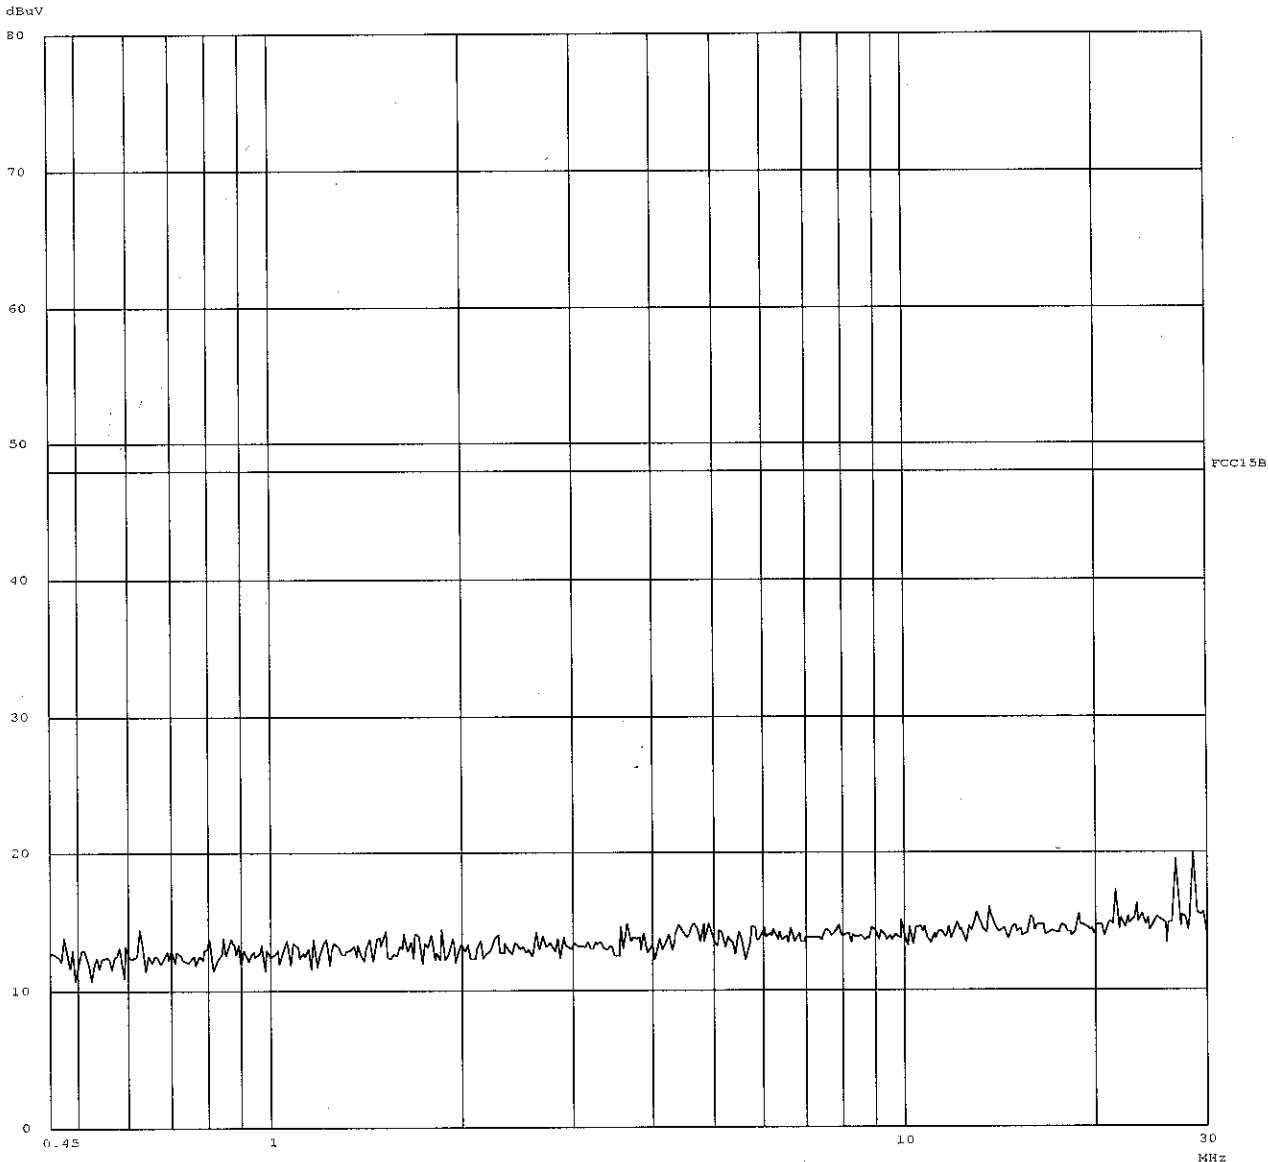
Scan Settings (1 Range)

Frequencies				Receiver Settings					
Start	Stop	Step	IF BW	Detector	M-Time	Atten	Preamp	OpRge	
450k	30M	5k	10k	PK	20ms	AUTO	LN	OFF 60dB

Final Measurement: N QP

Meas Time: 1 s  
 Subranges: 16  
 Acc Margin: 20dB

Transducer No.	Start	Stop	Name
3	9k	30M	EI078

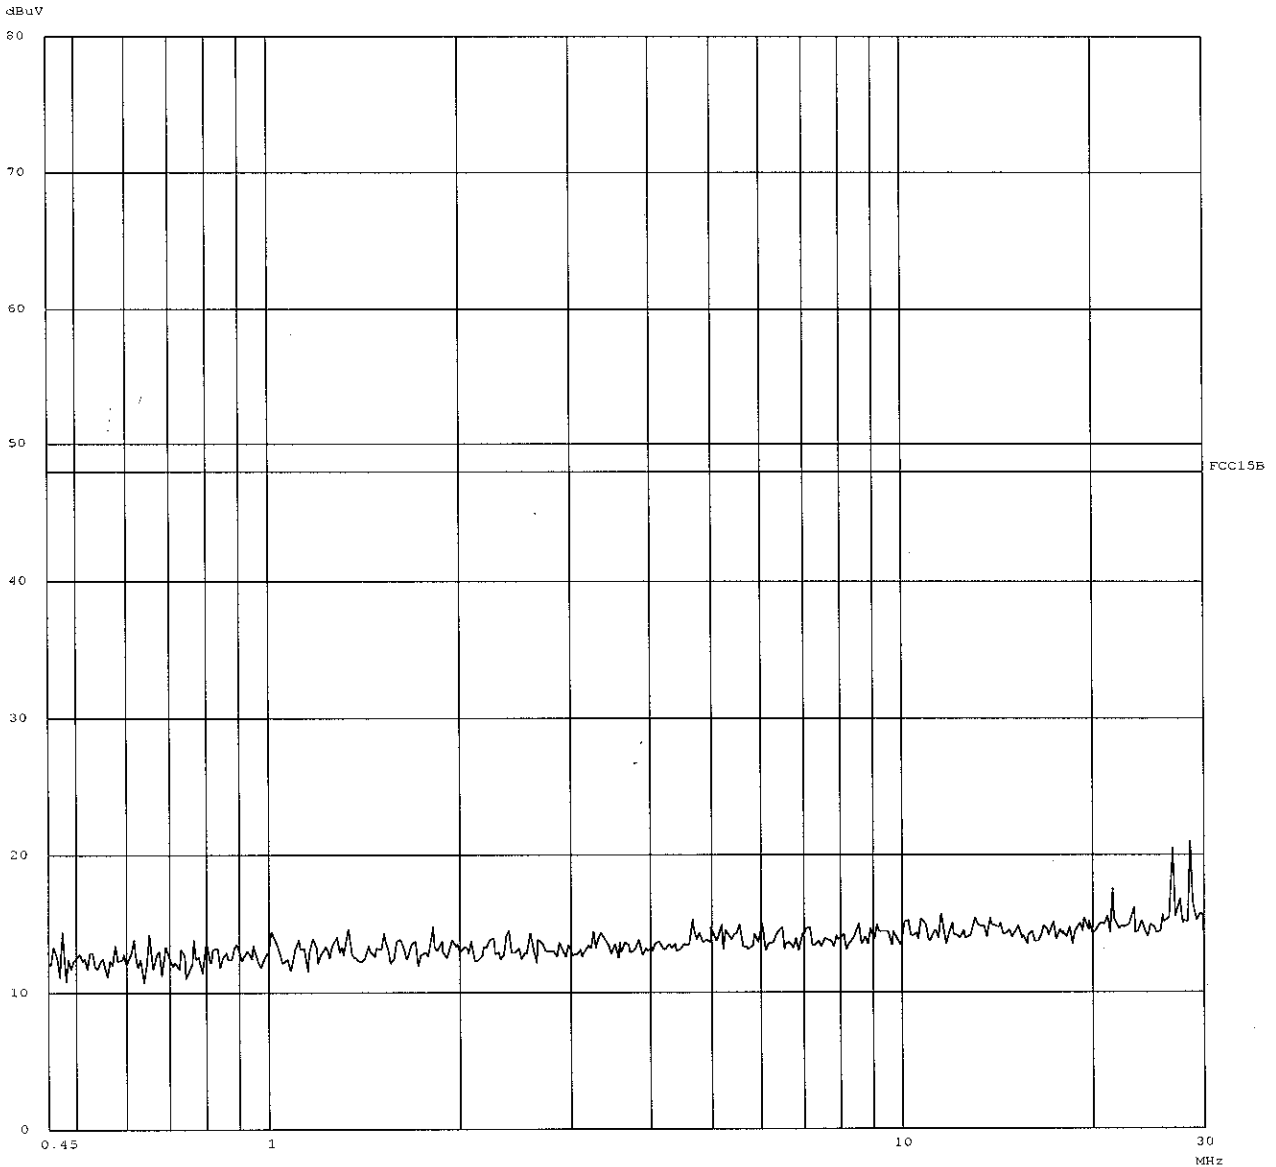
Mode = Standby

Scan Settings (1 Range)

Frequencies			Receiver Settings					
Start	Stop	Step	IF BW	Detector	M-Time	Atten	Preamp	OpRge
450k	30M	5k	10k	PK	20ms	AUTO	LN OFF	60dB

Final Measurement: X QP

Transducer No.	Start	Stop	Name
2	9k	30M	EI078

Meas Time: 1 s  
 Subranges: 16  
 Acc Margin: 20dB

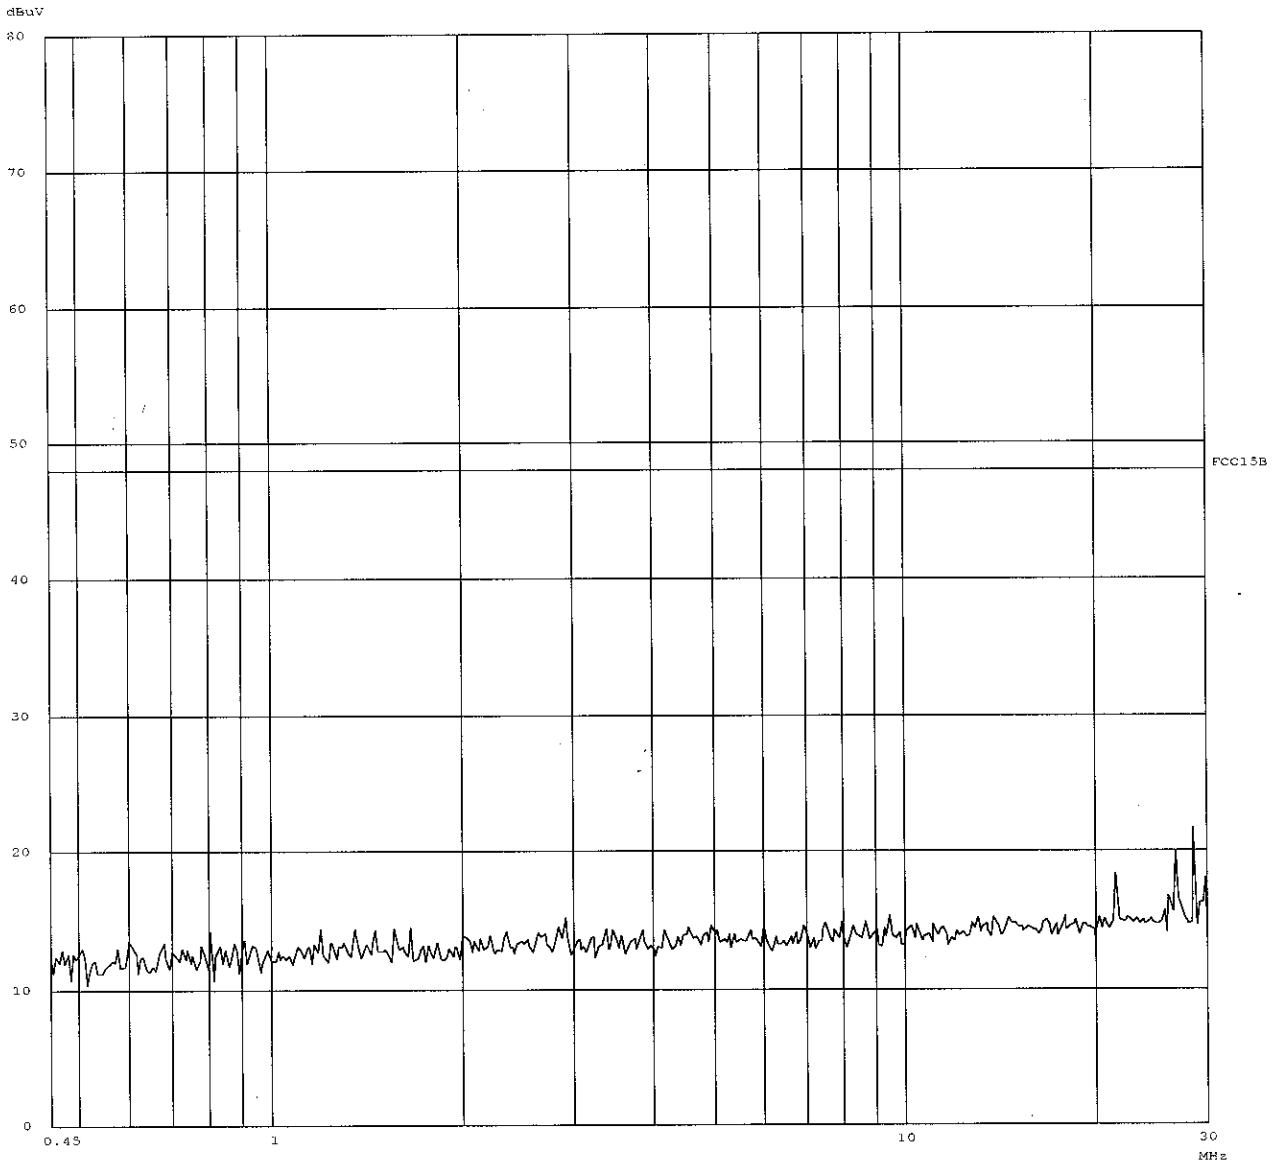
Mode = Charging

Scan Settings (1 Range)

Frequencies				Receiver Settings			
Start	Stop	Step	IF BW	Detector	M-Time	Atten	Preamp
450k	30M	5k	10k	PK	20ms	AUTO	LN OFF

Transducer No.	Start	Stop	Name
3	9k	30M	EI078

Final Measurement: 2 QP  
 Meas Time: 1 s  
 Subranges: 16  
 Acc Margin: 20dB
