Intertek Testing Services

Report No.: 9904580
 Mode: Charging

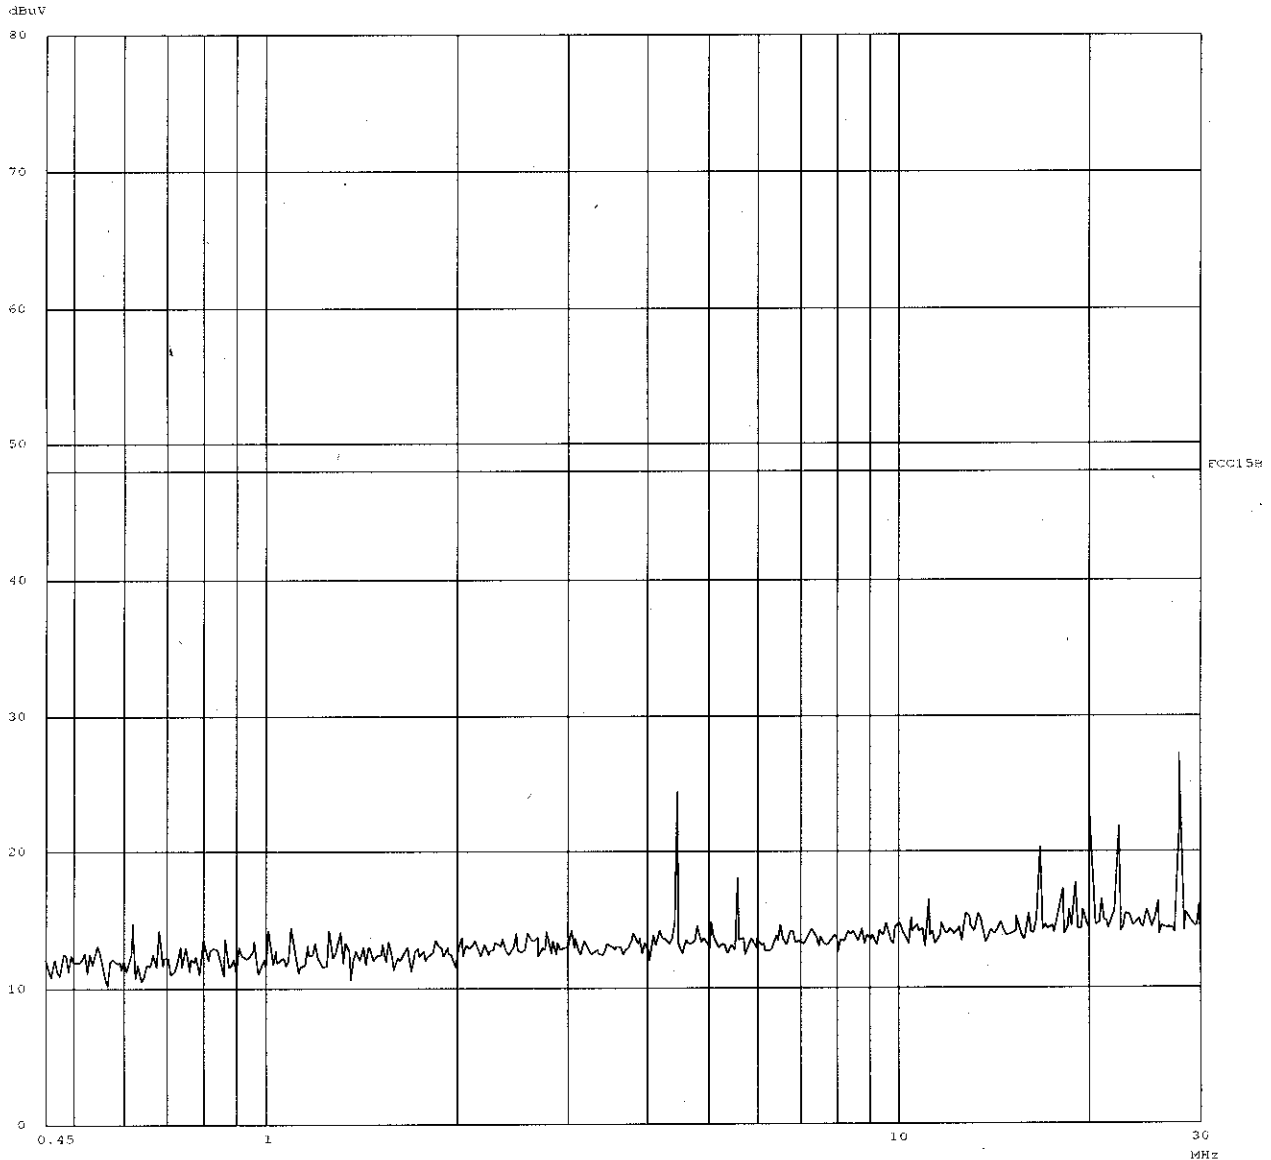
Scan Settings (1 Range)

Frequencies			Receiver Settings						
Start	Stop	Step	IF BW	Detector	M-Time	Atten	Preamp	OpRge	
450k	30M	5k	10K	PK	20ms	AUTO	LN	OFF	60dB

Final Measurement: NQP

Transducer No. Start Stop Name
 3 9k 30M EI078

Meas Time: 1 s
 Subranges: 16
 Acc Margin: .20dB

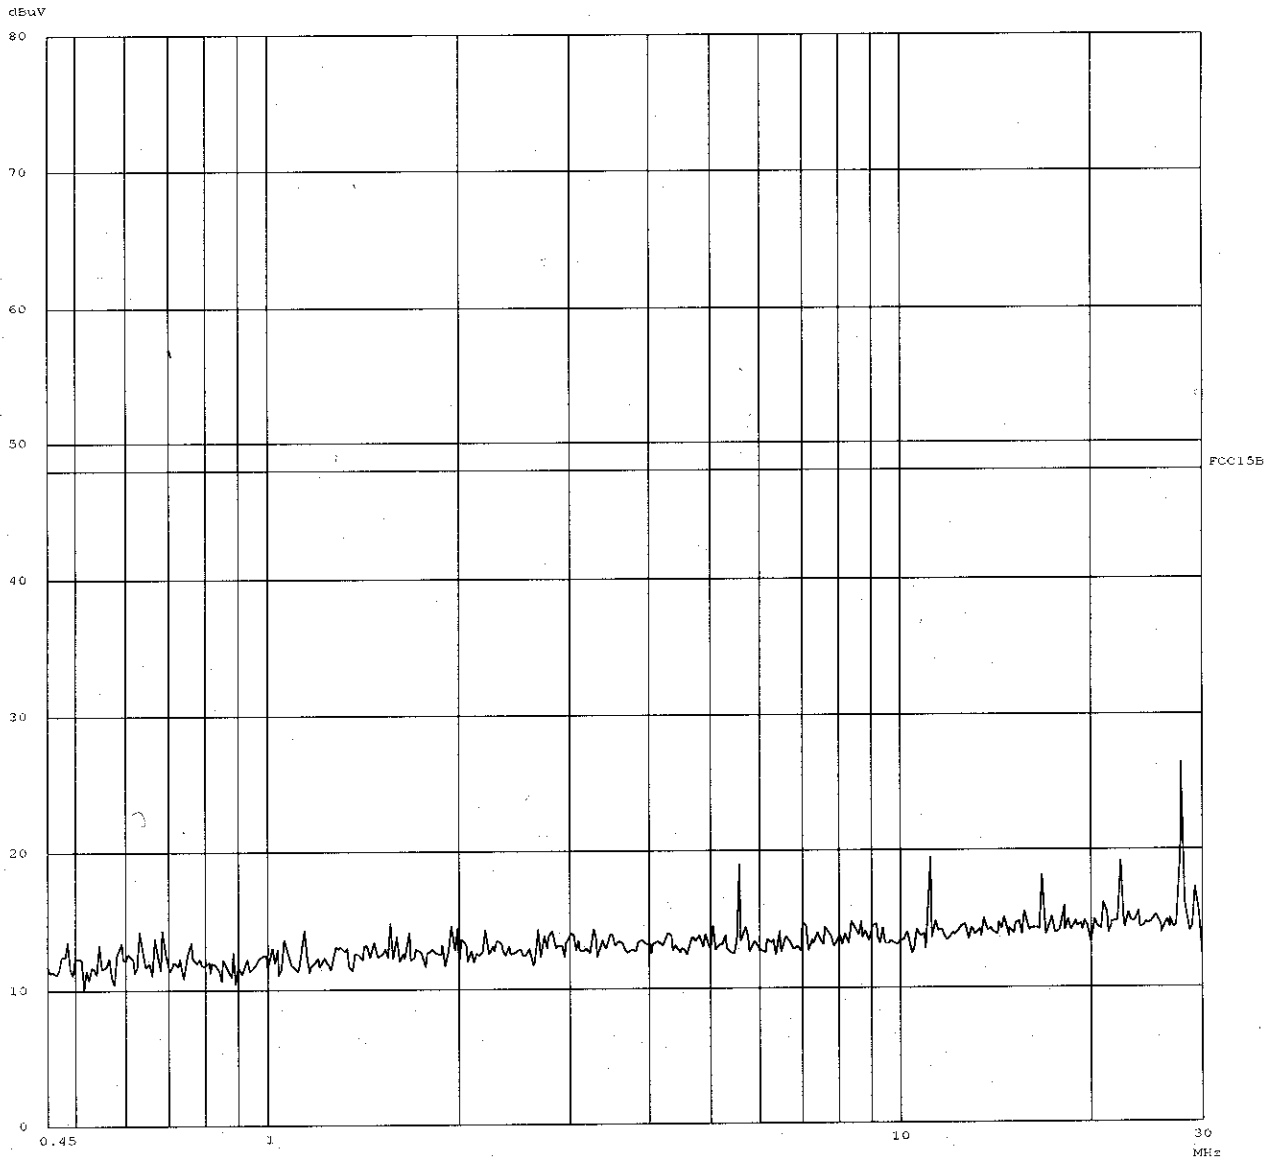
Report No.: 9904580
Mode: Standby

Tested By: Hong, Report No.: 9904580
Scan Settings (1 Range)

Frequencies		Receiver Settings						
Start	Stop	Stop	IF BW	Detector	M-Time	Atten	Preamp	OpRge
450k	30M	5k	10k	PK	20ms	AUTO	LN OFF	60dB

Final Measurement: \times QP
Transducer No. Start Stop Name
3 9k 30M EI078
Meas Time: 1 s
Subranges: 16
Acc Margin: 20dB

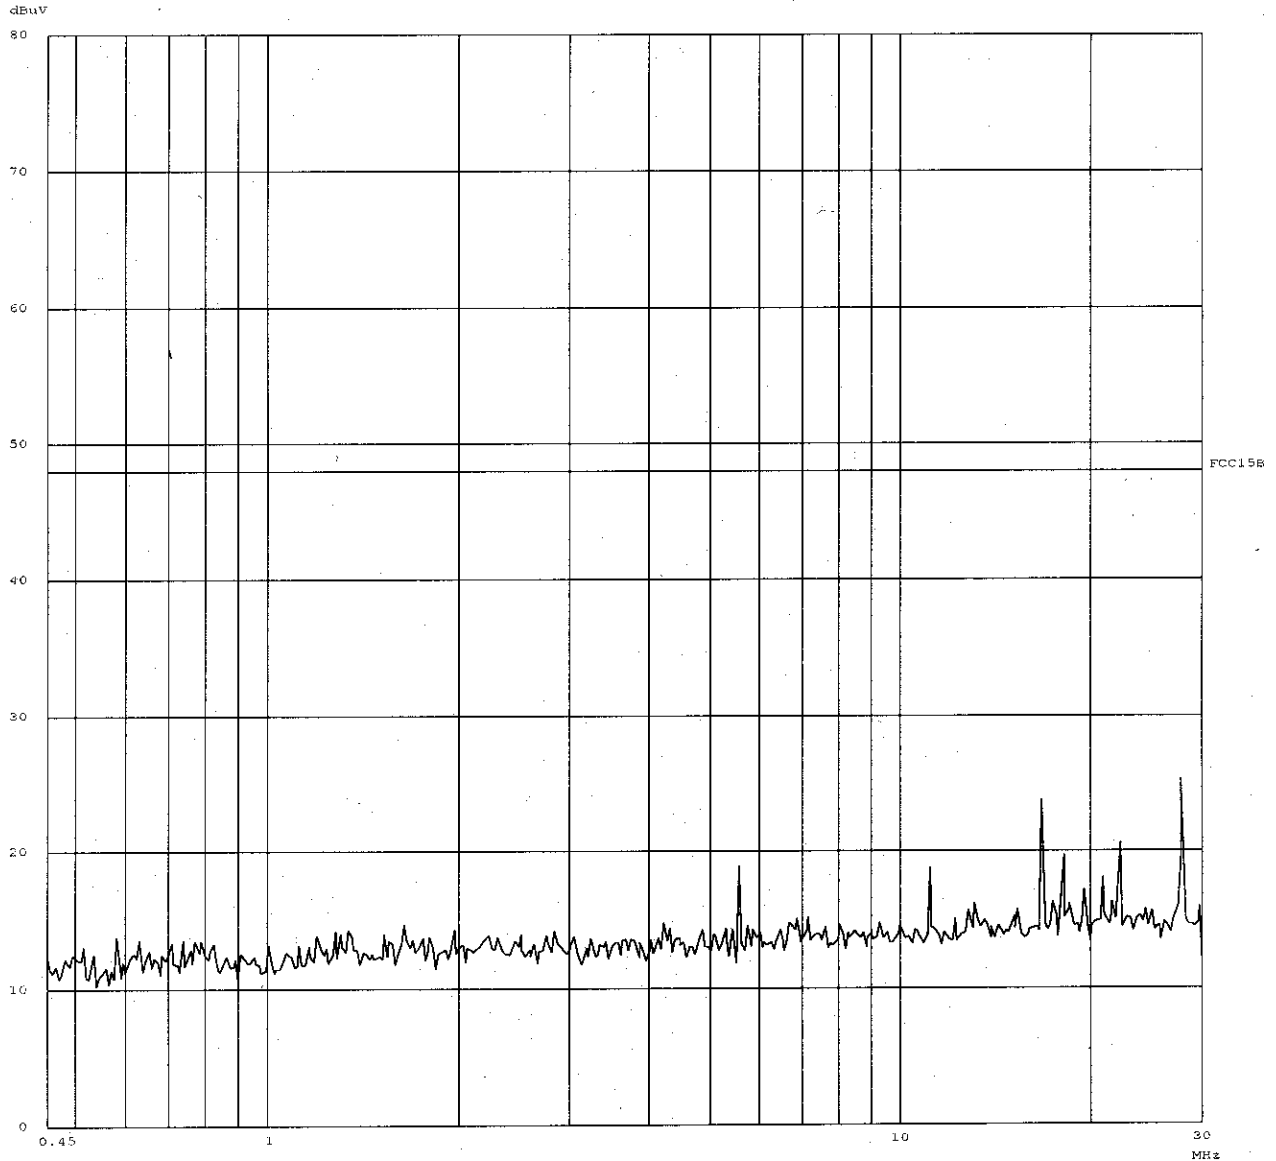
Mode: Transmission

Scan Settings (1 Range)

Frequencies			Receiver Settings					
Start	Stop	Step	IF BW	Detector	M-Time	Atten	Preamp	OpRge
450k	30M	5k	10k	PK	20ms	AUTO	LN OFF	60dB

Final Measurement: X QF

Transducer No.	Start	Stop	Name
3	9k	30M	E1078

Meas Time: 1 s
 Subranges: 16
 Acc Margin: -20dB
