Report Number: 98030018-1A

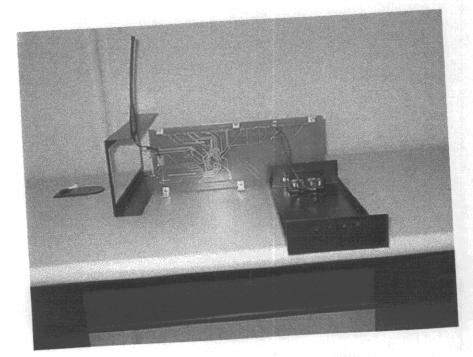
Figure 6 - PCB & LCD Panel out of Chassis

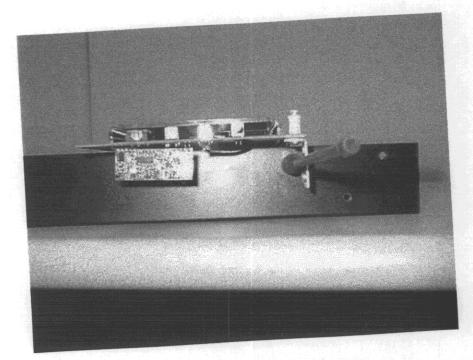
Figure 7 - End view of PCB/LCD panel
