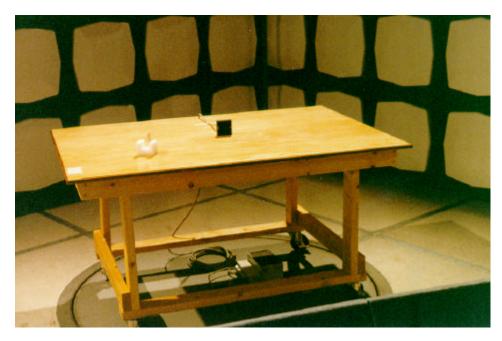
Test Setup in Semianechoic Chamber. Cable was re-wrapped *non-inductively* during the test. (See report for details.)

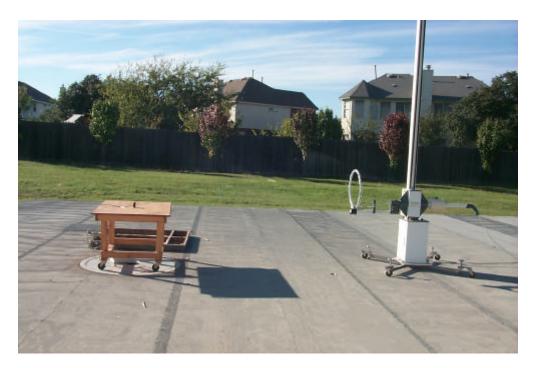
Test Set-up on OATS.
