## 7.6 Conducted RF Spurious Emission

*BlueAsia* of Technical Services (Shenzhen) Co., Ltd.

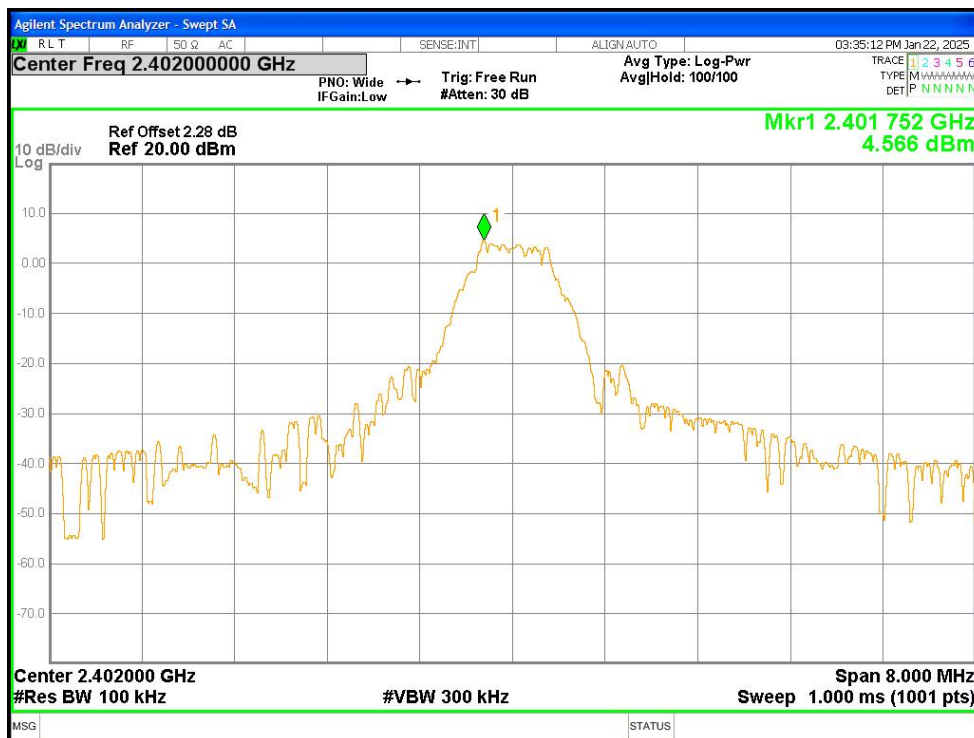
Band Edge NVNT BLE 1M 2402MHz Ant1 Ref

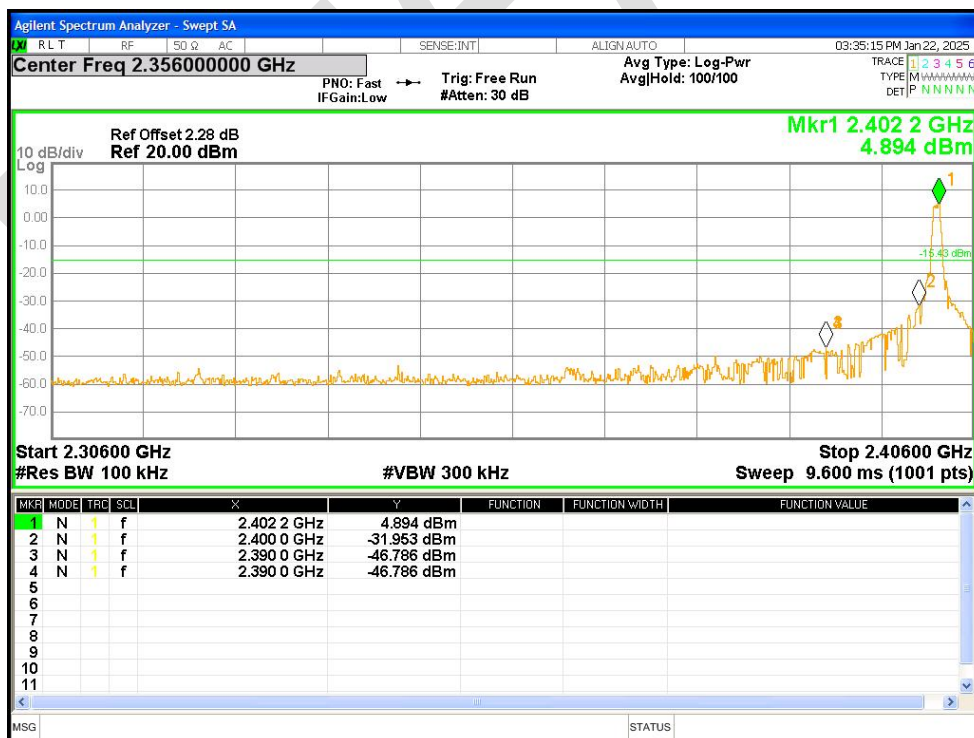
Band Edge NVNT BLE 1M 2402MHz Ant1 Emission

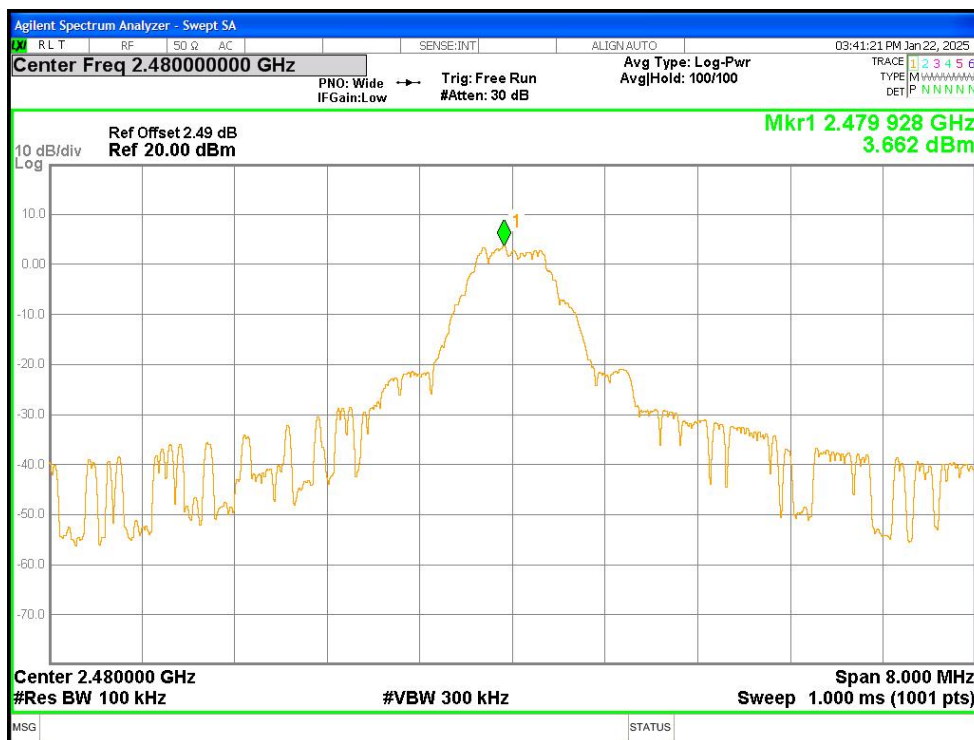
Band Edge NVNT BLE 1M 2480MHz Ant1 Ref

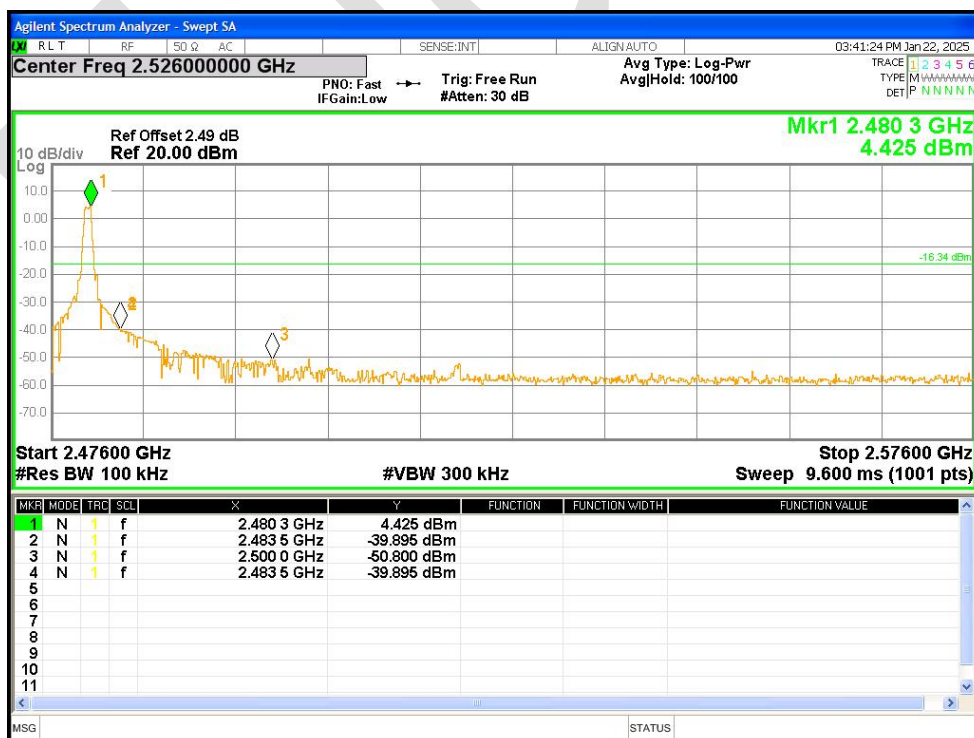
Band Edge NVNT BLE 1M 2480MHz Ant1 Emission

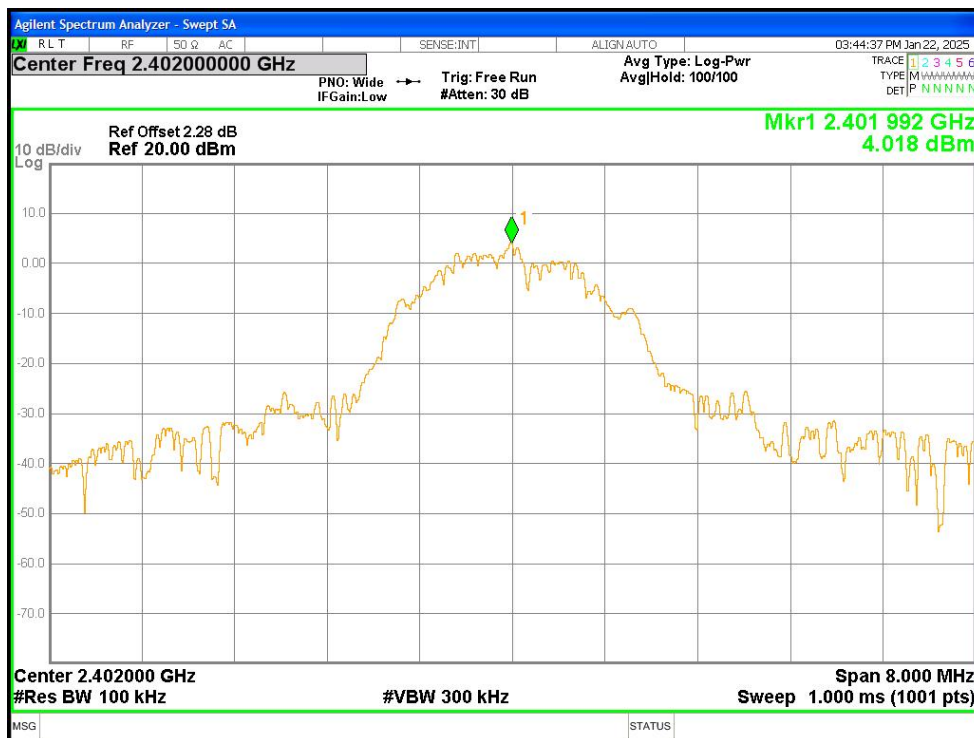
Band Edge NVNT BLE 2M 2402MHz Ant1 Ref

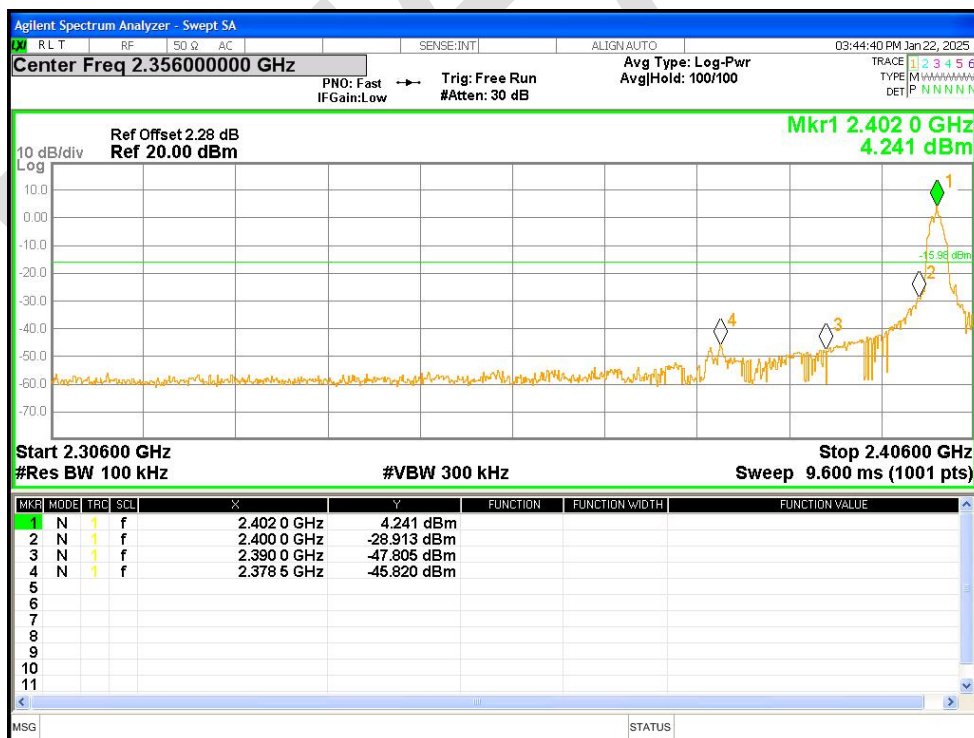
Band Edge NVNT BLE 2M 2402MHz Ant1 Emission

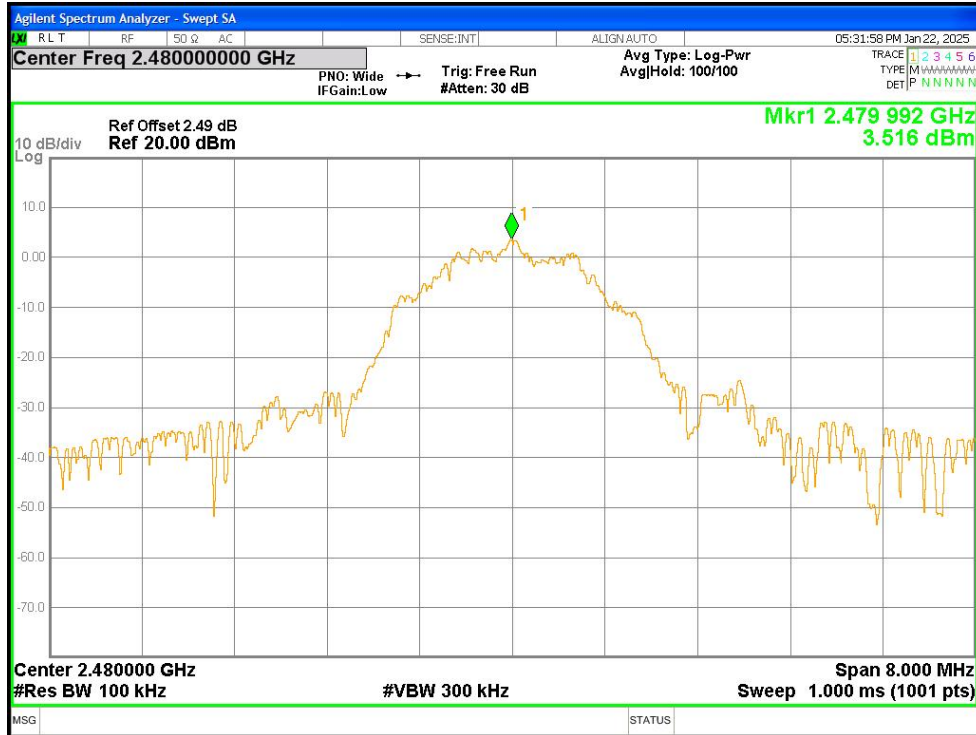
Band Edge NVNT BLE 2M 2480MHz Ant1 Ref

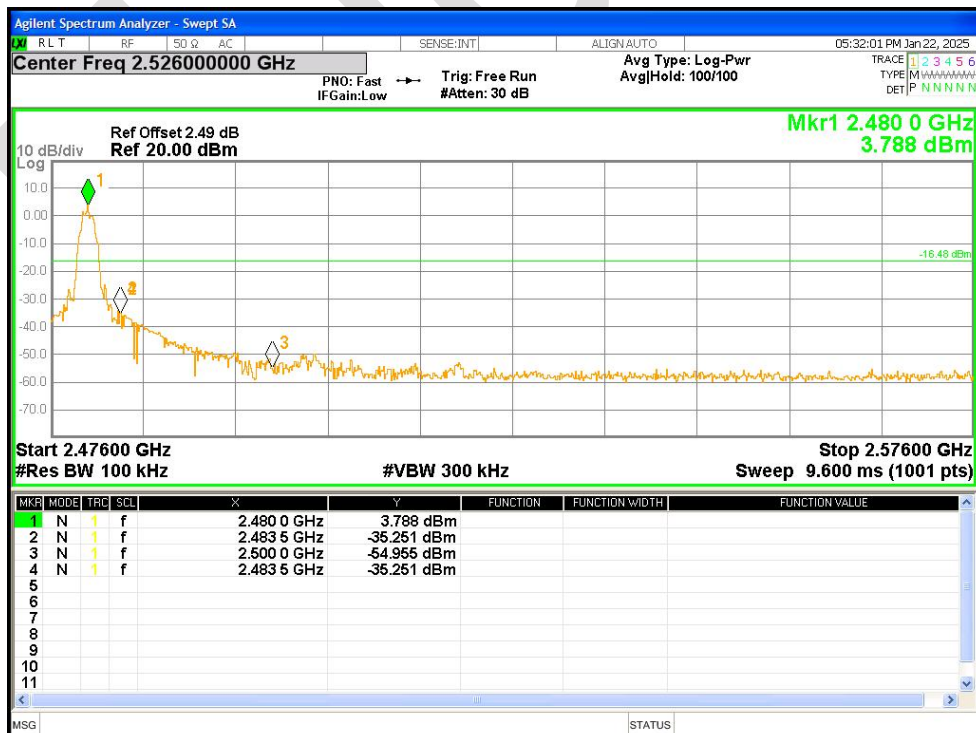
Band Edge NVNT BLE 2M 2480MHz Ant1 Emission

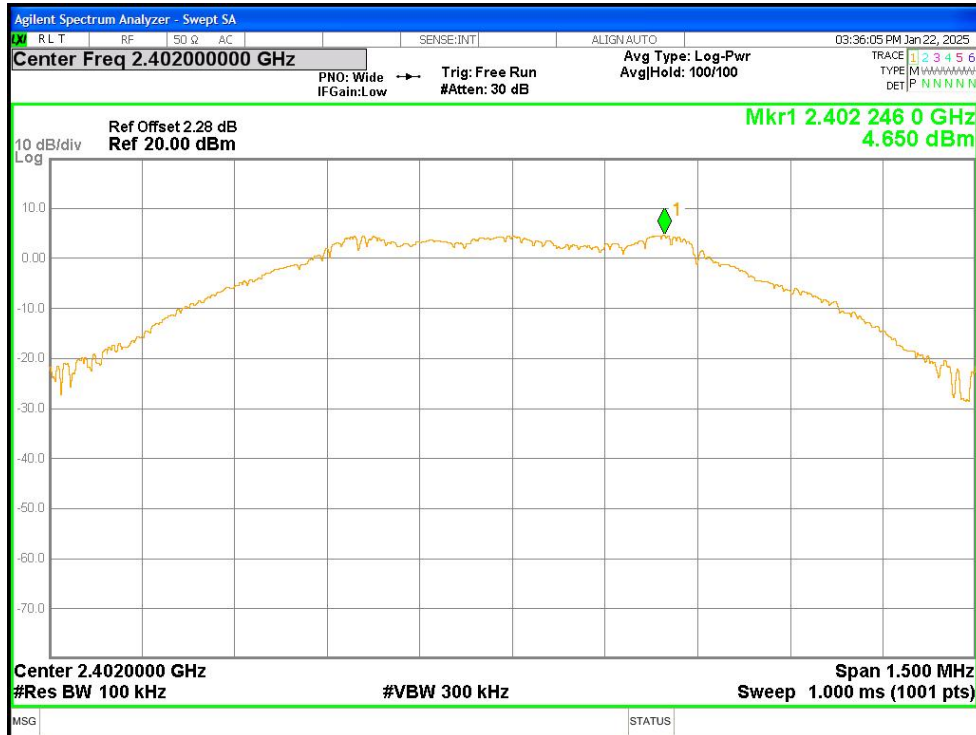
Tx. Spurious NVNT BLE 1M 2402MHz Ant1 Ref

| Condition | Mode | Frequency (MHz) | Antenna | Max Value (dBc) | Limit (dBc) | Verdict |
|---|---|---|---|---|---|---|
| NVNT | BLE 1M | 2402 | Ant1 | -50.03 | -20 | Pass |

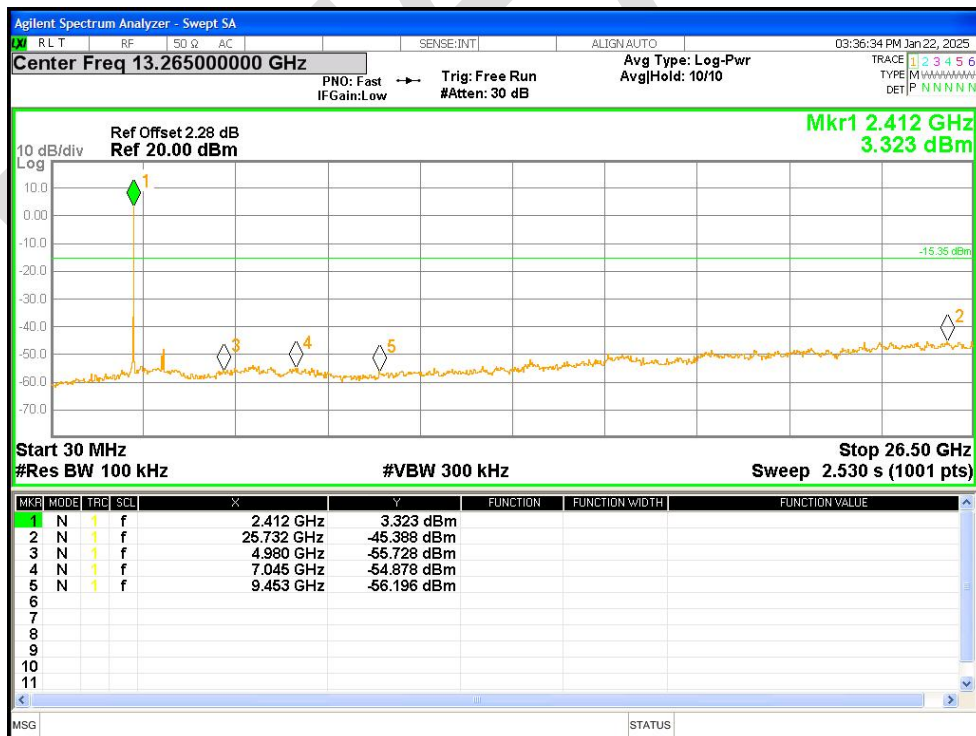
Tx. Spurious NVNT BLE 1M 2402MHz Ant1 Emission

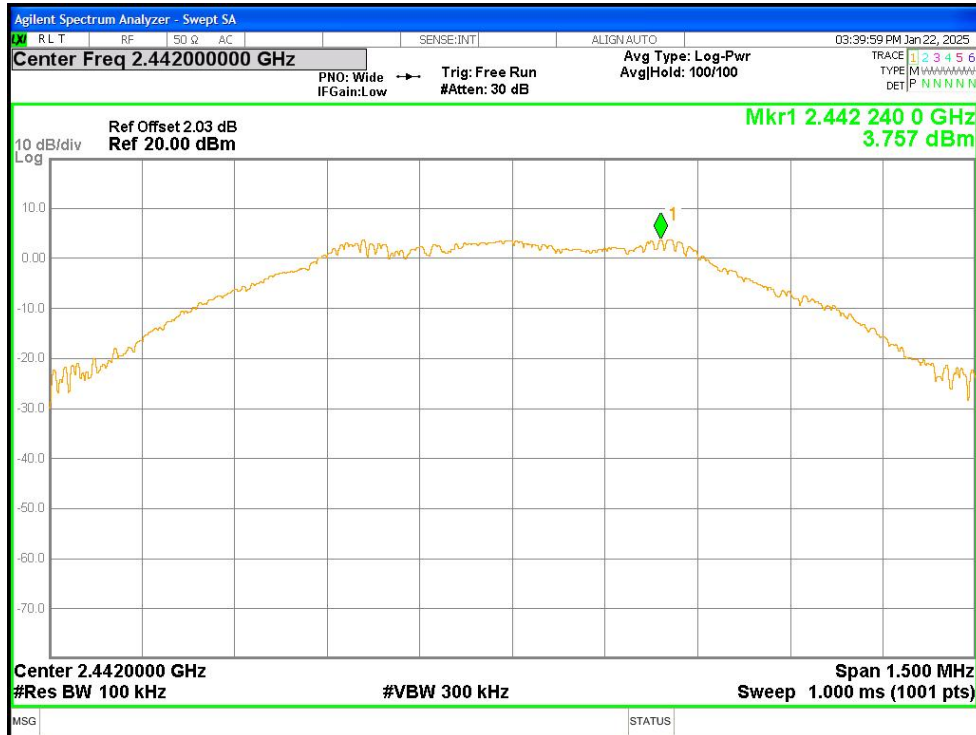
Tx. Spurious NVNT BLE 1M 2442MHz Ant1 Ref

| Condition | Mode | Frequency (MHz) | Antenna | Max Value (dBc) | Limit (dBc) | Verdict |
|---|---|---|---|---|---|---|
| NVNT | BLE 1M | 2442 | Ant1 | -49 | -20 | Pass |

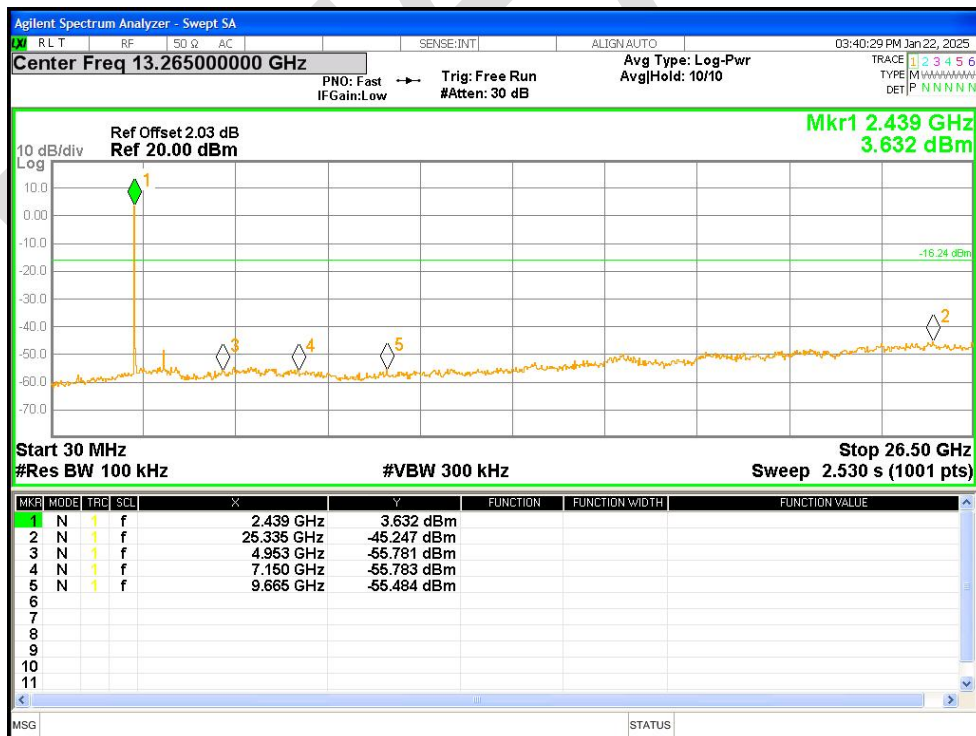
Tx. Spurious NVNT BLE 1M 2442MHz Ant1 Emission

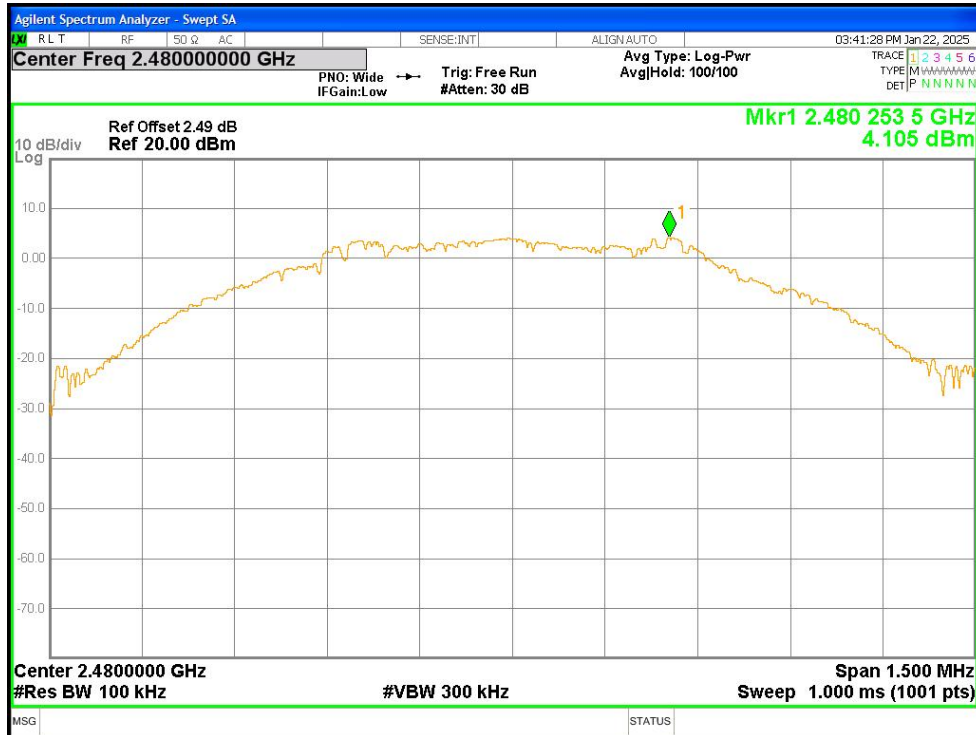
Tx. Spurious NVNT BLE 1M 2480MHz Ant1 Ref

| Condition | Mode | Frequency (MHz) | Antenna | Max Value (dBc) | Limit (dBc) | Verdict |
|---|---|---|---|---|---|---|
| NVNT | BLE 1M | 2480 | Ant1 | -49.6 | -20 | Pass |

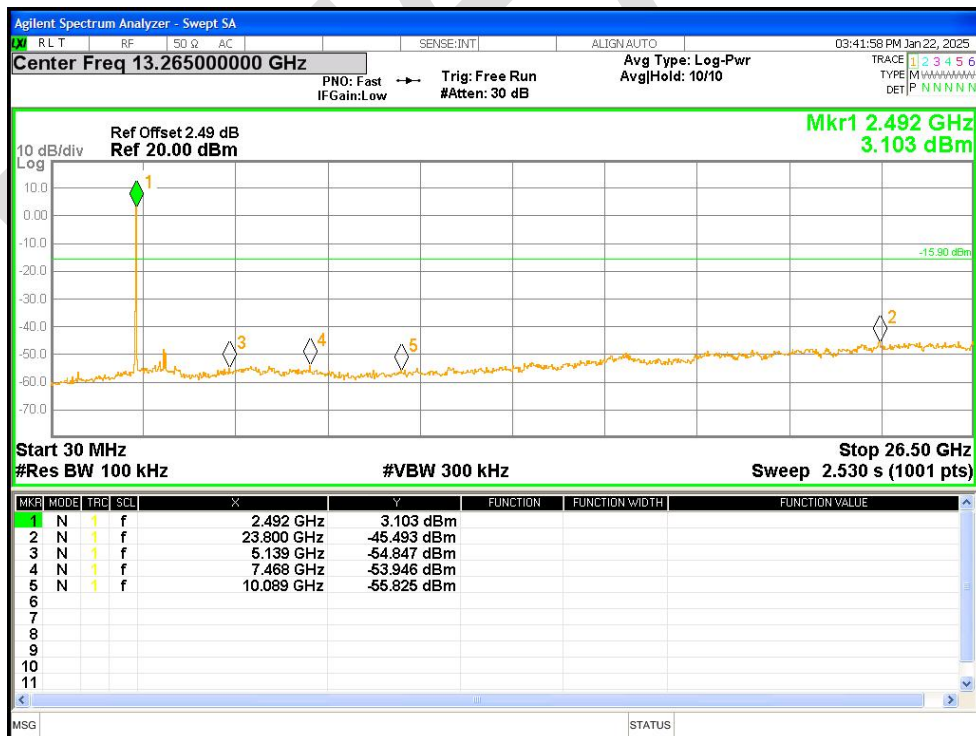
Tx. Spurious NVNT BLE 1M 2480MHz Ant1 Emission

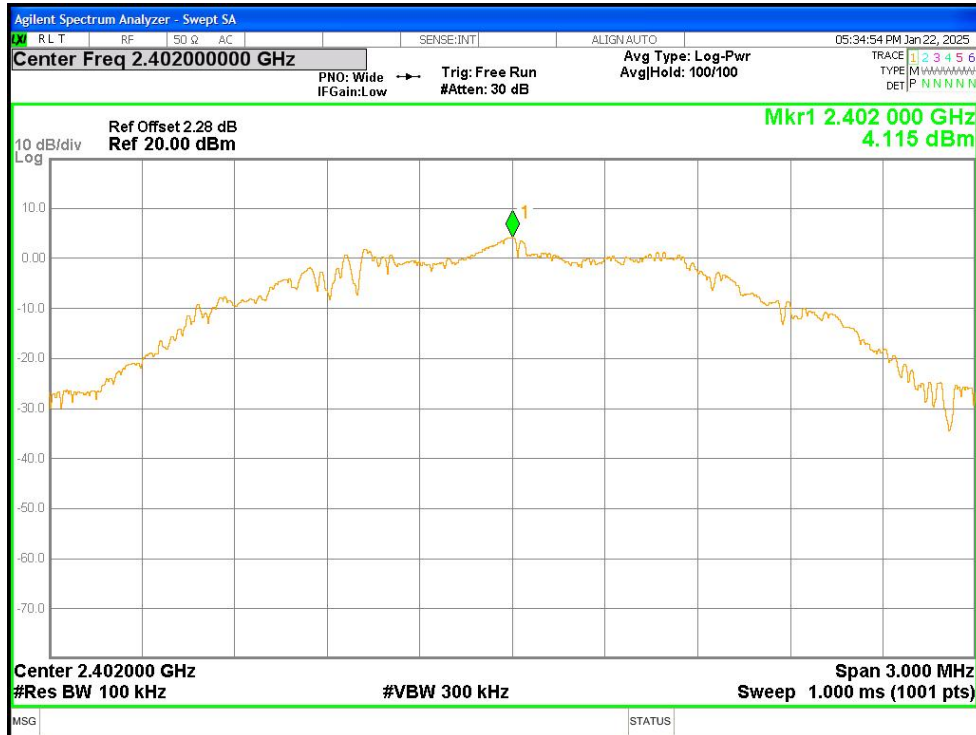
Tx. Spurious NVNT BLE 2M 2402MHz Ant1 Ref

| Condition | Mode | Frequency (MHz) | Antenna | Max Value (dBc) | Limit (dBc) | Verdict |
|---|---|---|---|---|---|---|
| NVNT | BLE 2M | 2402 | Ant1 | -49.65 | -20 | Pass |

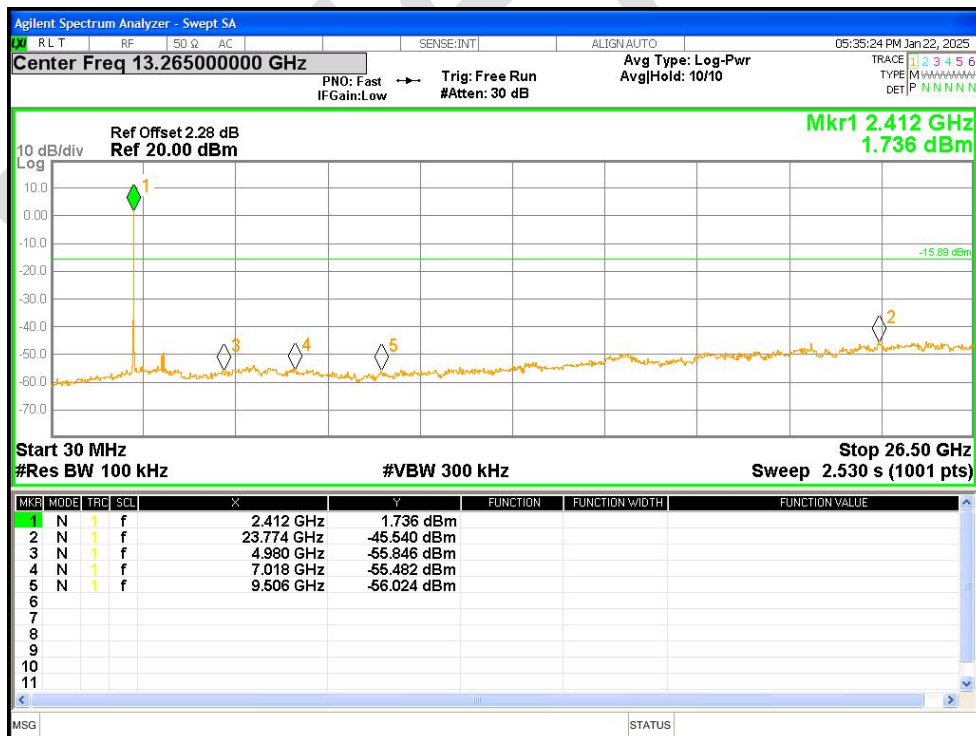
Tx. Spurious NVNT BLE 2M 2402MHz Ant1 Emission

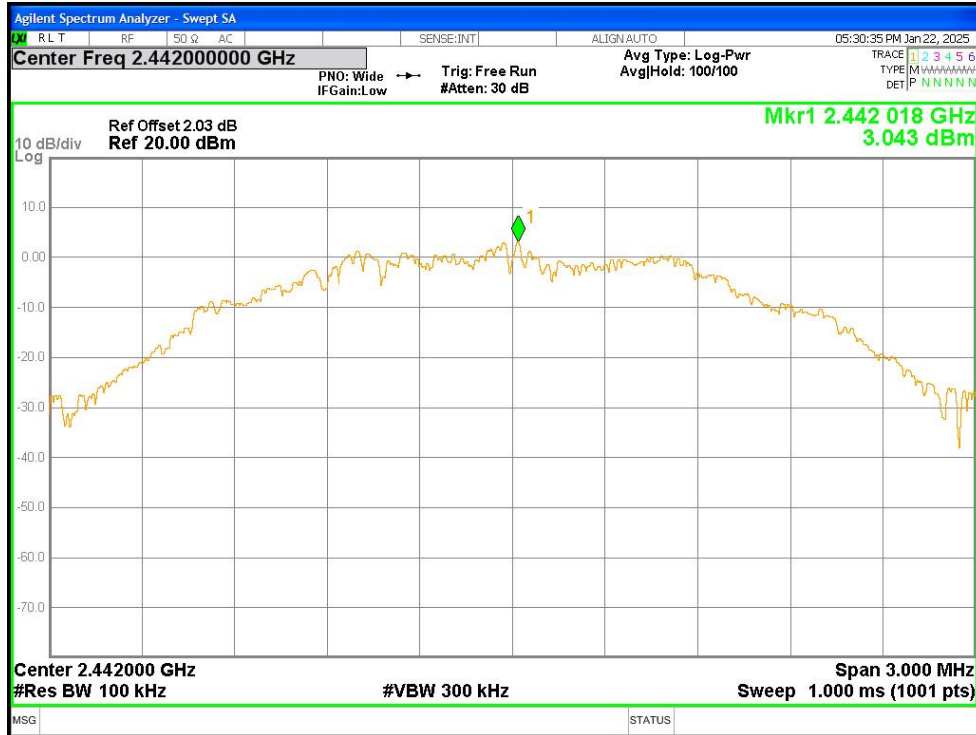
Tx. Spurious NVNT BLE 2M 2442MHz Ant1 Ref

| Condition | Mode | Frequency (MHz) | Antenna | Max Value (dBc) | Limit (dBc) | Verdict |
|---|---|---|---|---|---|---|
| NVNT | BLE 2M | 2442 | Ant1 | -47.84 | -20 | Pass |

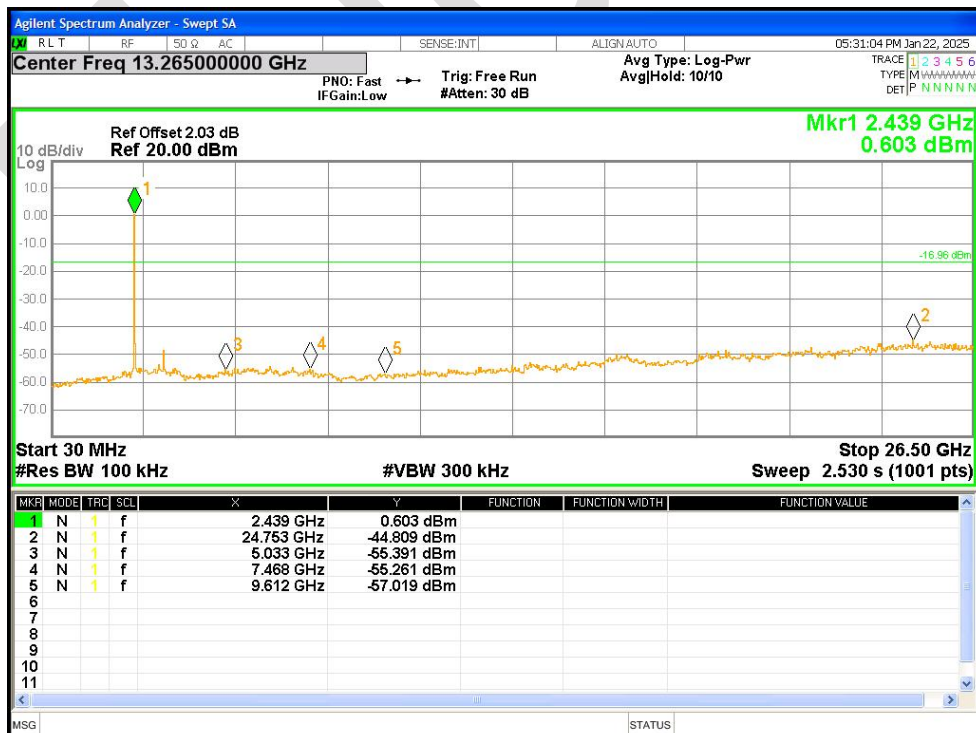
Tx. Spurious NVNT BLE 2M 2442MHz Ant1 Emission

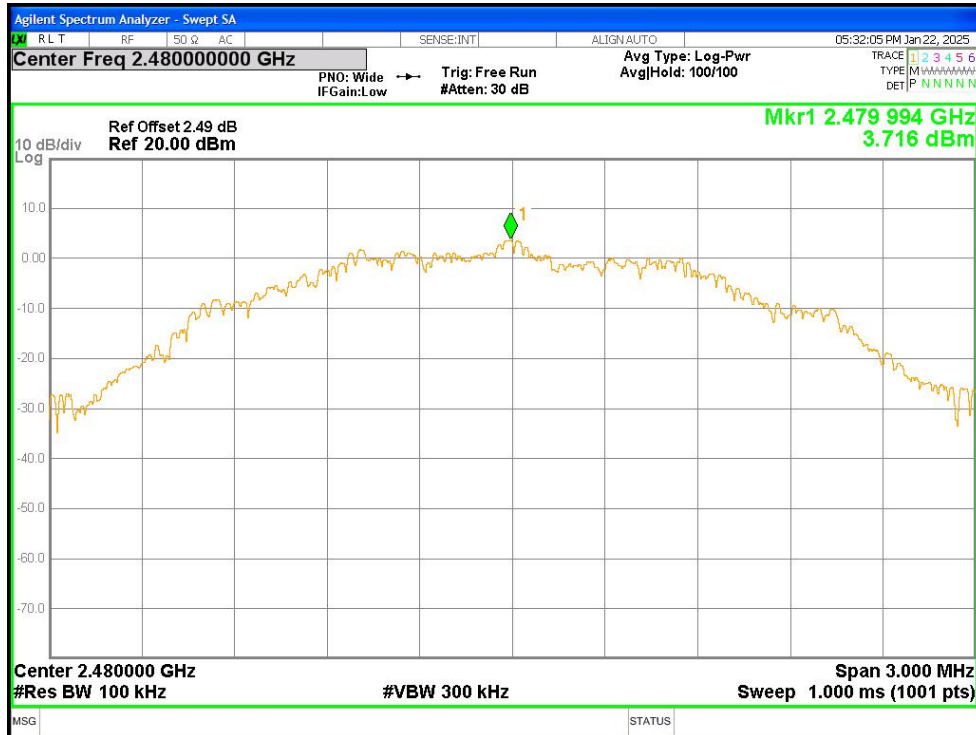
Tx. Spurious NVNT BLE 2M 2480MHz Ant1 Ref

| Condition | Mode | Frequency (MHz) | Antenna | Max Value (dBc) | Limit (dBc) | Verdict |
|---|---|---|---|---|---|---|
| NVNT | BLE 2M | 2480 | Ant1 | -48.84 | -20 | Pass |

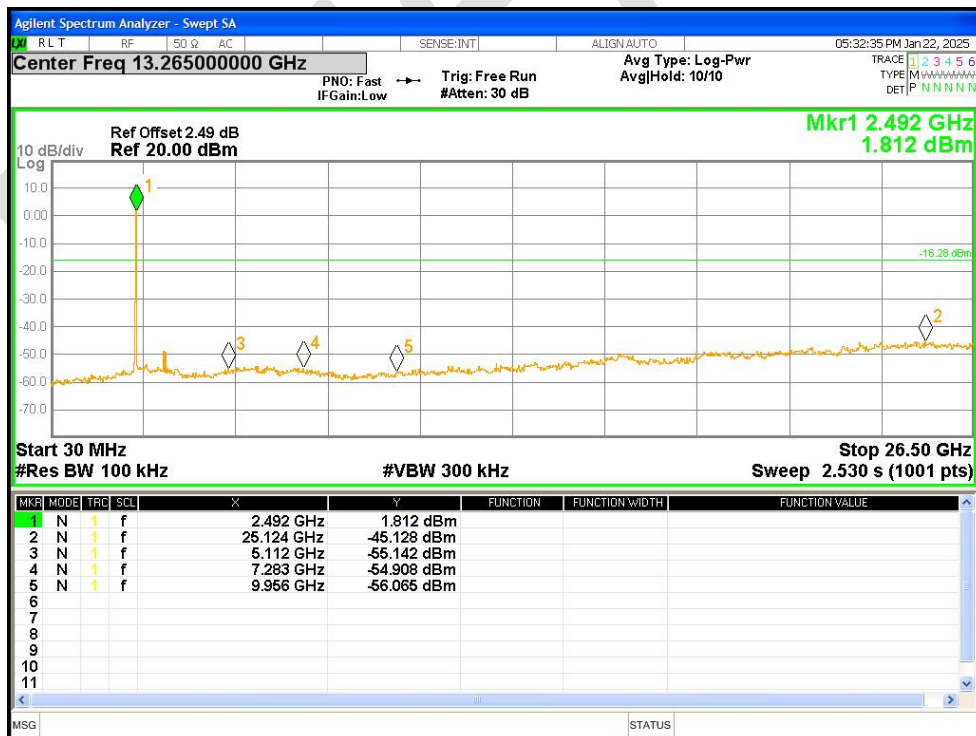
Tx. Spurious NVNT BLE 2M 2480MHz Ant1 Emission

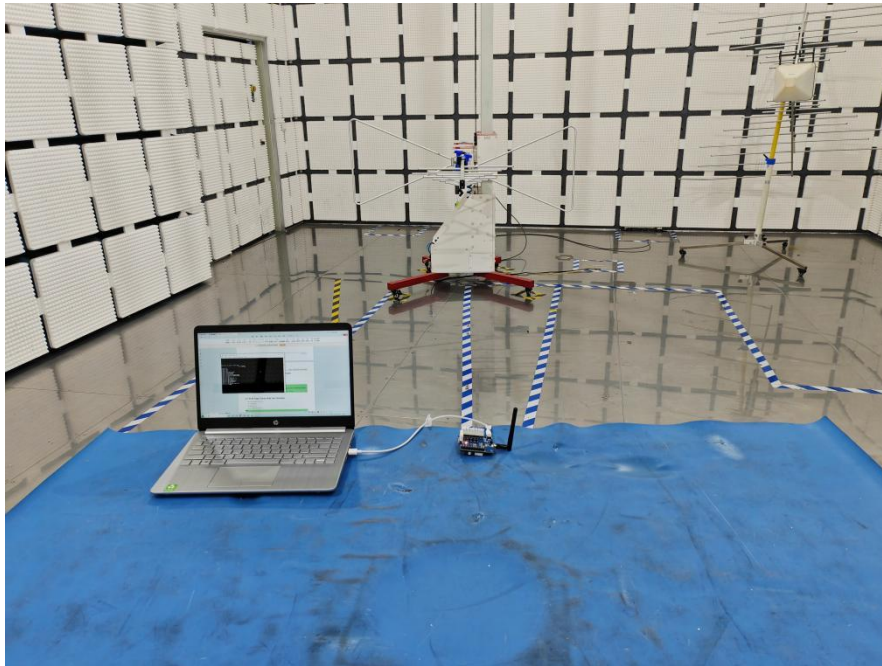
Radiated Emissions (30MHz-1GHz)

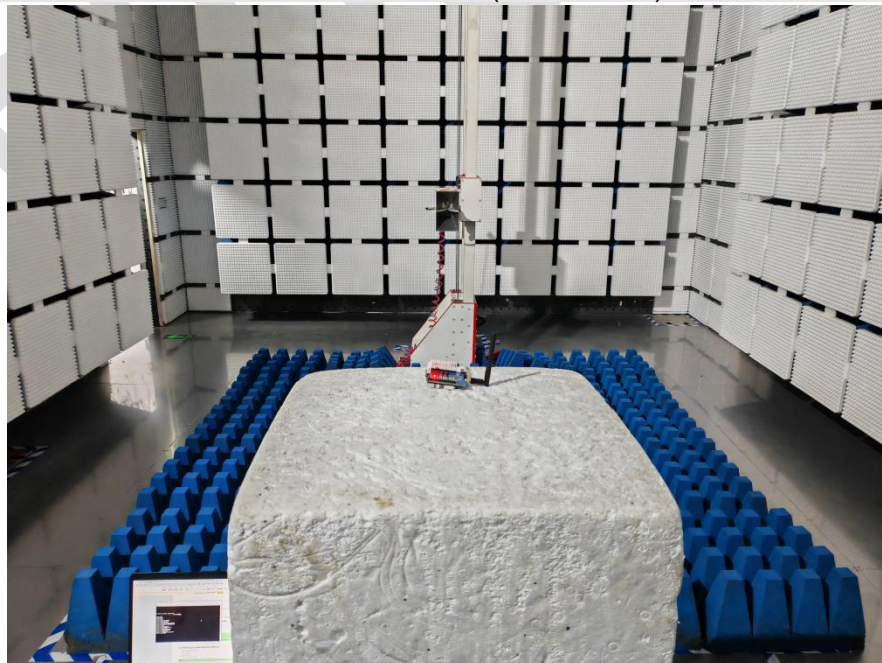
Radiated Emissions (above 1GHz)
