6. Photographs of the Test Setup

Prüfbericht - Nr.: 50004840 001
Test Report No.:

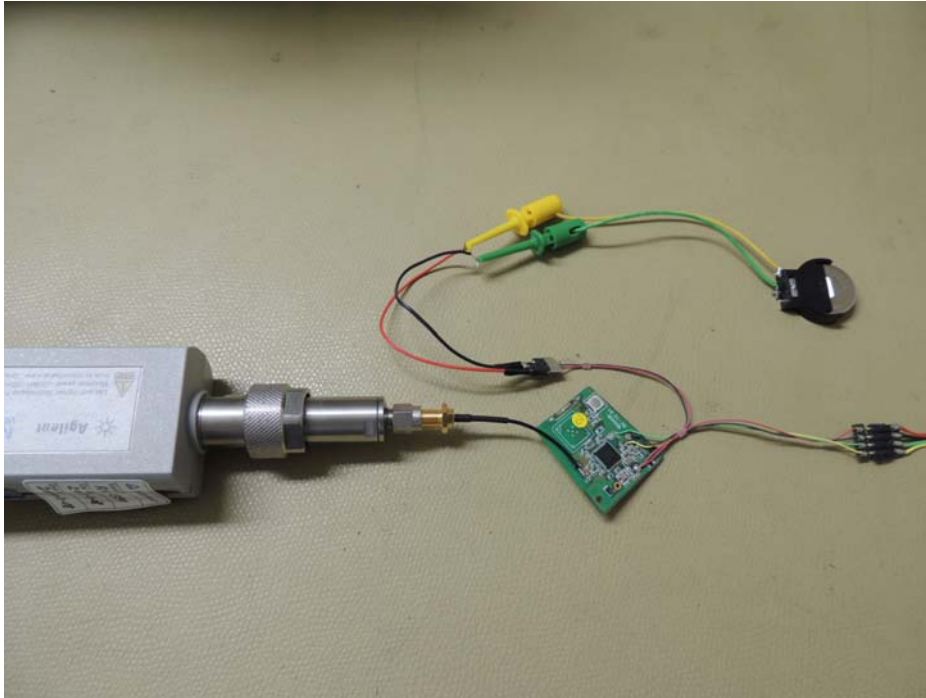
Photograph 1: Set-up for RF Conducted Power at Antenna Port

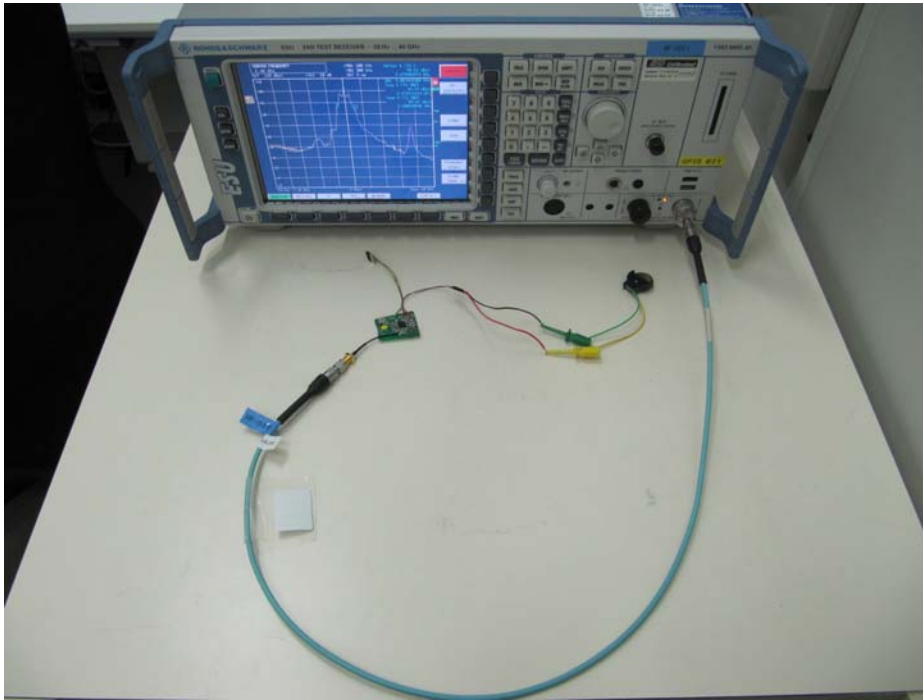
Photograph 2: Set-up for Bandwidth Test

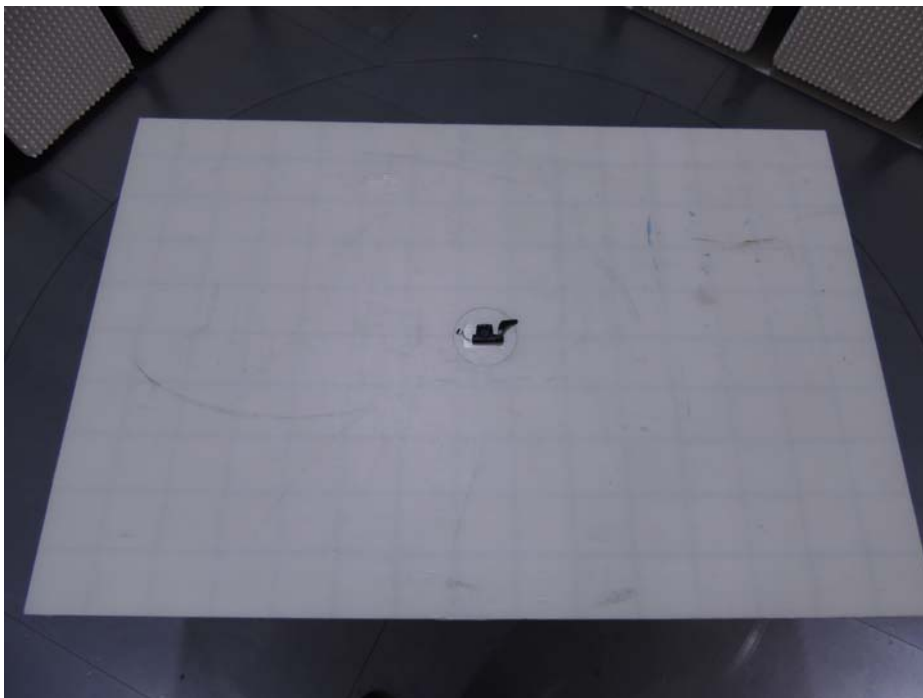
Photograph 3: Set-up for Radiated Test of Transmitter, Front View

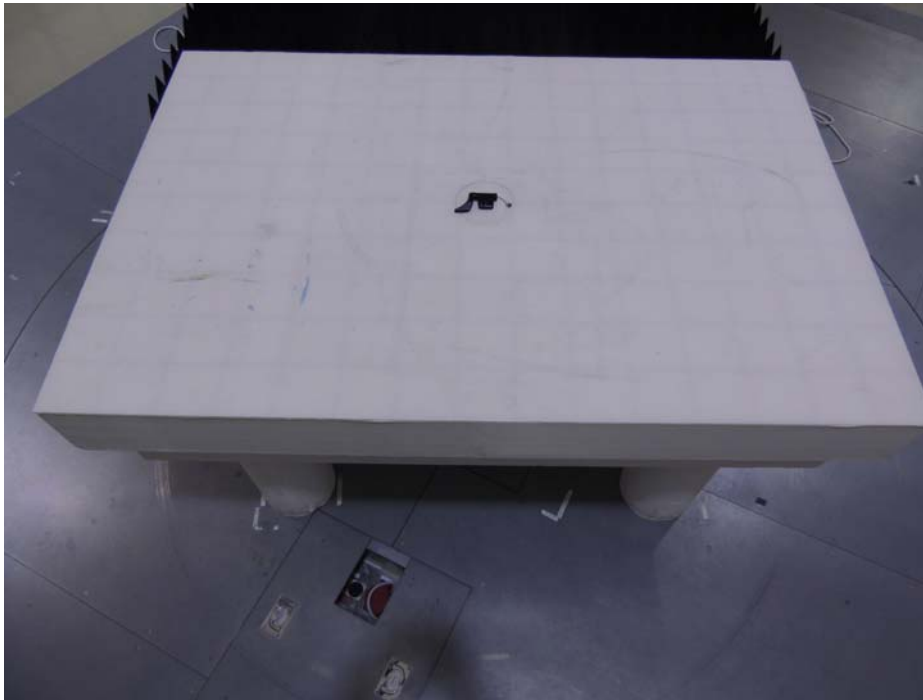
Photograph 4: Set-up for Radiated Test of Transmitter, Rear View

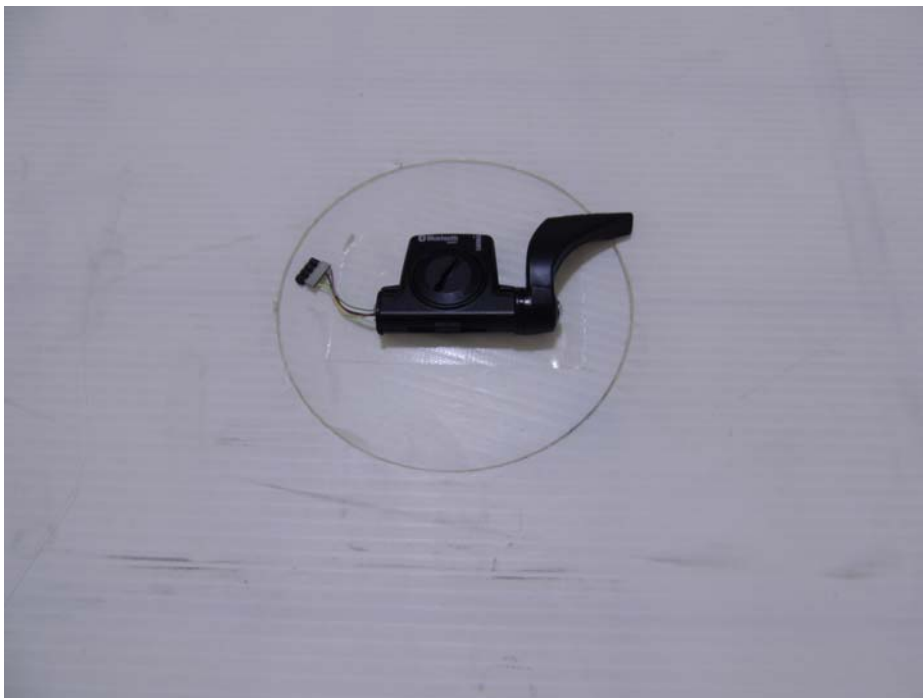
Photograph 5: Set-up for Radiated Emission, EUT Configuration X-Axis

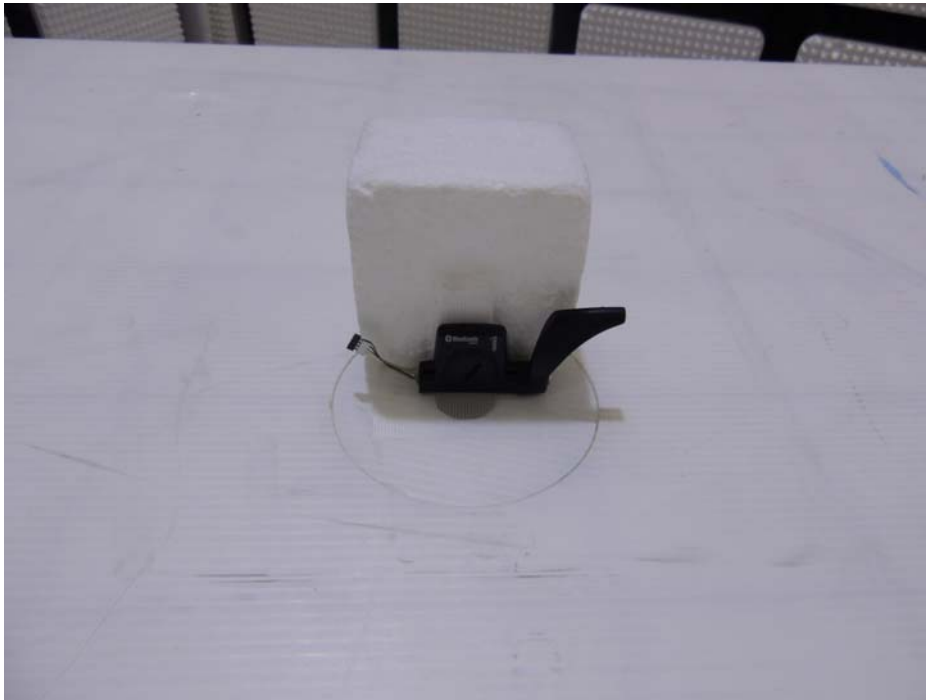
Photograph 6: Set-up for Radiated Emission, EUT Configuration Y-Axis

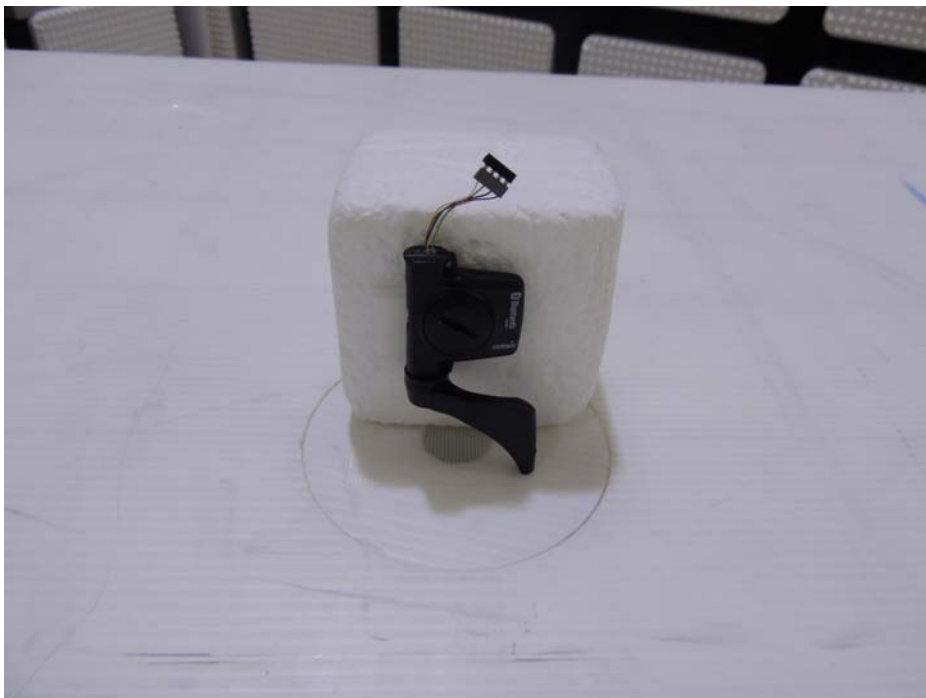
Photograph 7: Set-up for Radiated Emission, EUT Configuration Z-Axis
