GE Photos Taken During Radiated Emission Testing  
FCC ID# OU52014748

Photos of the EUT during Radiated Emission Testing in the 3 Meter FCC Listed Chamber

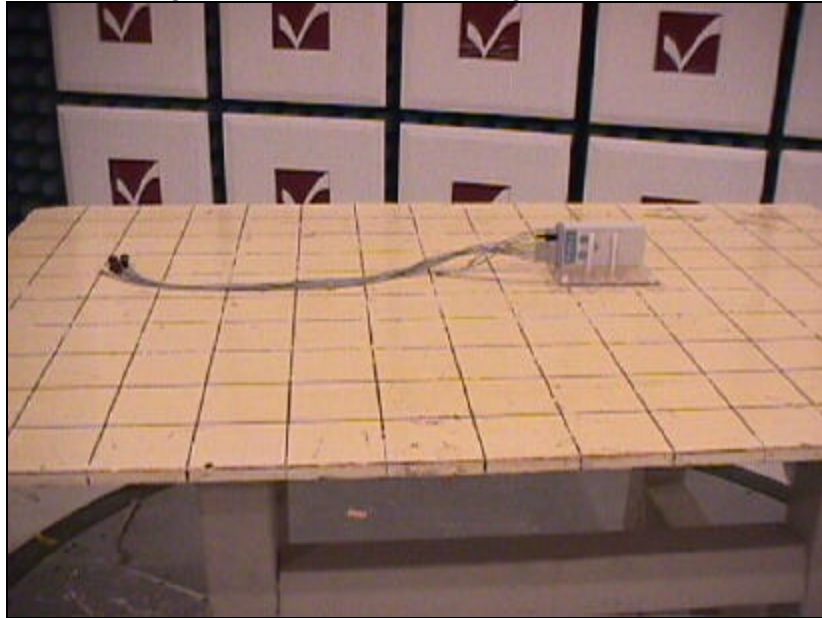
Highest emissions noted were with the device in the side orientation as shown here.

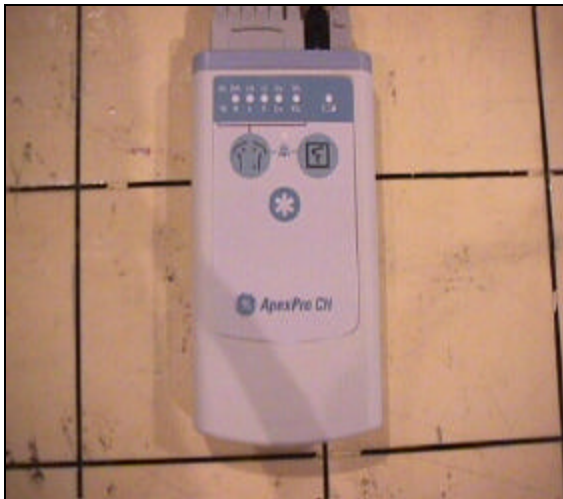
Close up view, front of the device.

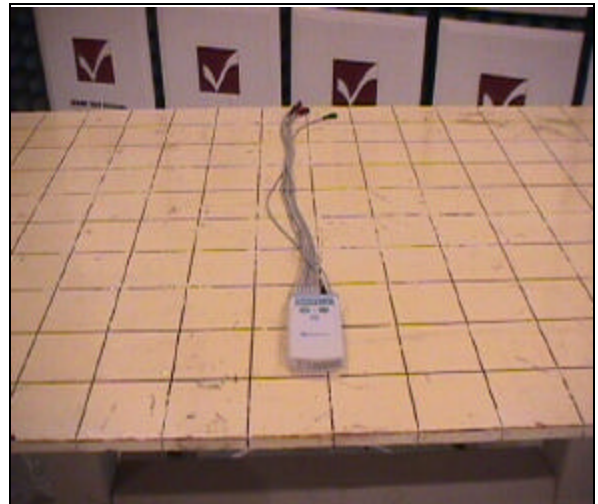
Device pictured in horizontal orientation.
