APPENDIX 1: Photographs of test setup

Radiated emission

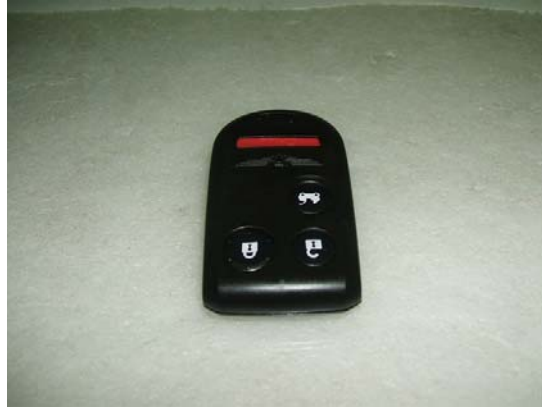
X-axis

Worst case position

Below 1GHz (Horizontal: X-axis/Vertical : Y-axis)

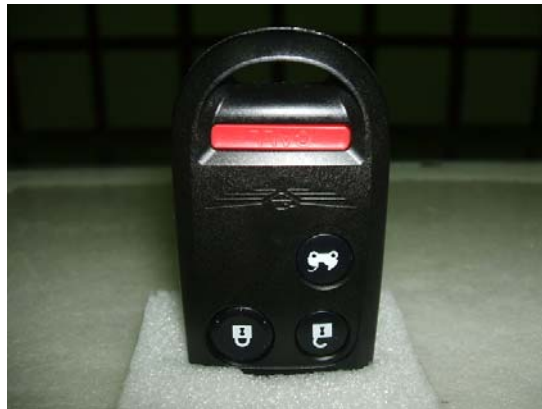
Y-axis

Above 1GHz (Horizontal: Z-axis/Vertical : Y-axis)
