APPENDIX 3: Photographs of test setup

Radiated Emission

Radiated Emission
Immobilizer

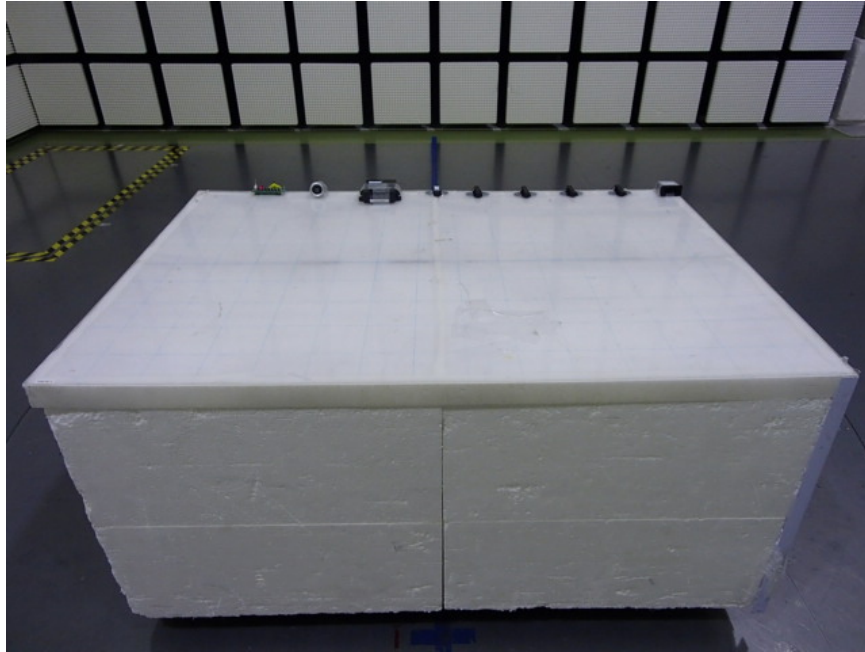
Photo 1

LF Antenna

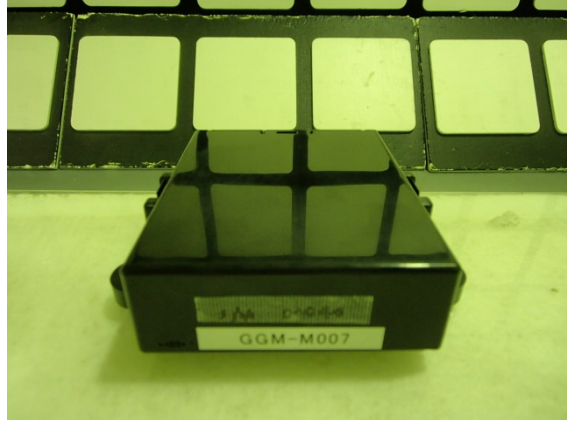
ECU
Below 30MHz: X
Above 30MHz: Horizontal X, Vertical X
X-axis

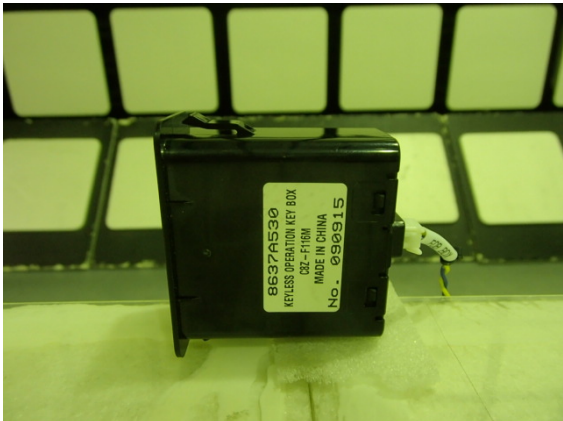
Y-axis

(Inserted)
