APPENDIX 3: Photographs of test setup

Radiated Emission

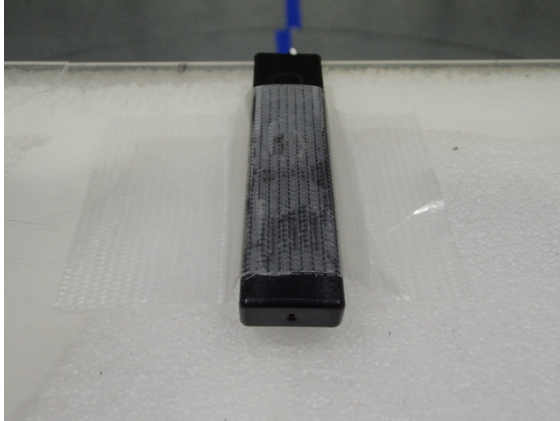
LF Antenna
Below 30MHz: X-axis
Above 30MHz
Horizontal: X-axis / Vertical: X-axis

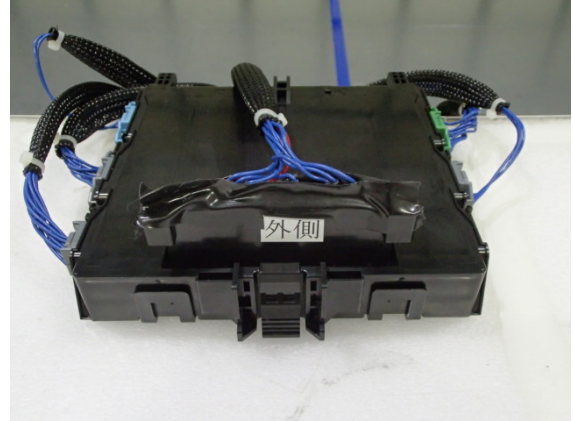
ECU
Below 30MHz: X-axis
Above 30MHz
Horizontal: X-axis / Vertical: X-axis
