APPENDIX 3: Photographs of test setup

Radiated Emission

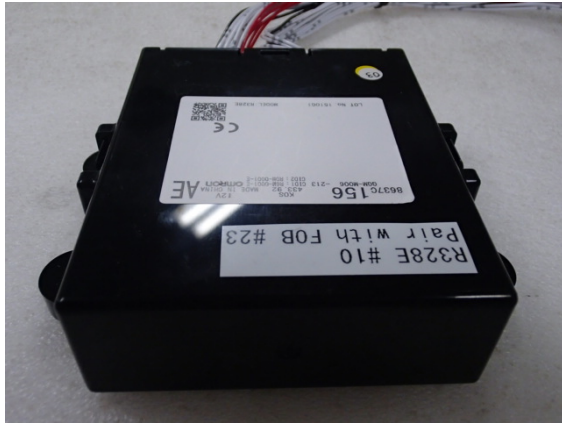
ECU
Below 30 MHz:
X-axis

Above 30MHz:
Horizontal: X-axis / Vertical: X-axis

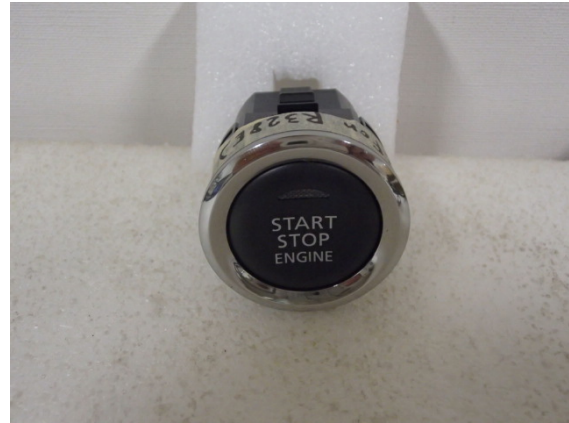
Push Start Switch
Below 30 MHz:
X-axis

Above 30 MHz:
Horizontal: X-axis / Vertical: X-axis

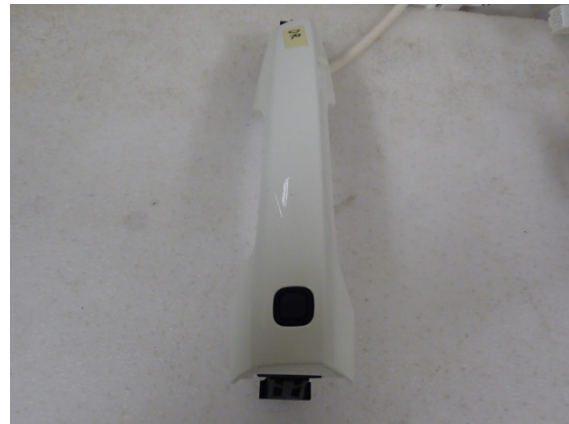
LF Antenna DR

Below 30 MHz:

X-axis

Above 30 MHz:

Horizontal: X-axis / Vertical: X-axis

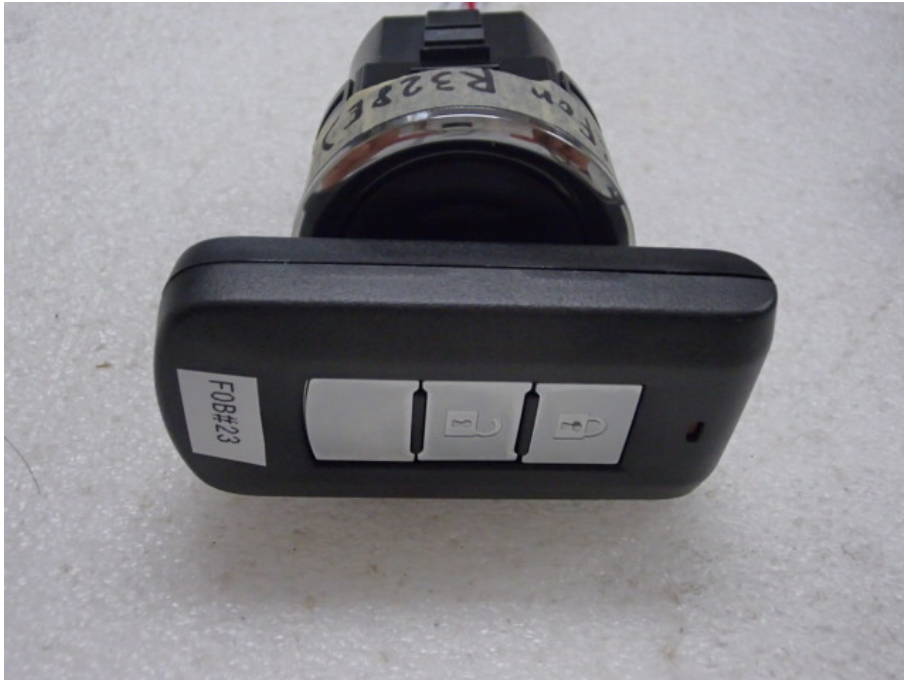
With Key
