APPENDIX 3: Photographs of test setup

Radiated Emission **(DR Antenna)**

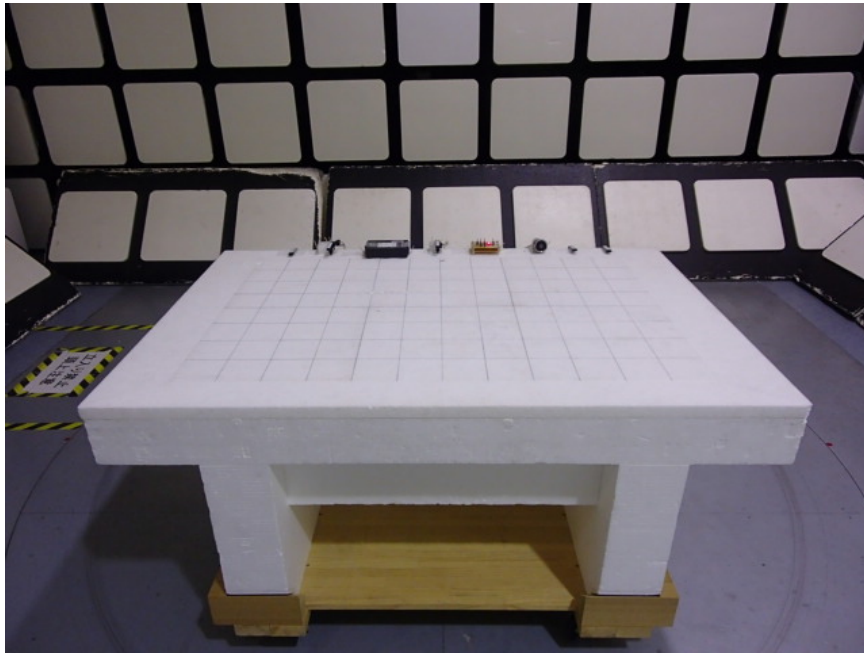
Photo 1

Radiated Emission
(InF Antenna)

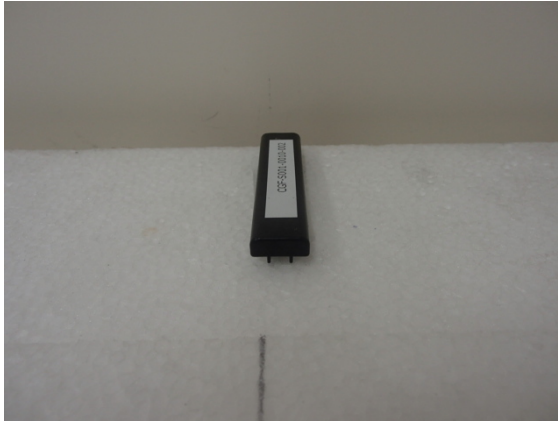
LF Antenna(DR Antenna)

Below 30MHz: X-axis

Horizontal: X-axis / Vertical: X-axis

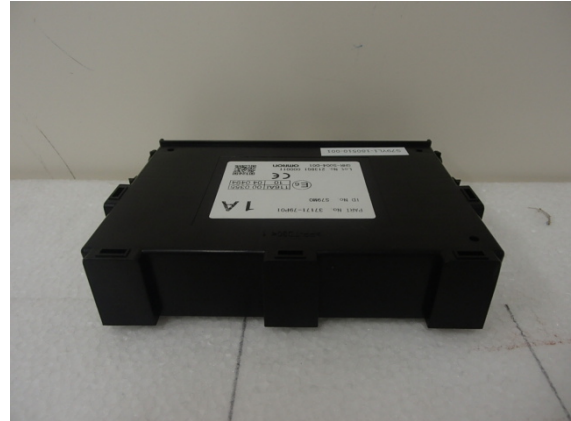
ECU

Below 30MHz: X-axis

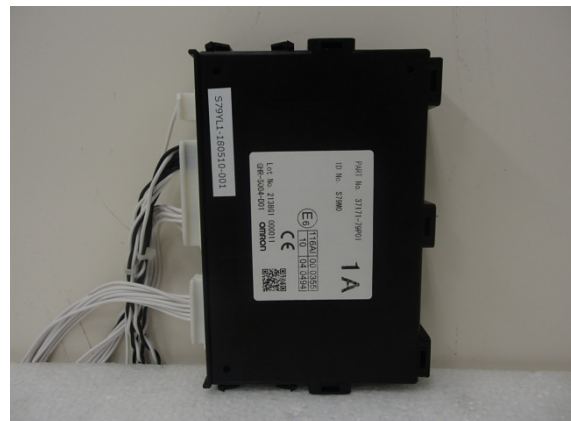
Horizontal: Z-axis / Vertical: Z-axis

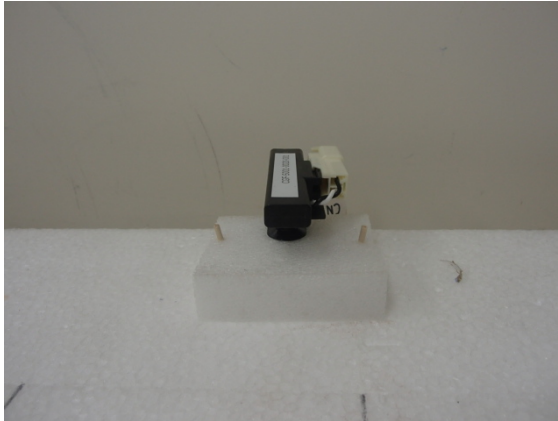
LF Antenna(InF Antenna)

Below 30MHz: X-axis

Horizontal: X-axis / Vertical: X-axis

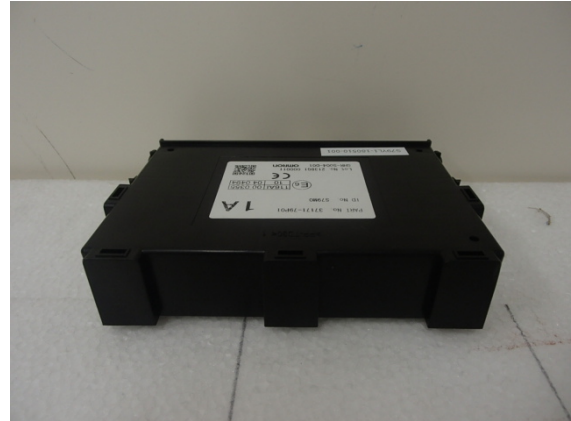
ECU

Below 30MHz: X-axis

Horizontal: X-axis / Vertical: X-axis
