4. TEST REPORT

4.1 RF Power Measurements

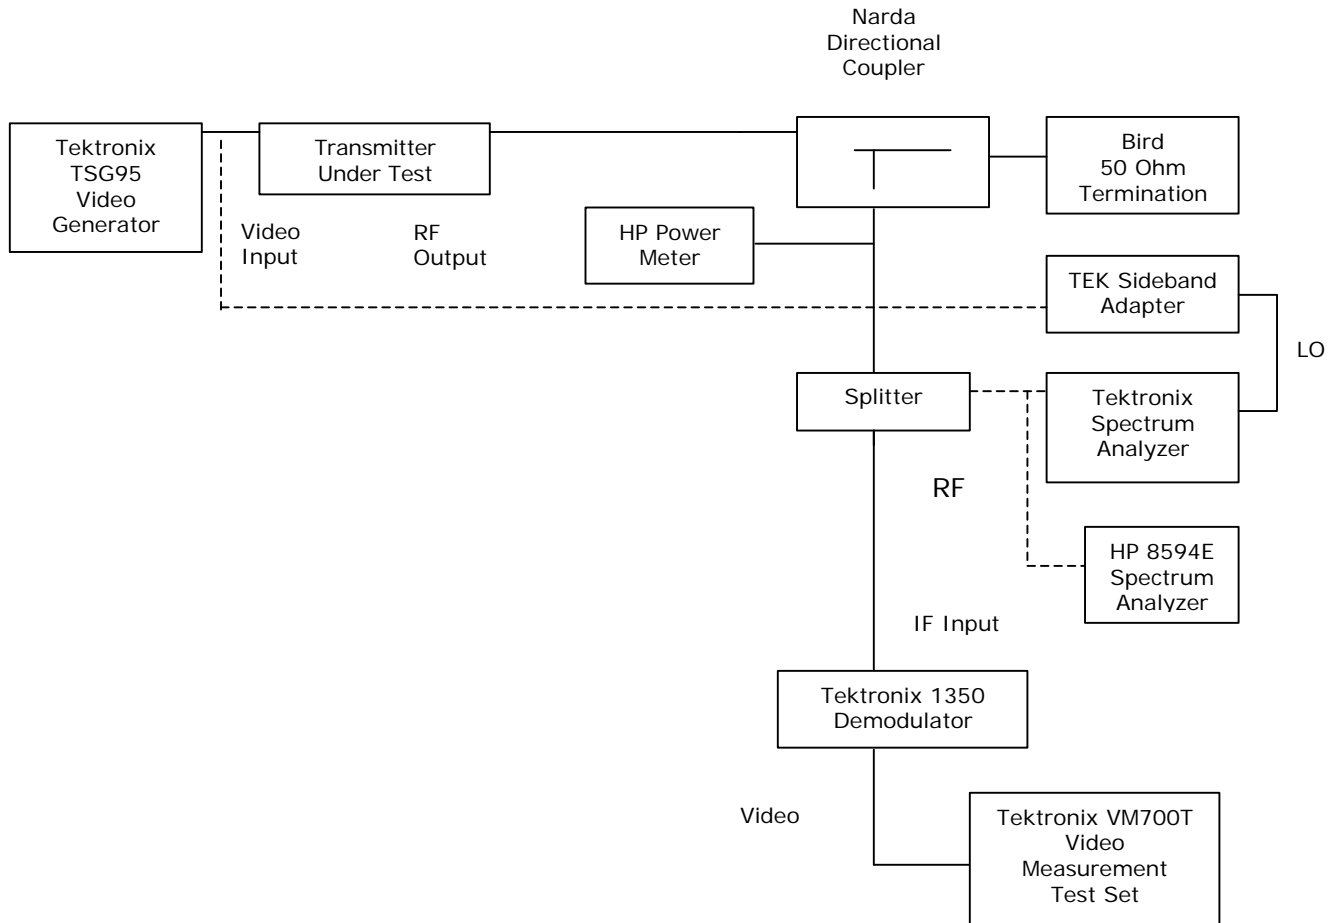
Figure 4-1. Test Equipment Setup for RF Power Measurements

Figure 4-1 shows the test equipment setup for the RF power measurements.

The video modulation was adjusted for 25% with sync and blanking video signals and the aural power was turned off. The power was then adjusted to obtain 1590 watts of average visual RF output (2650 watts peak sync at the output connector). This level was used to establish a reference on the spectrum analyzer.

The test setup shown in Figure 4-1 was used to adjust the video signal to obtain a white picture level. Using the Tektronix 1350 demodulator chopper function, the modulation was accurately measured to be 87.5% while maintaining a depth of modulation at blanking.

Using the test setup in Figure 4-1, the envelope delay was measured and the data recorded as shown in Table 4-1. A $\sin x/x$ test pattern was used.

The test setup in Figure 4-1 was used to observe the video on the waveform monitor. The video was set for 40 IRE, Sync only. The noise on the VM700T measurement set was -57 dB.

The test setup shown in Figure 4-1 was used to record the detected video frequency response; the results are shown in Table 4-2 and Figure 4-3.

The RF sideband response was recorded using the test setup shown in Figure 4-1. With the output power set to 2650 watts peak of sync, the Tektronix TSG95 video generator was adjusted to provide a cable sweep test signal and the RF sideband response was recorded. Data from this test is provided in Table 4-3.

Note: Using the test setup shown in Figure 4-1, the visual modulation was adjusted to 87.5% at white with the modulated staircase waveform and the aural deviation adjusted to ± 25 kHz (100%) with the 400-Hz audio tone.

Using the test setup shown in Figure 4.1, the spectrum outside of the specified channel was observed and the data was recorded on all products above the 70-dB noise floor of the spectrum analyzer. This data is shown in Table 4-6 and is presented as graphs in Figures 4-9 and 4-10.

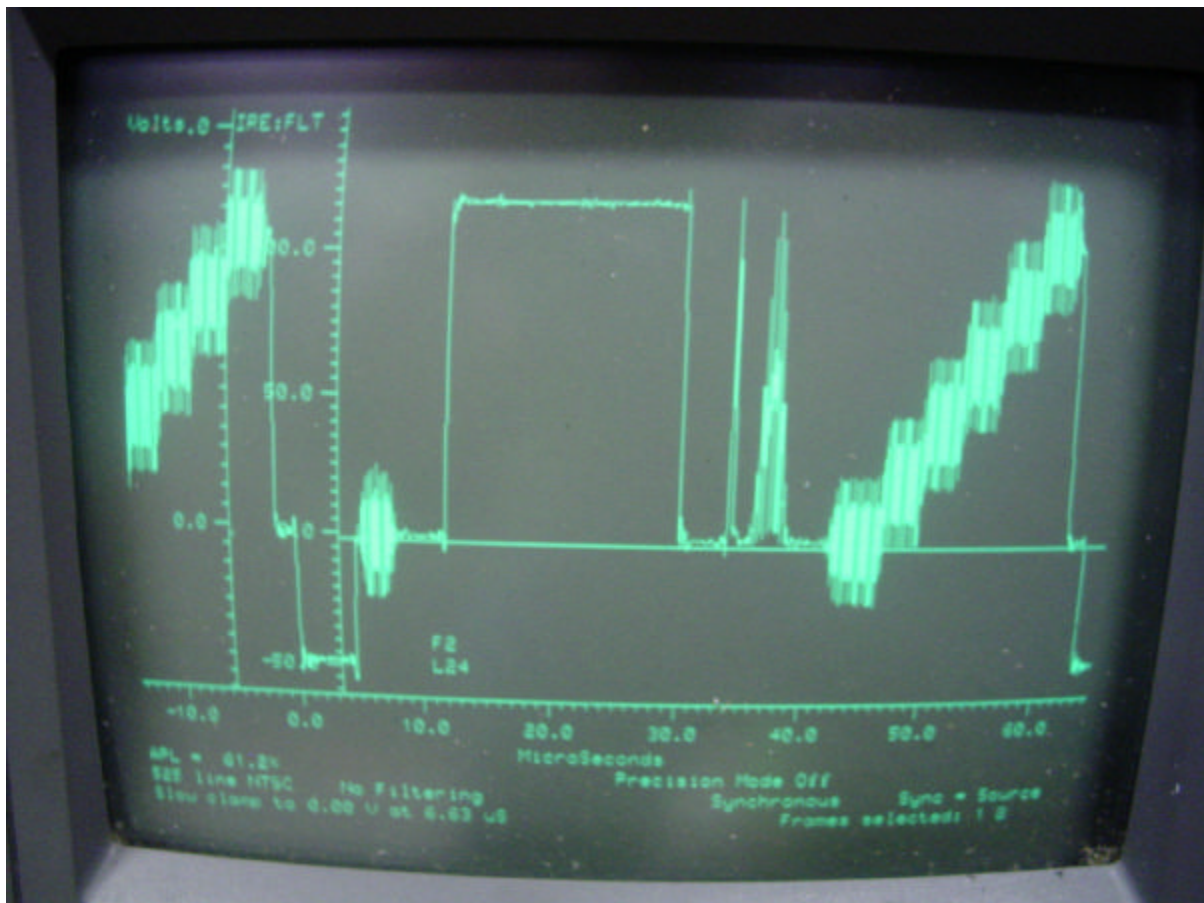
Figure 4-2. Substantially Linear Transfer Characteristics of the Transmitter as a Demodulated Video Waveform

Figure 4-2 shows the substantially linear transfer characteristics of the transmitter as a demodulated video waveform.

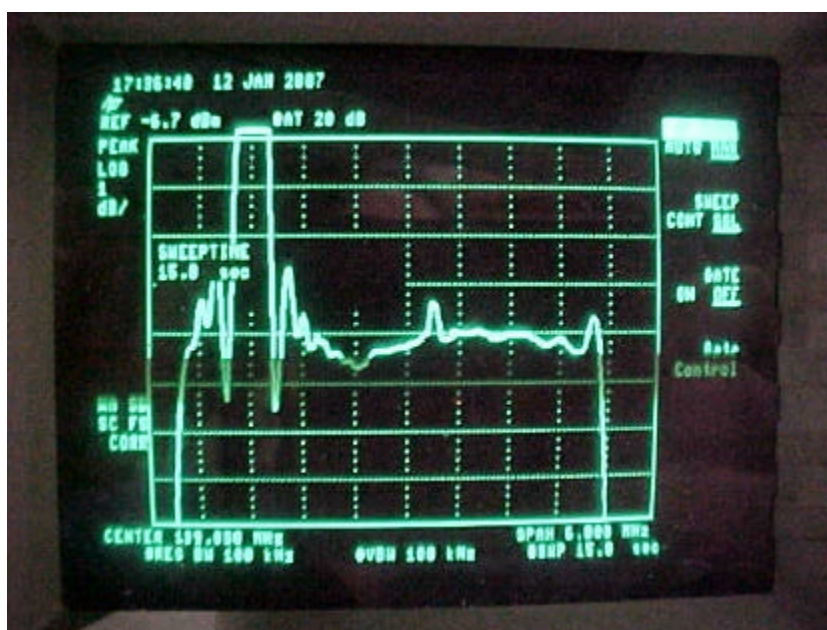
Figure 4-3. Graph of Detected Video Frequency Response

Note: For this test, the video signal was adjusted to provide a 50% average picture level and the video sweep signal level was set to cover the range from black to white picture.

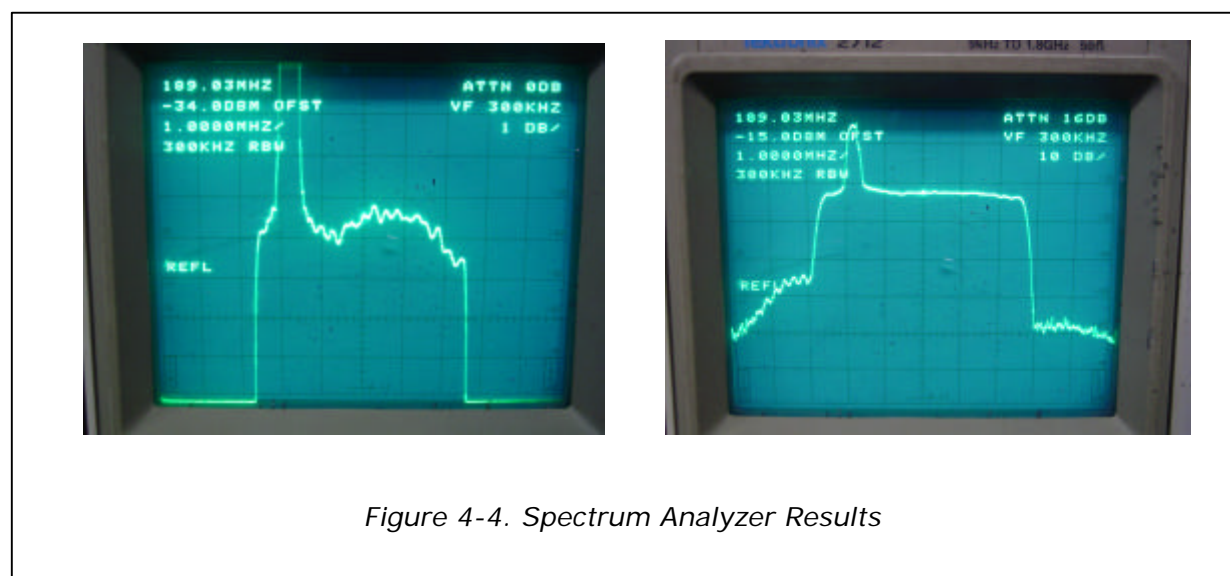
Photographs of the spectrum analyzer results are shown in Figure 4-4.

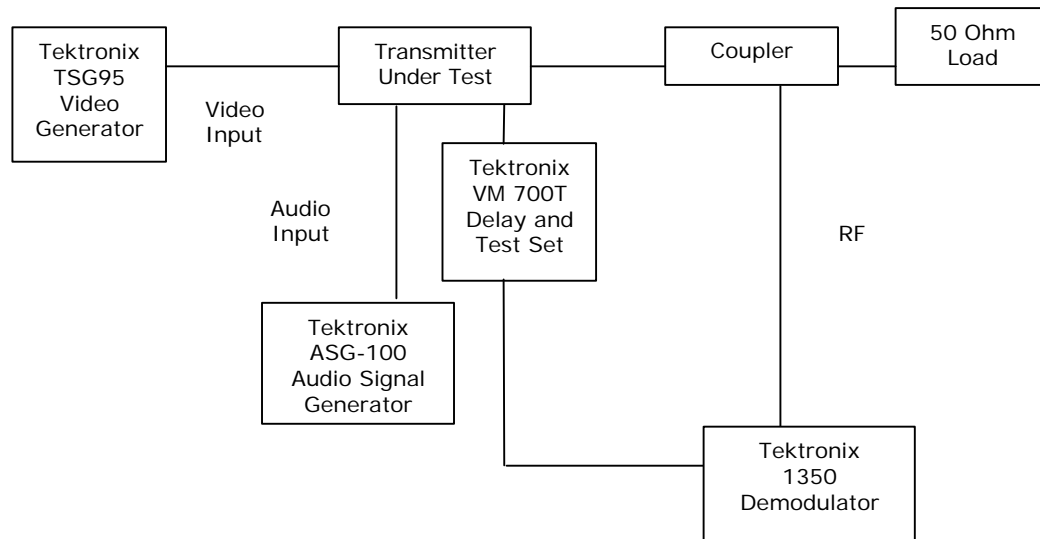
Figure 4-5. Test Setup for Measuring FM Deviation and Distortion

The FM deviation and distortion was measured using the test setup shown in Figure 4-5.

The results of measuring the FM deviation and distortion are shown in Table 4-4.

The FM noise was recorded using the test setup shown in Figure 4-5.

Dotted lines were used for the AM tests and solid lines were used for the FM tests with the following results:

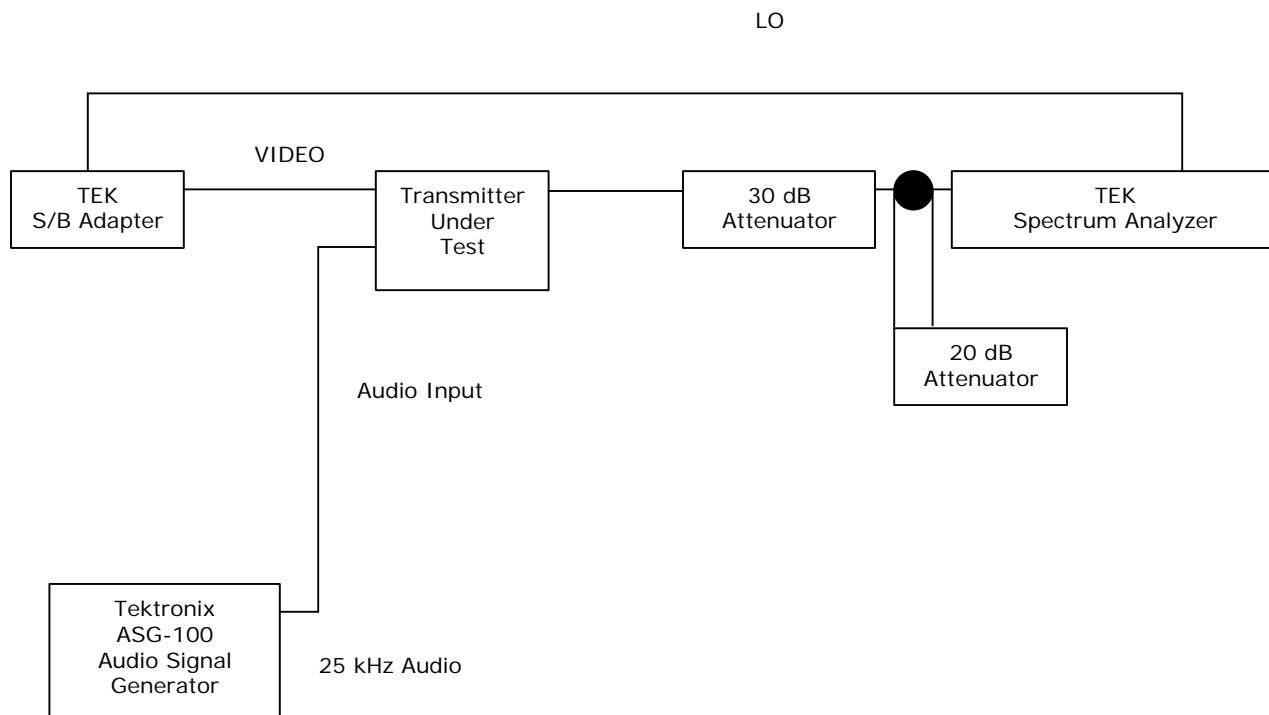
Figure 4-6. Test Setup for Occupied Bandwidth Spectrum Analysis

Using the test setup in Figure 4-6, with the transmitter operating at maximum power, photographs of the transmitter-occupied bandwidth spectrum were taken and are shown in Figures 4-7 and 4-8.

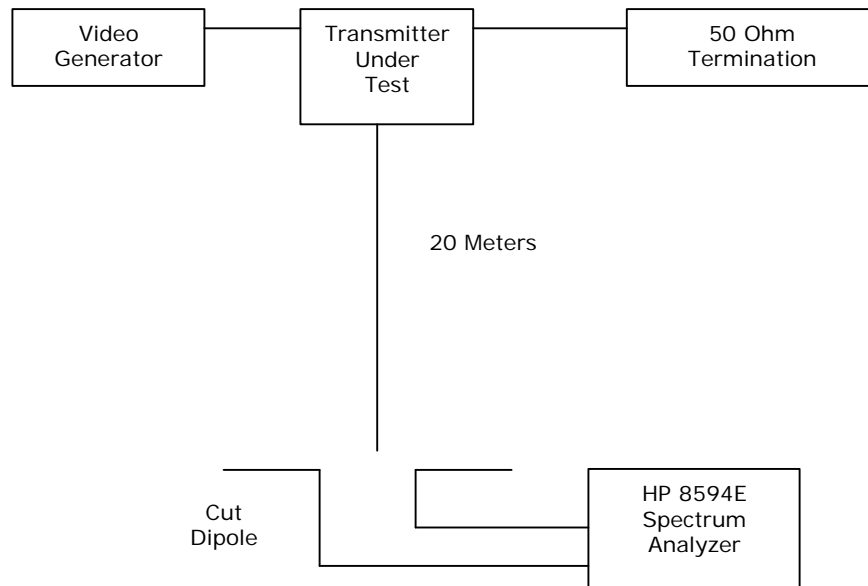
Figure 4-11. Test Setup for Measuring Radiated Emissions

Using the test setup shown in Figure 4-11, with the transmitter operating at full power, the spectrum analyzer was moved 20 meters from the transmitter and connected to a dipole antenna cut to 188 MHz. This antenna was oriented to maximize the received level and the data was recorded. The antenna was then cut to the local oscillator frequency and the second and third harmonic frequencies of the transmitter, and all of the signals received, were maximized by antenna orientation and their absolute levels were recorded.

With these various antennas, and with an adjustable length dipole for 40 to 650 MHz, the frequency spectrum from 40 MHz to 13,000 MHz was observed. The only measurable levels observed were at 187.26 MHz and 191.76 MHz. These levels are shown below in Table 4-8 and an analysis of the relative field and strength is provided in the following paragraphs.
