### **Probe Calibration Parameters**

CALIBRATION CERTIFICATE																																			
Object(s)	ET3DV6 - SN:1664																																		
Calibration procedure(s)	QA CAL-01.v2 Calibration procedure for dosimetric E-field probes																																		
Calibration date:	September 2, 2004																																		
Condition of the calibrated item	In Tolerance (according to the specific calibration document)																																		
<p>This calibration certificate documents the traceability to national standards, which realize the physical units of measurements (SI). The measurements and the uncertainties with confidence probability are given on the following pages and are part of the certificate.</p> <p>All calibrations have been conducted in the closed laboratory facility: environment temperature 22 +/- 2 degrees Celsius and humidity &lt; 75%.</p> <p>Calibration Equipment used (M&amp;TE critical for calibration)</p>

# Probe ET3DV6

## SN:1664

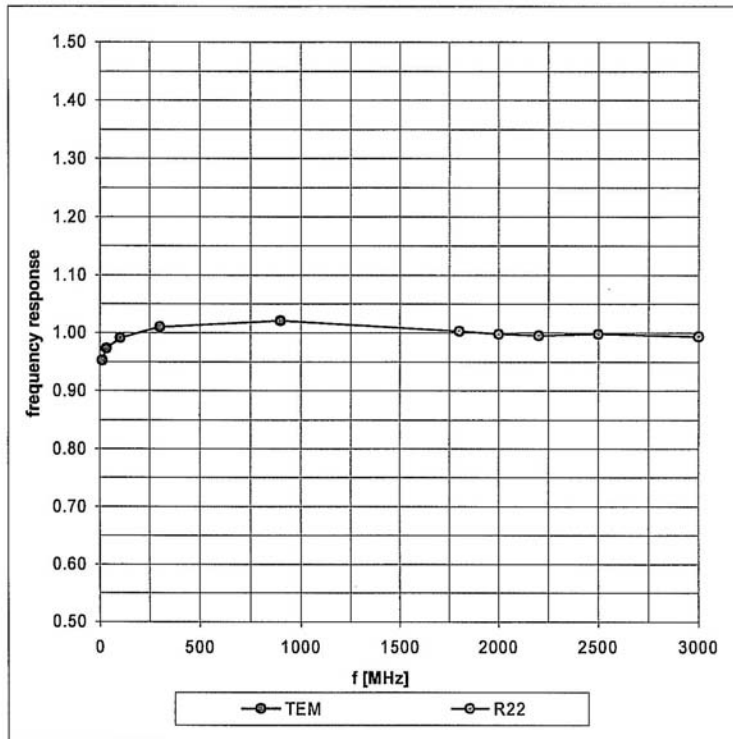
### Frequency Response of E-Field

( TEM-Cell:ifi110, Waveguide R22)

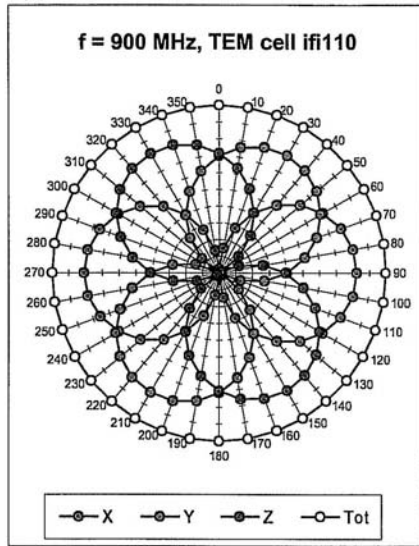
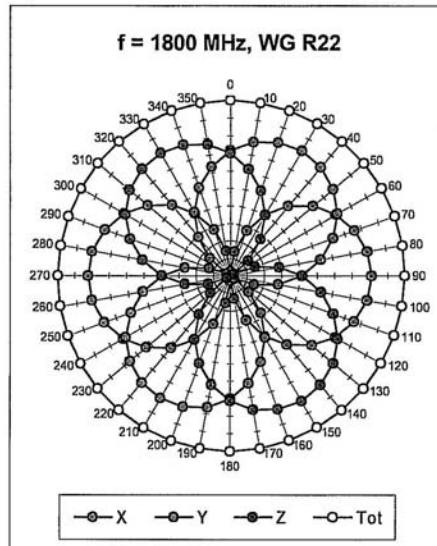
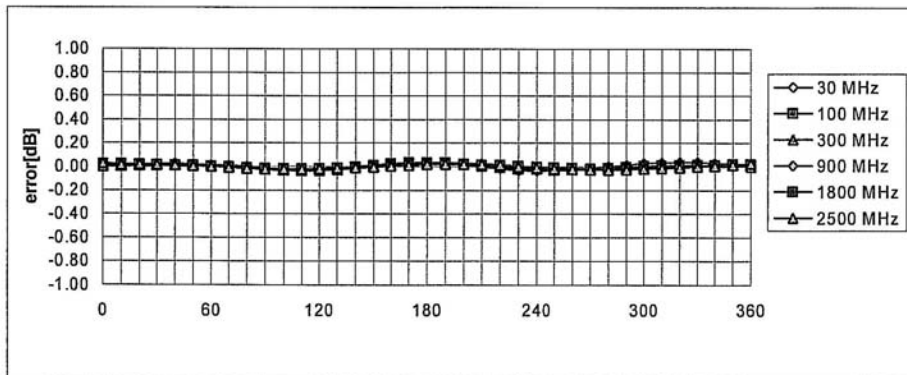
**Receiving Pattern ( $\phi$ ),  $\theta = 0^\circ$**

**Axial Isotropy Error <math>\lt; \pm 0.2 \text{ dB}</math>**

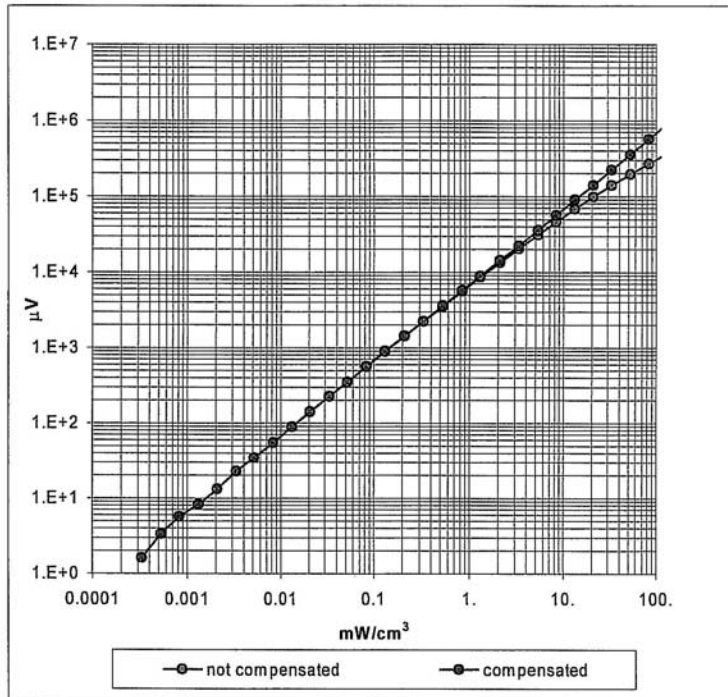
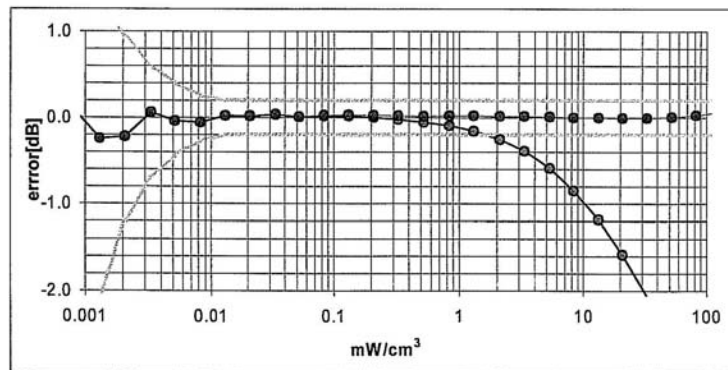
### Dynamic Range $f(\text{SAR}_{\text{head}})$ ( Waveguide R22 )

Probe Linearity Error  $< \pm 0.2$  dB

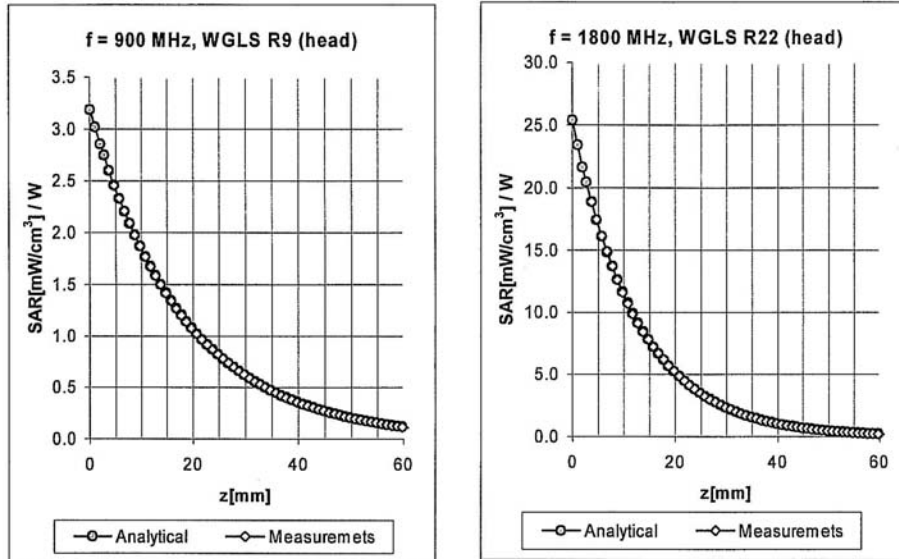
### Conversion Factor Assessment

f [MHz]	Validity [MHz] <sup>B</sup>	Tissue	Permittivity	Conductivity	Alpha	Depth	ConvF Uncertainty
900	800-1000	Head	41.5 ± 5%	0.97 ± 5%	0.64	1.80	6.56 ± 11.3% (k=2)
1800	1710-1910	Head	40.0 ± 5%	1.40 ± 5%	0.48	2.61	5.43 ± 11.7% (k=2)
900	800-1000	Body	55.0 ± 5%	1.05 ± 5%	0.52	2.11	6.17 ± 11.3% (k=2)
1800	1710-1910	Body	53.3 ± 5%	1.52 ± 5%	0.55	2.73	4.72 ± 11.7% (k=2)

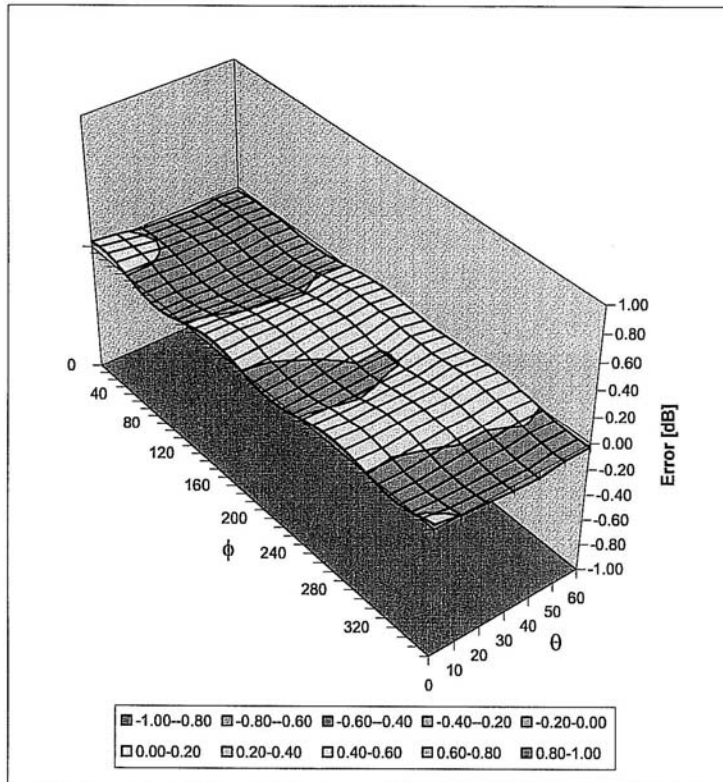
### Deviation from Isotropy in HSL

Error ( $\theta, \phi$ ),  $f = 900$  MHz

**Spherical Isotropy Error  $< \pm 0.4$  dB**
