APPENDIX 1: Photographs of test setup

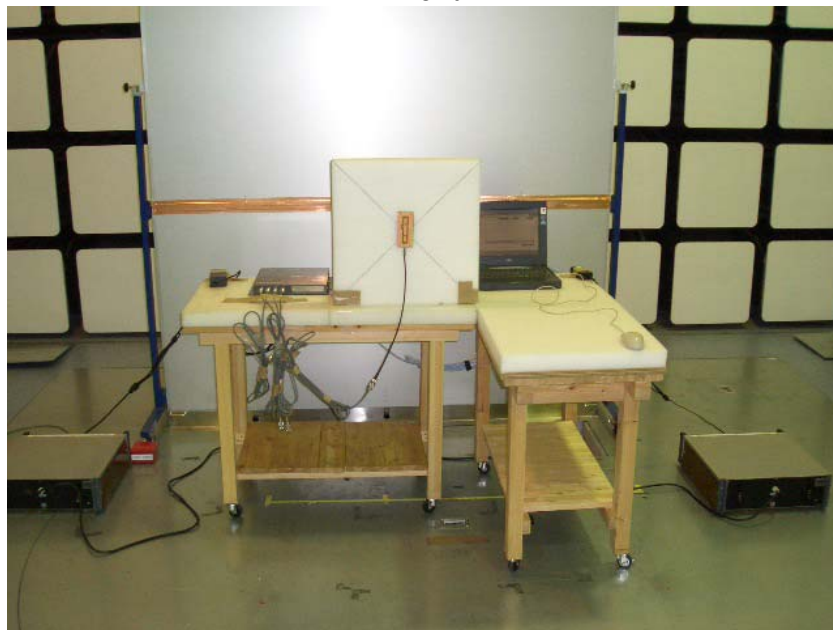
Front

Conducted Emission

*The test configuration is set up in the actual usage, which is in the worst conditions of the noise level.

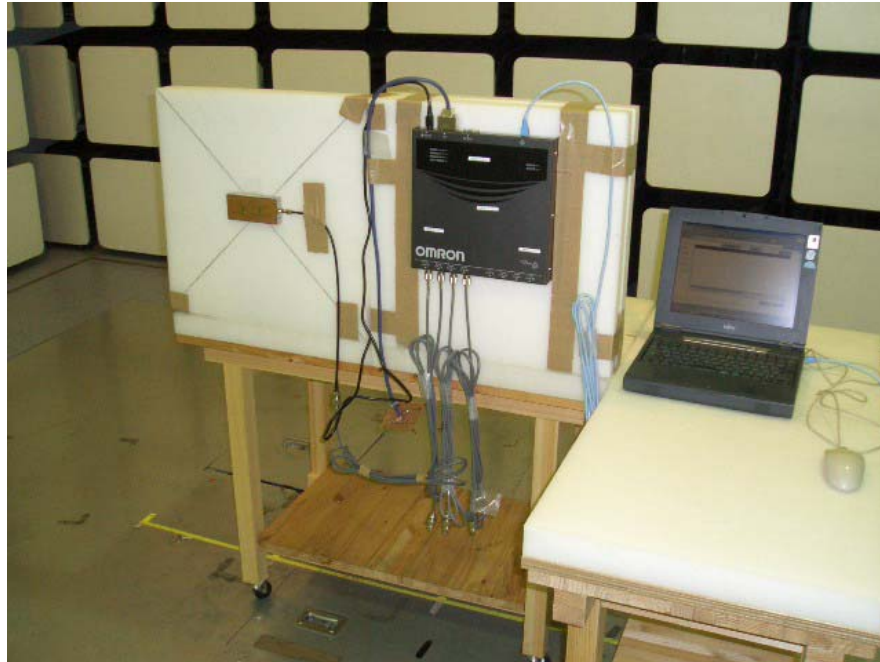
Front

Spurious Emission (Radiated)

*The test configuration is set up in the actual usage, which is in the worst conditions of the noise level.

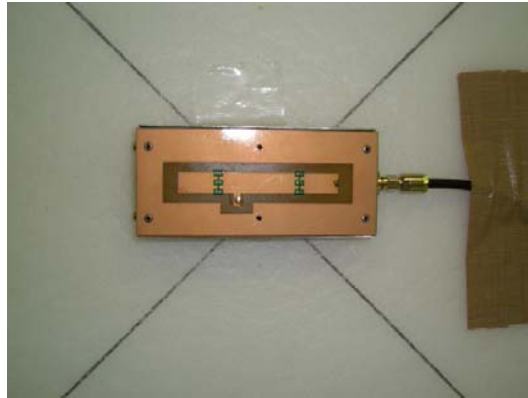
X-axis

Worst Case Position (Horizontal: X-axis/ Vertical:Y-axis)
