## Appendix 2 Photodocumentation

Department: EMC

Test report reference:  
M/EMV-01/260

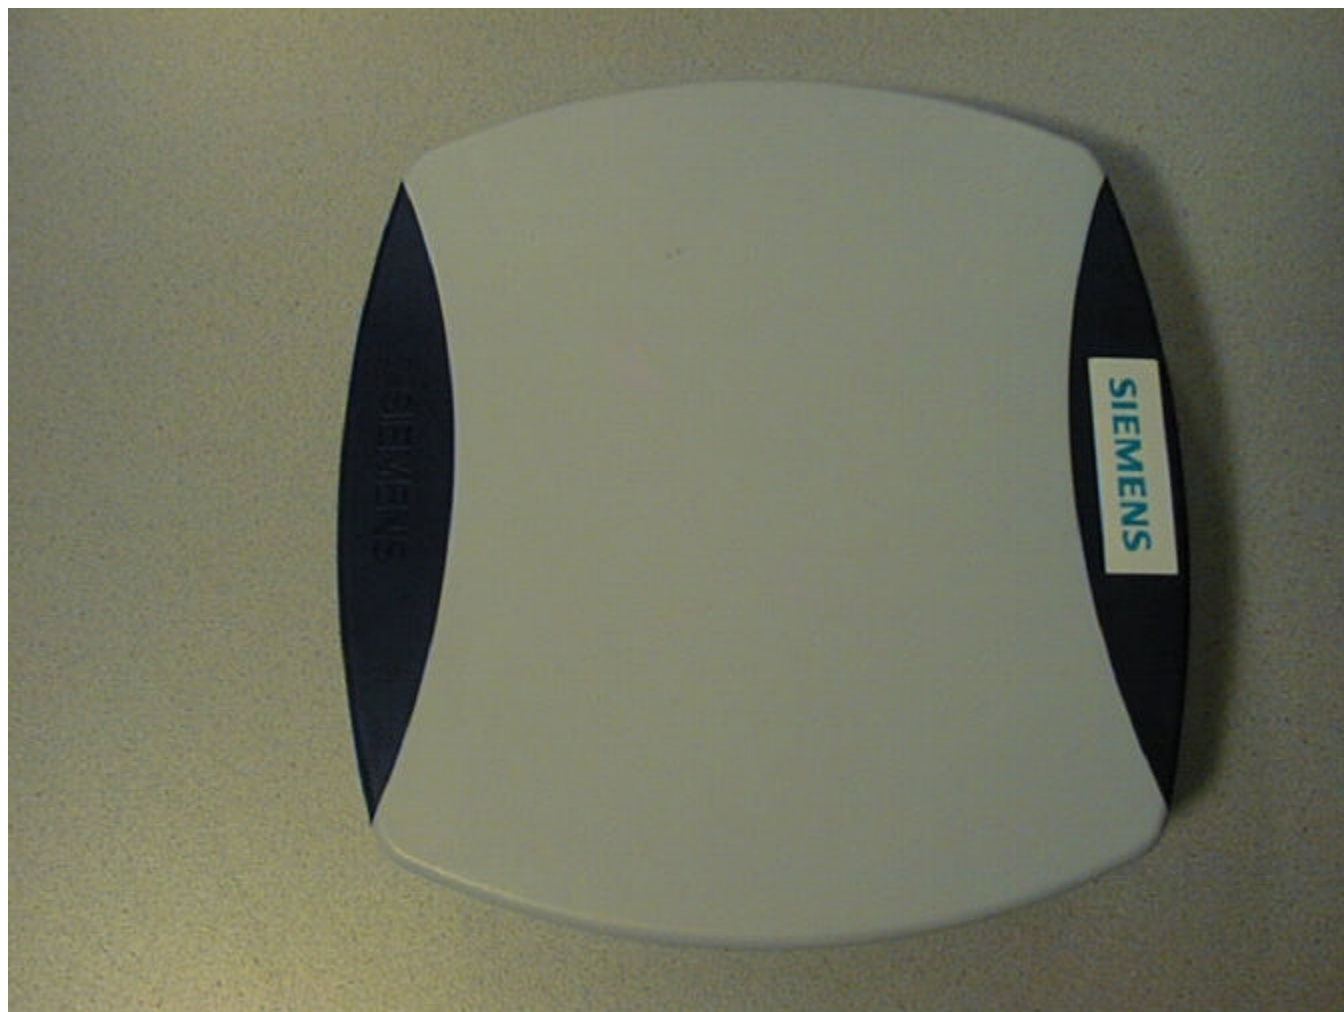
Description: Top view

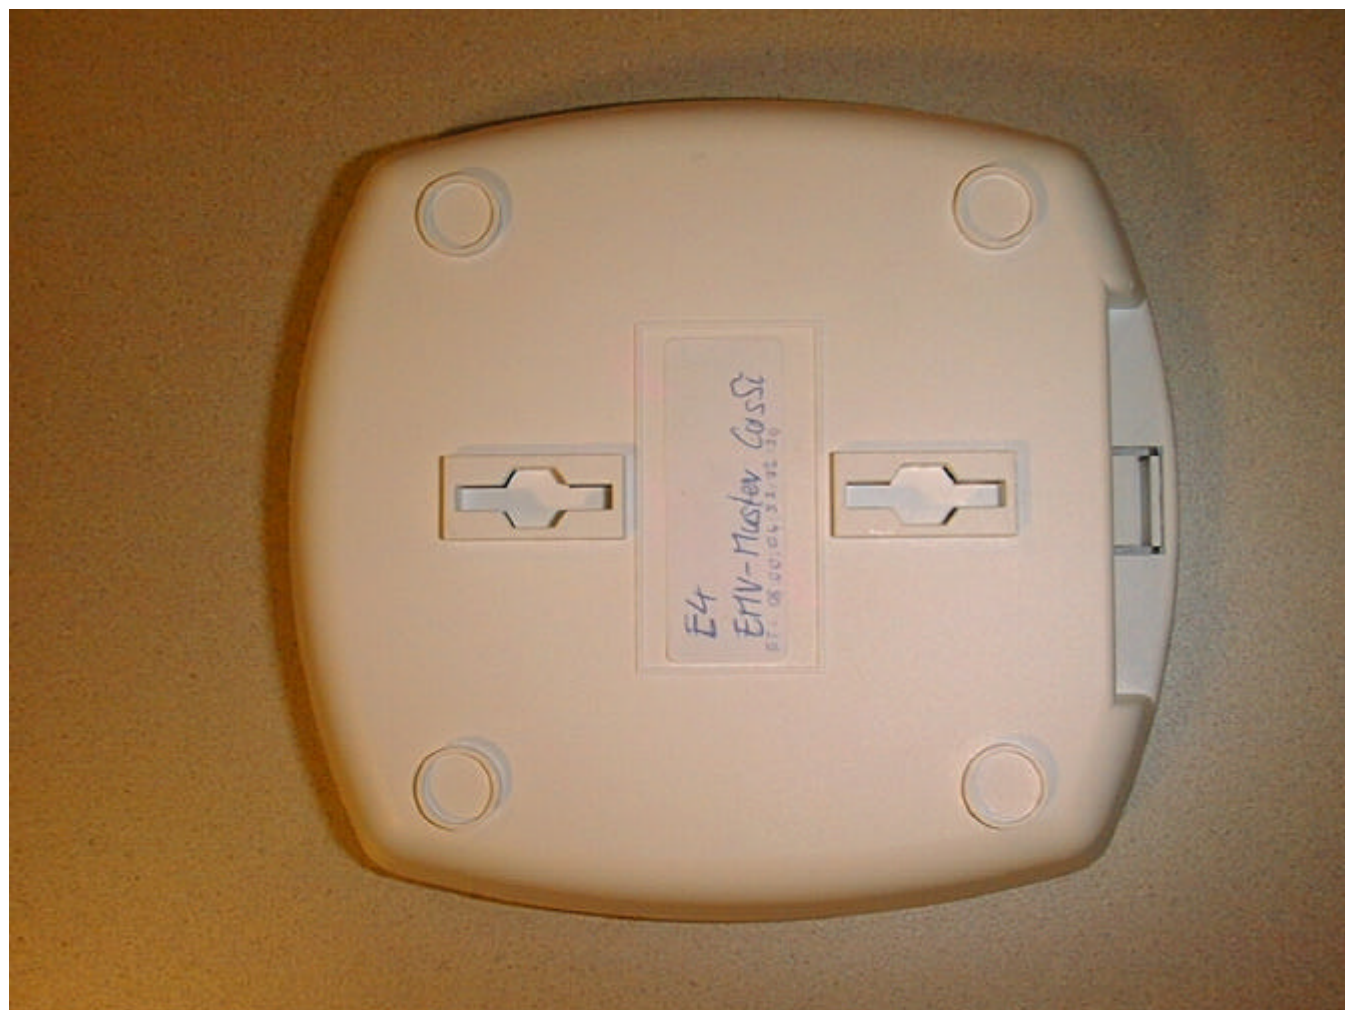
Description: Bottom view

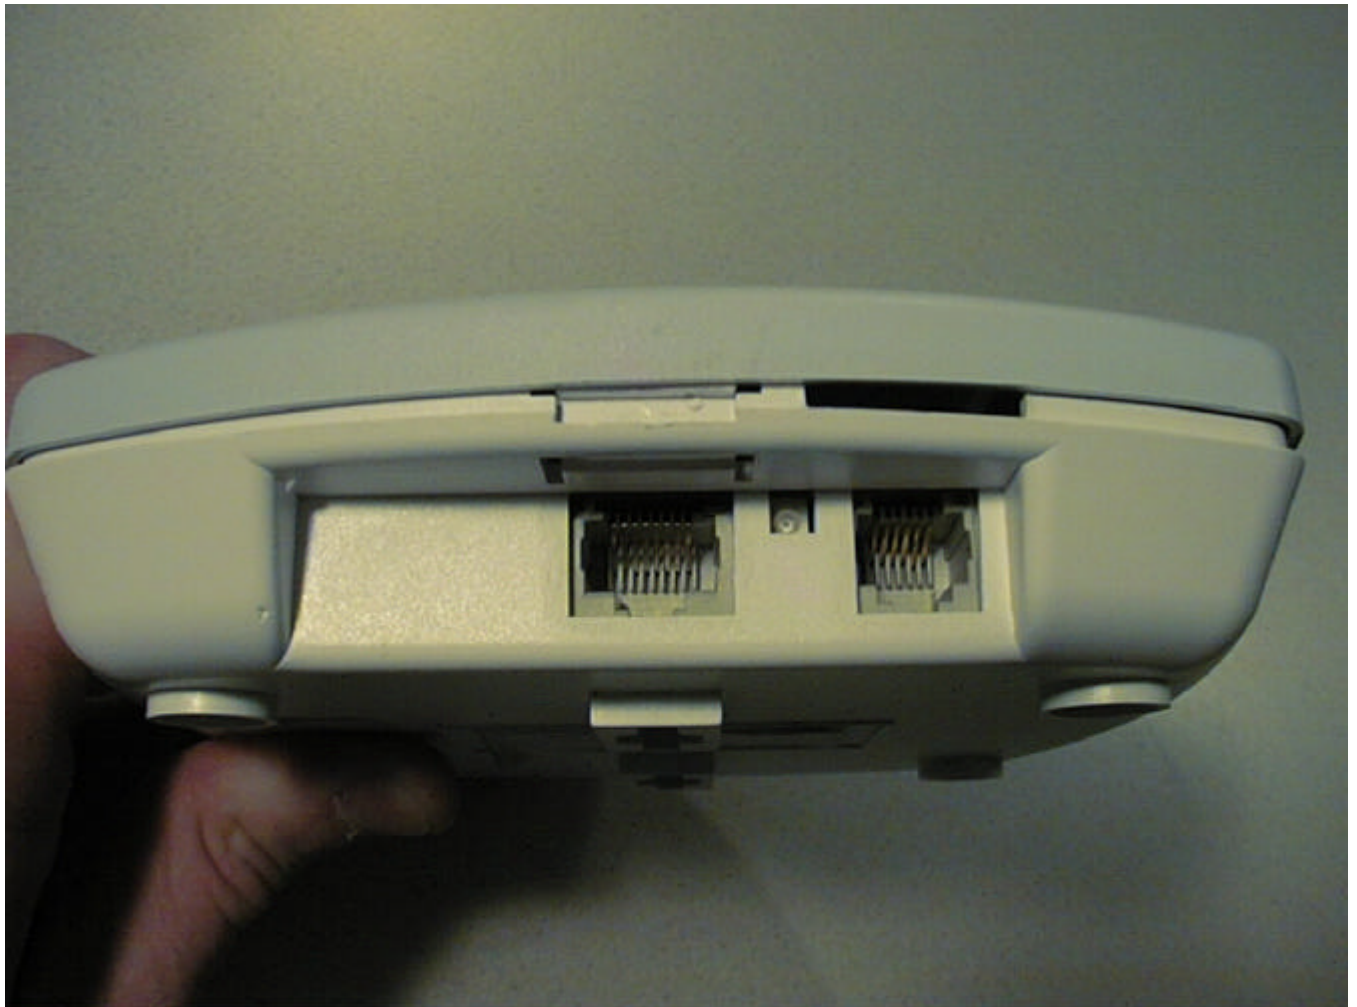
Description: View of connectors

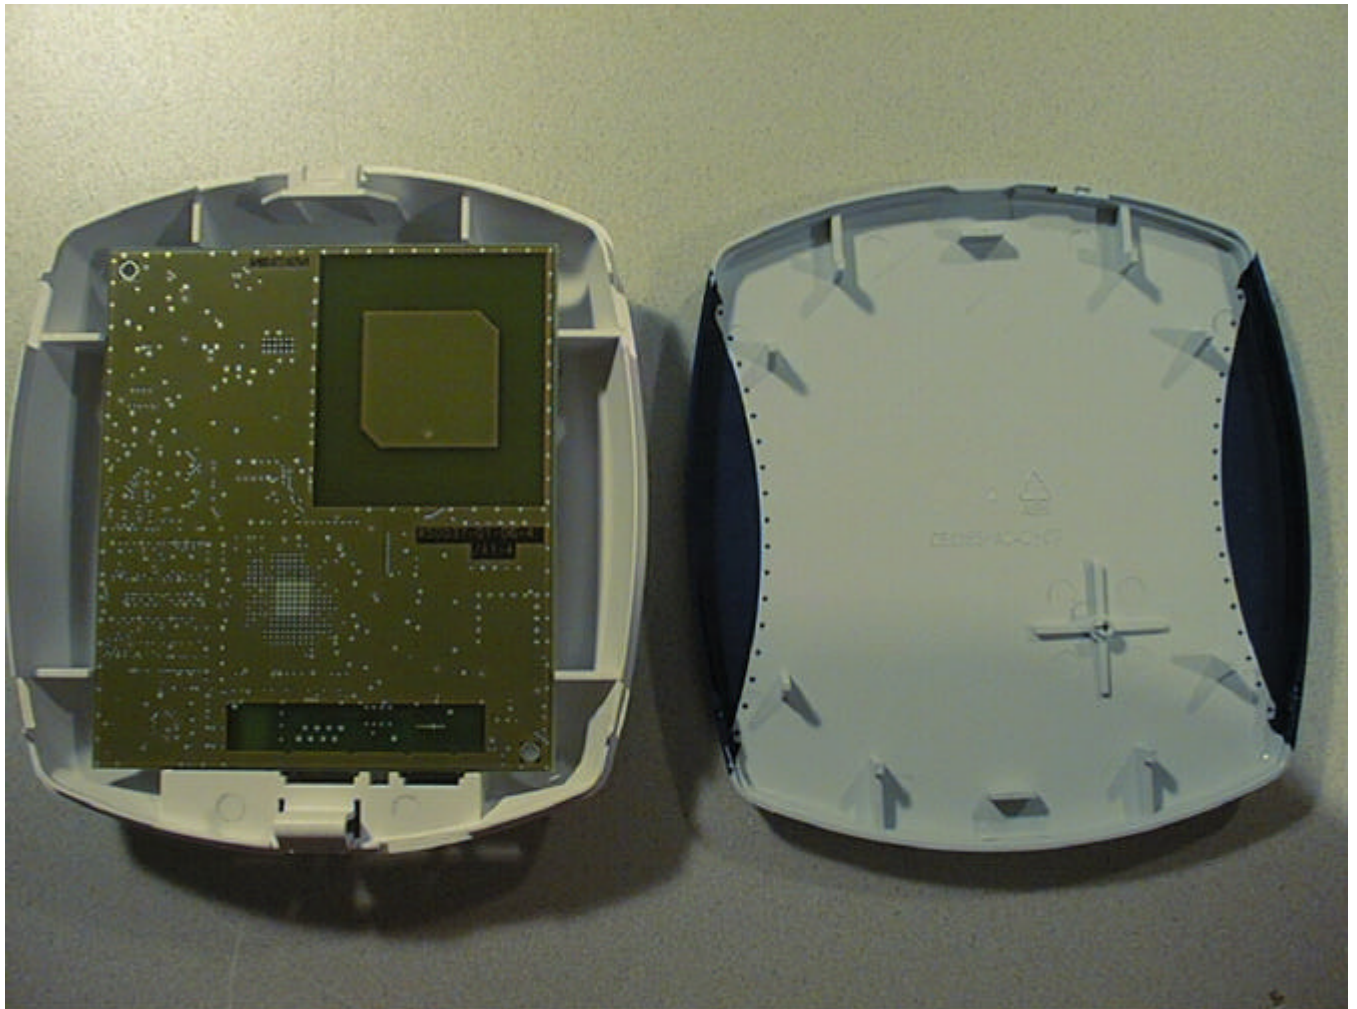
Description: Case opened

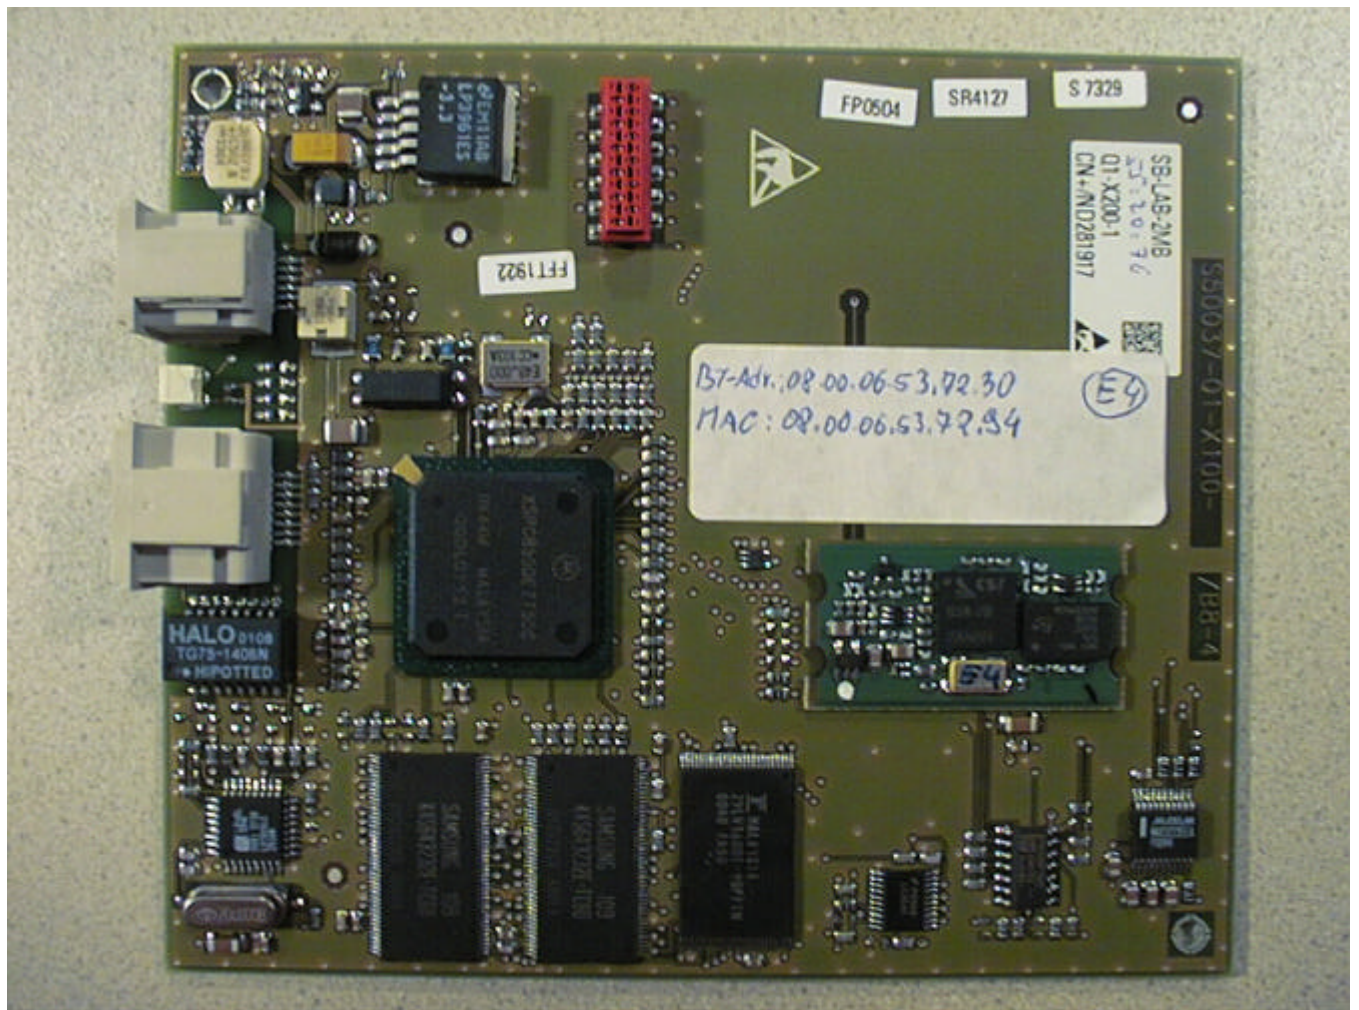
Description: PCB view #1

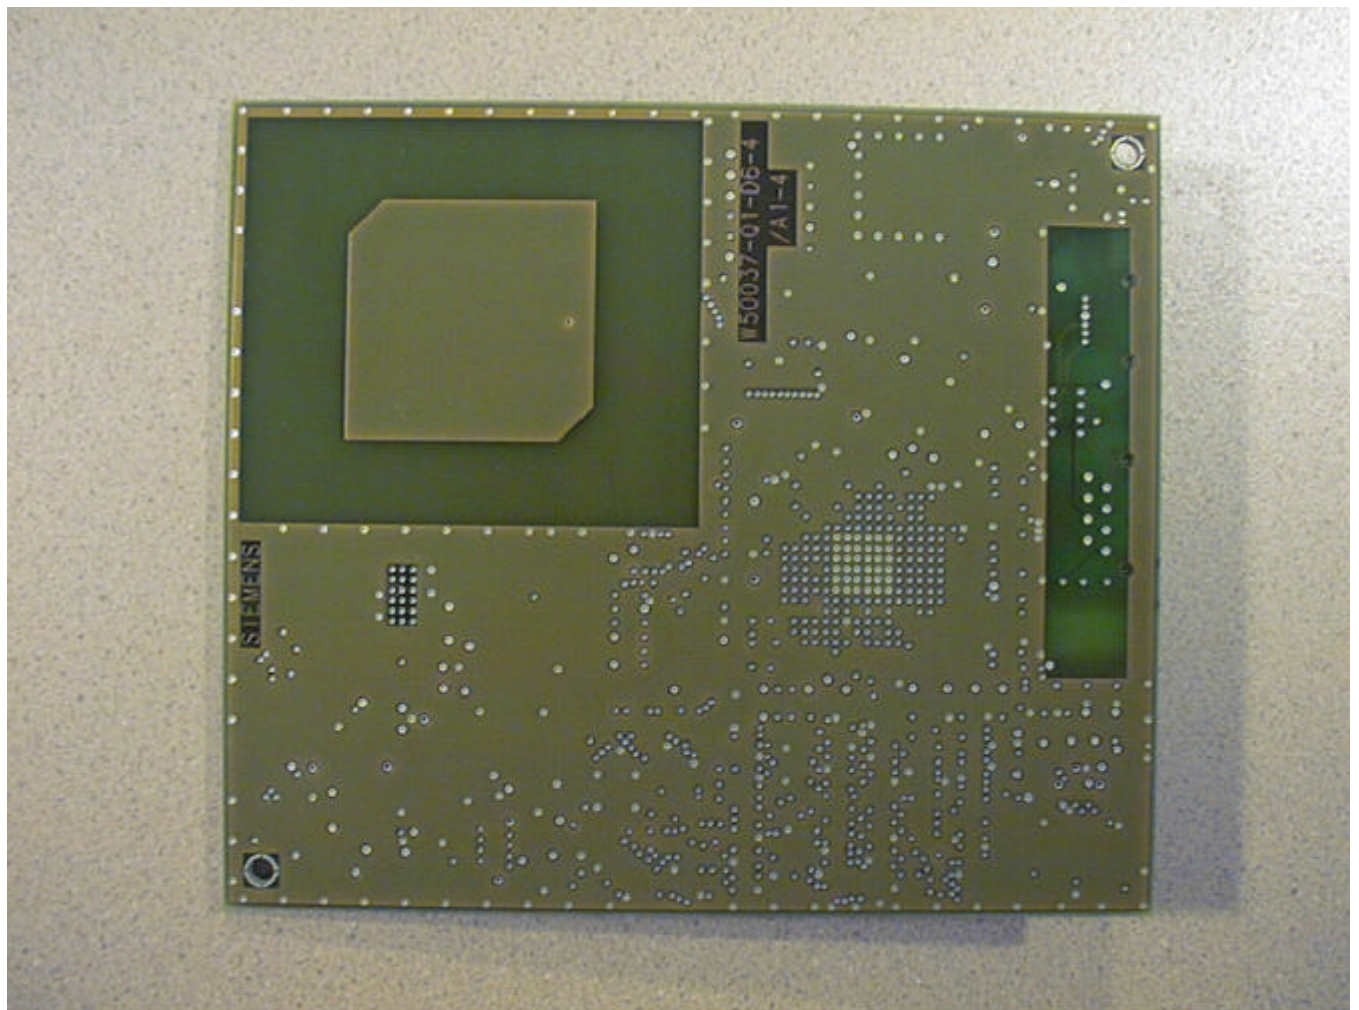
Description: PCB view #2

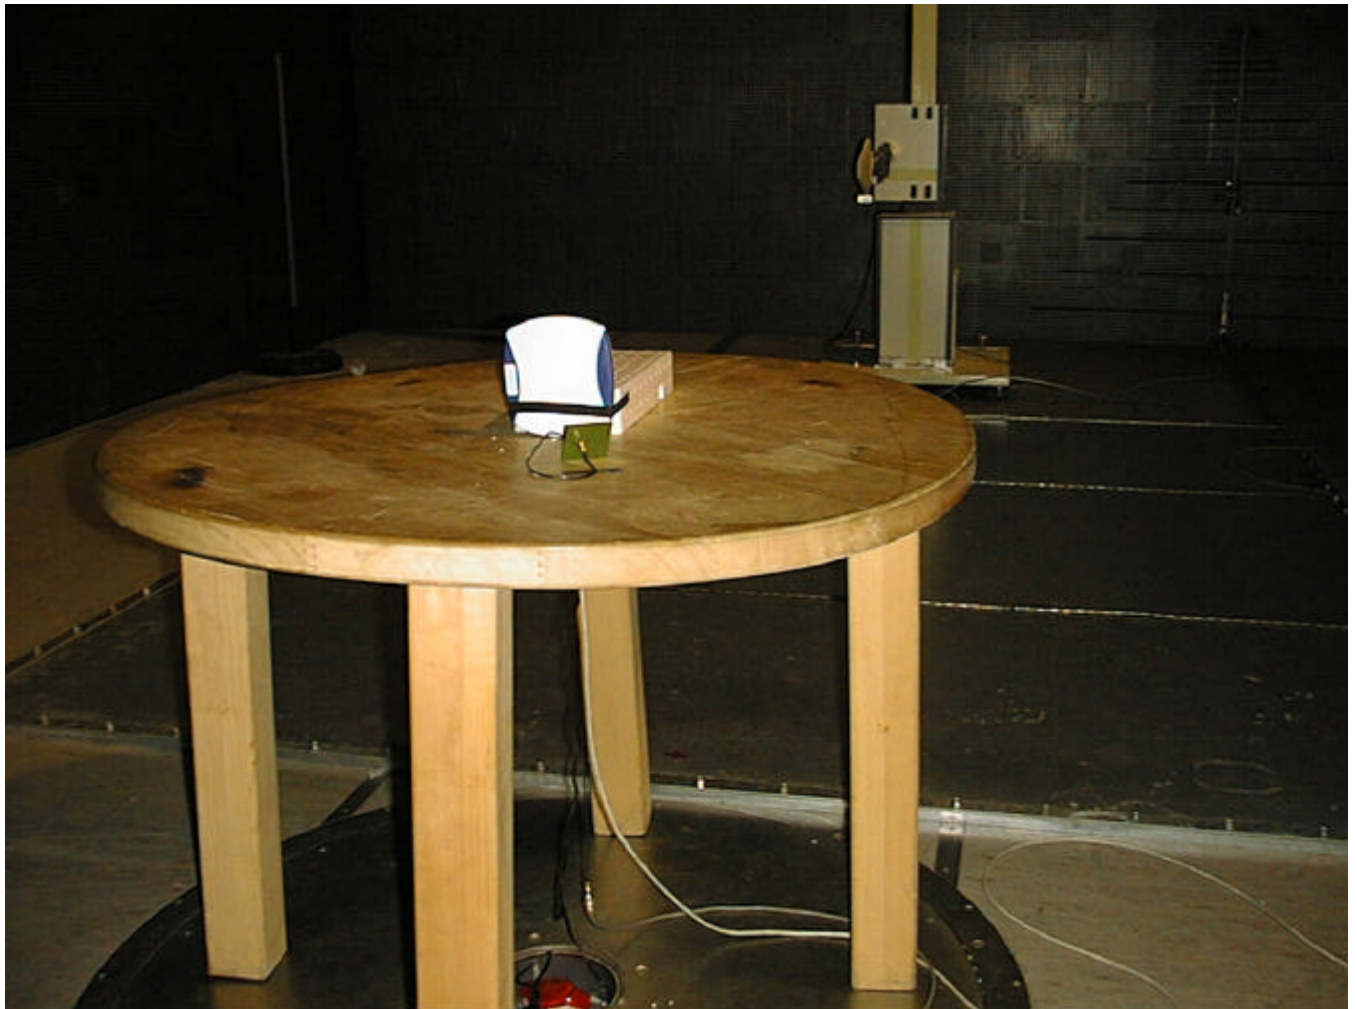
Description: Test setup radiated emissions 30  
MHz to 2 GHz

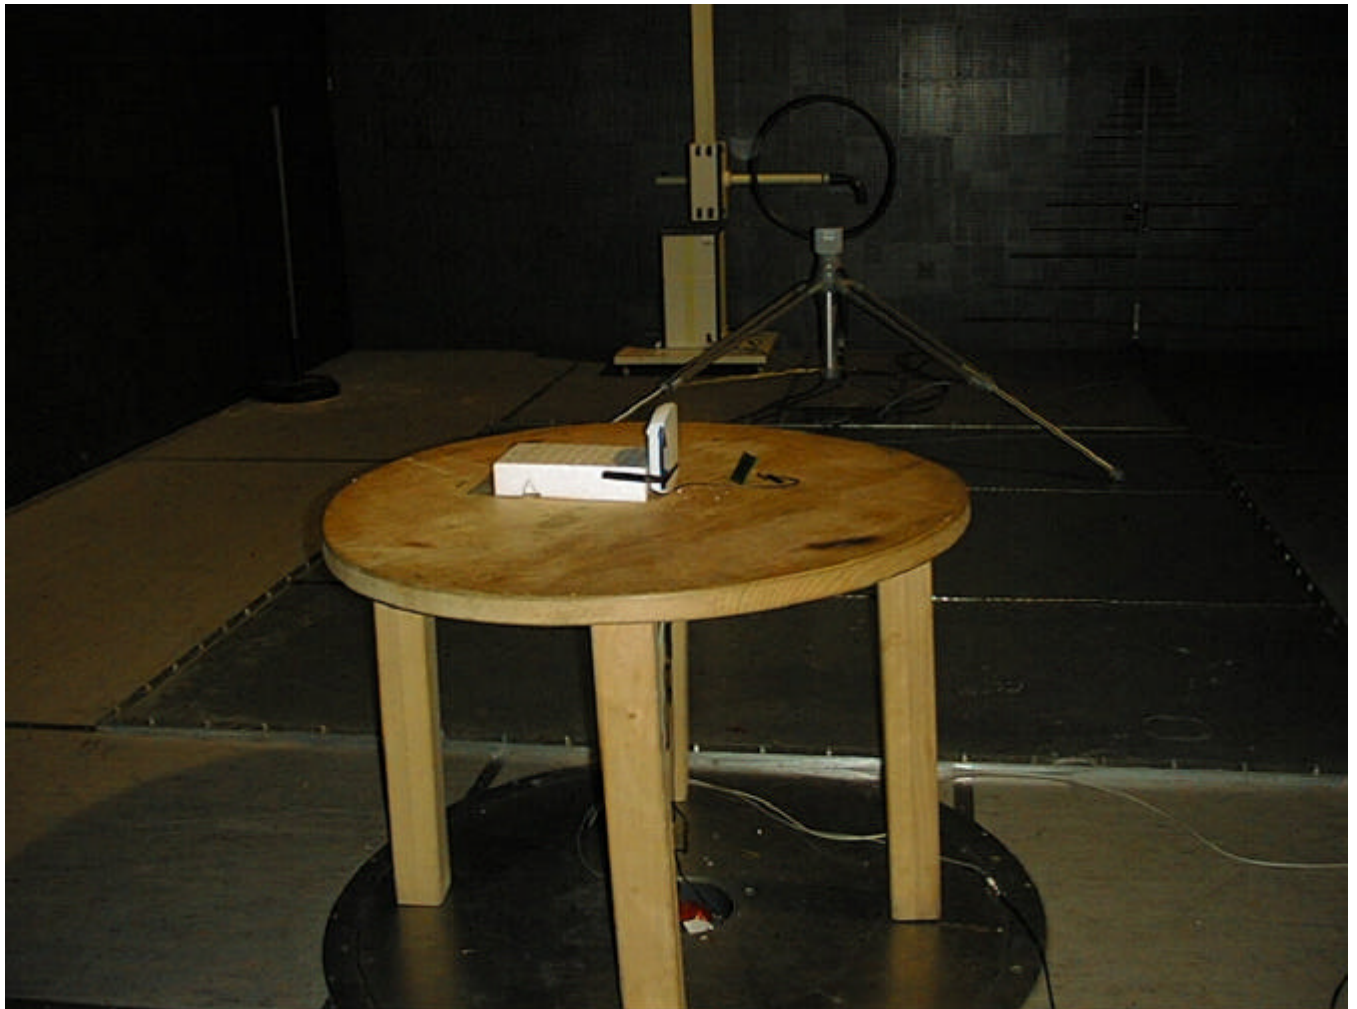
Description: Test setup radiated emissions below  
30 MHz

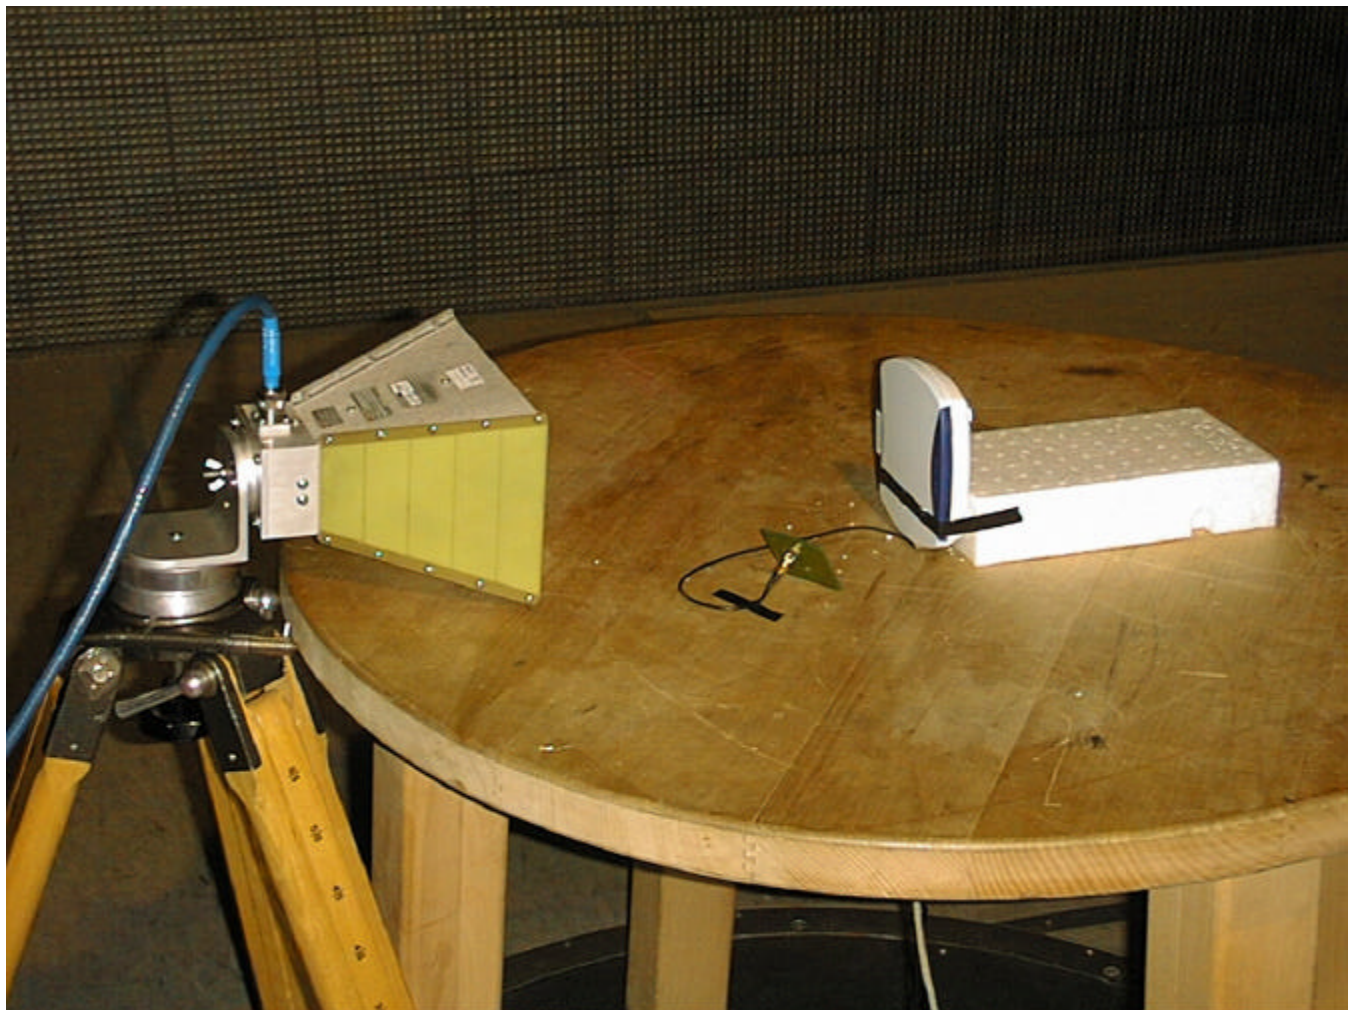
Description: Test setup radiated emissions above 2 GHz\*

\* The measurement distance was reduced because no emissions were found in 1m distance, but there were no emissions found with the smaller distance too.

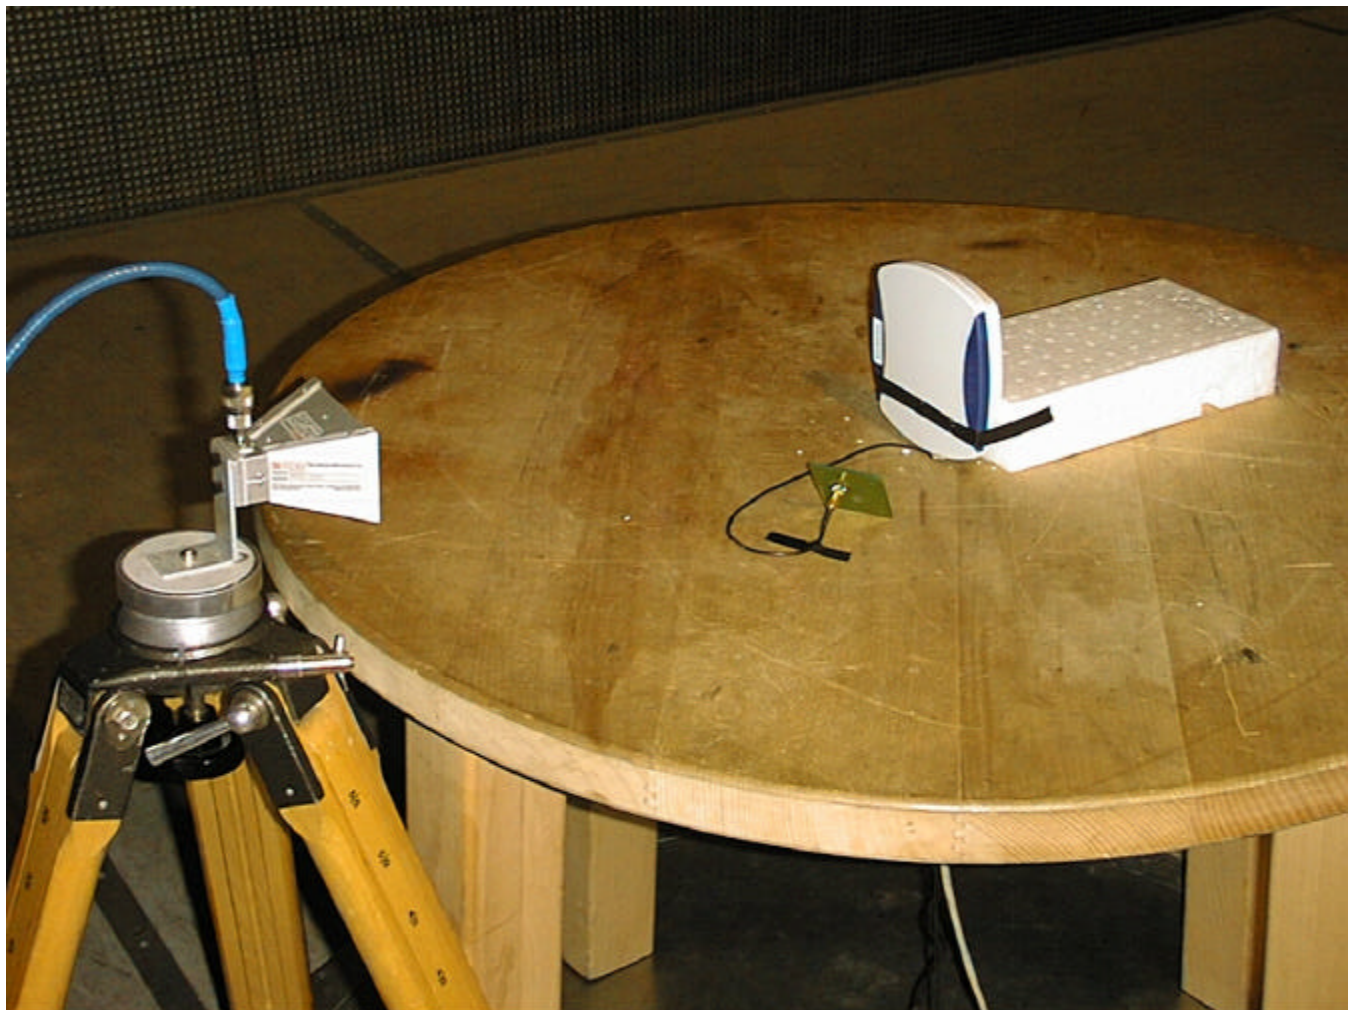
Description: Test setup radiated emissions above 18 GHz\*

\* The measurement distance was reduced because no emissions were found in 1m distance, but there were no emissions found with the smaller distance too.
