**APPENDIX 3: Photographs of test setup**

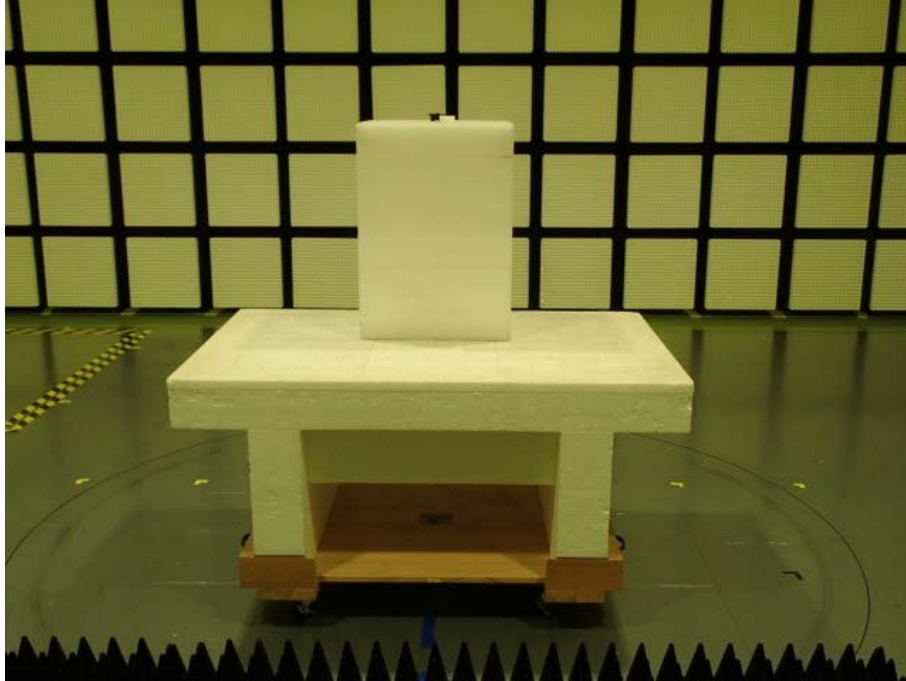
**Photo 1**

**Radiated Emission**  
**(Below 1 GHz)**

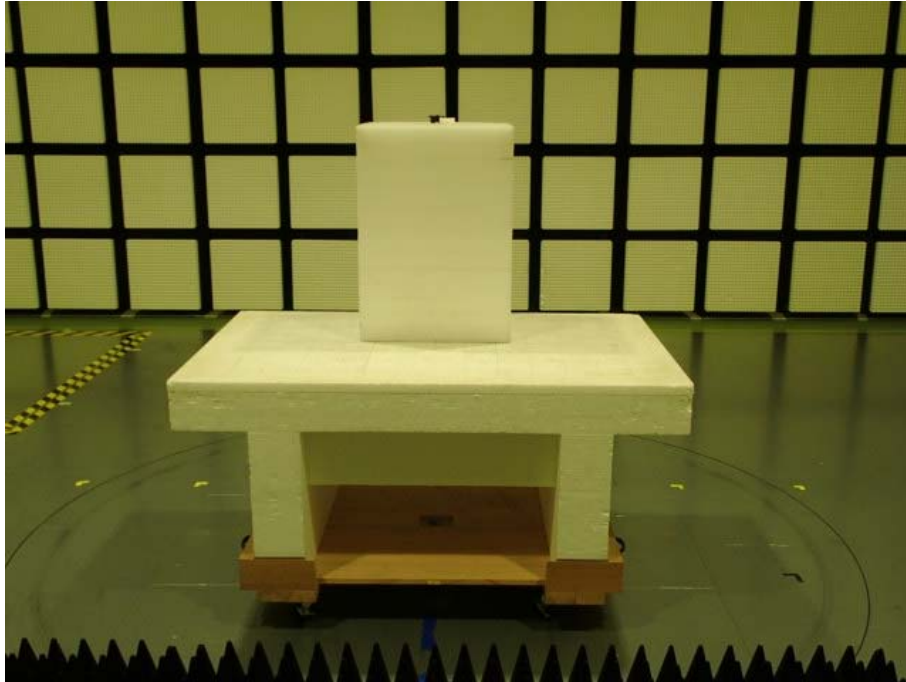
**Photo 1**

**Radiated emission**  
**(Above 1 GHz)**

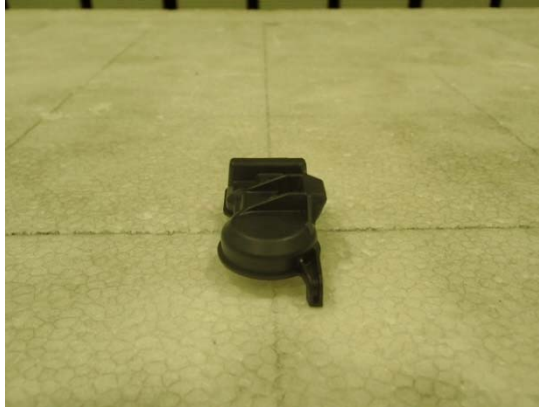
**X-axis**

**Worst Case Position**

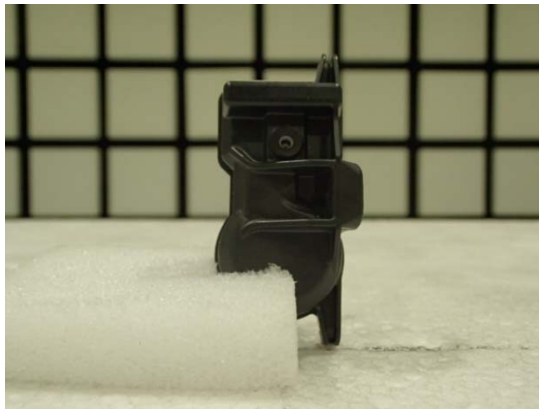
**Y-axis**

Below 1 GHz: (Horizontal: Y-axis / Vertical: Z-axis)

Above 1 GHz: (Horizontal: Z-axis / Vertical: Y-axis)
