**Figure 1:** Internal Photo of HomePortal 3801HGV - PCB Board (Front Side)

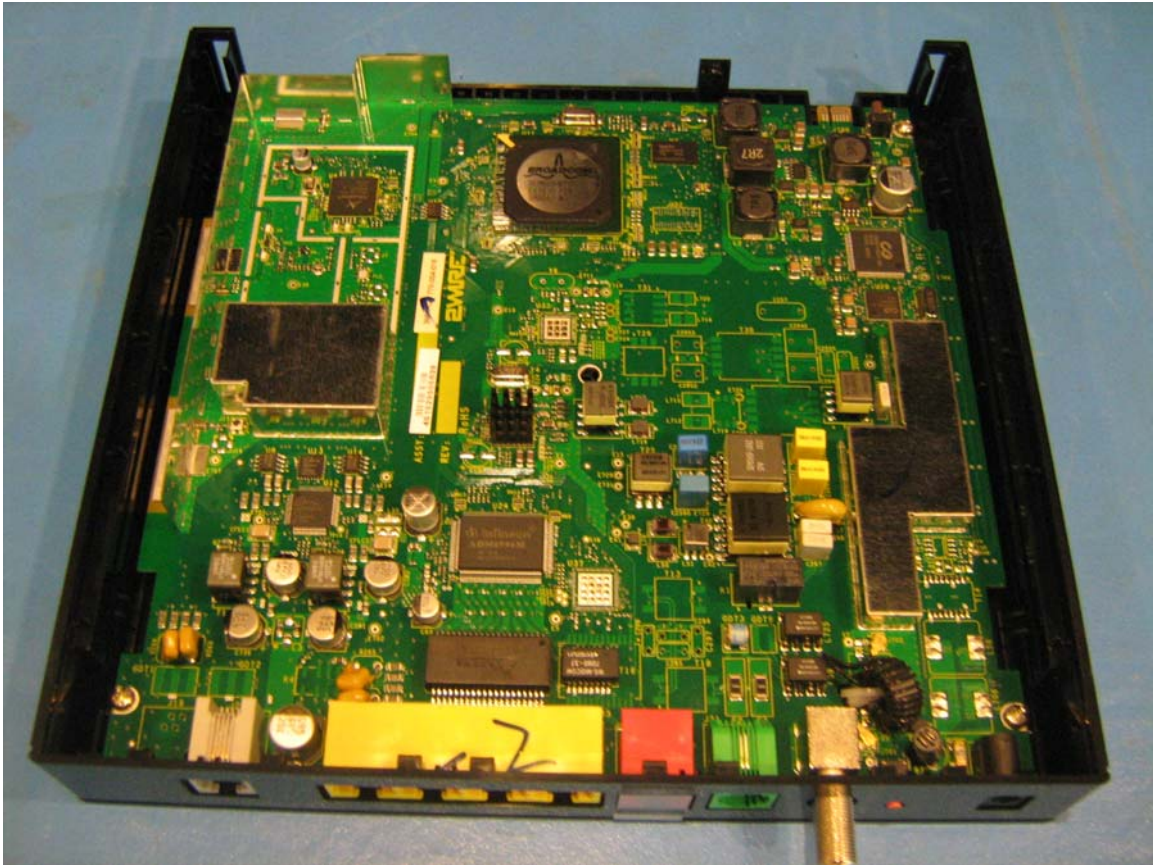
**Figure 3:** Internal Photo of HomePortal 3801HGV - PCB Board (inside Plastic Housing)
