**Internal Photos**

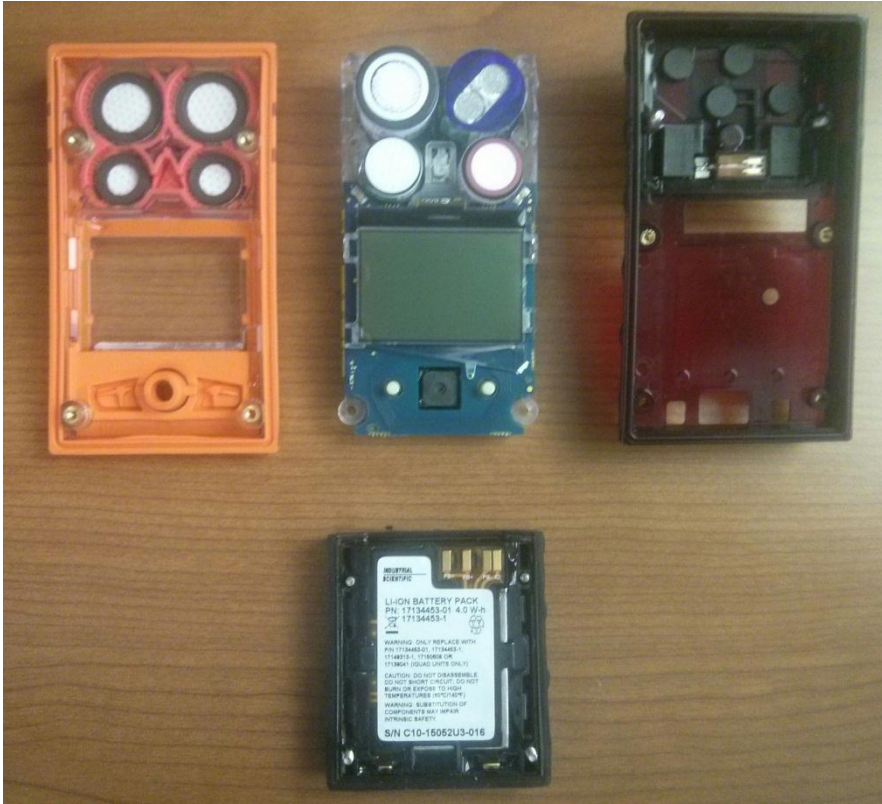
1. Shown below, instrument battery (bottom), case front (left) and case back (right) are removed. PCBA assembly on plastic frame, with gas sensors and LCD installed (center).

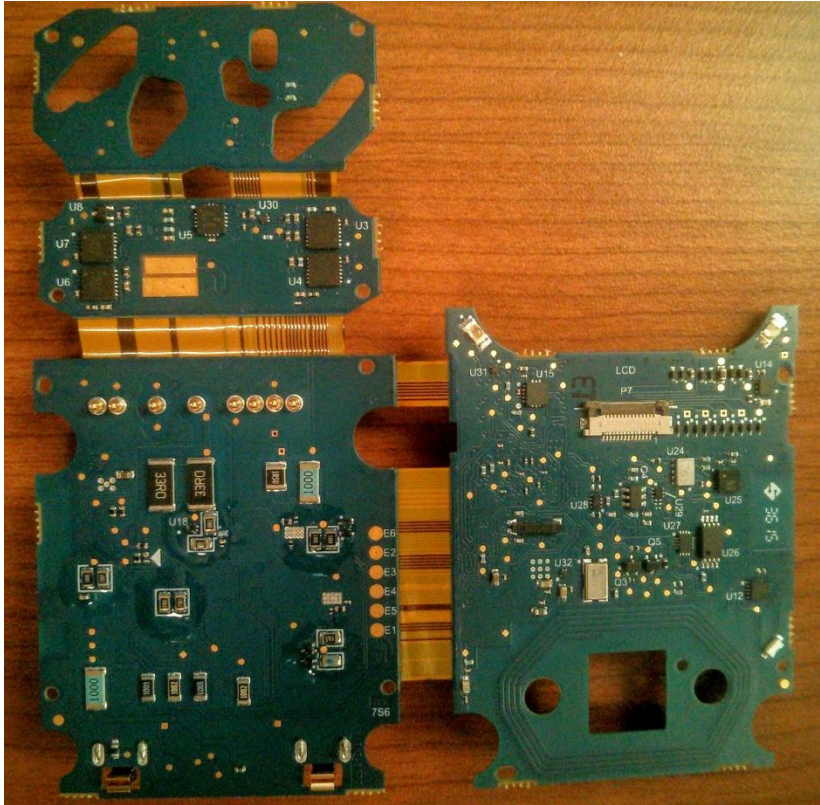
The opposite side of the PCBA is shown below, with the NFC antenna shown at bottom right.
