Change of contents

FCC ID : PP4PX-800

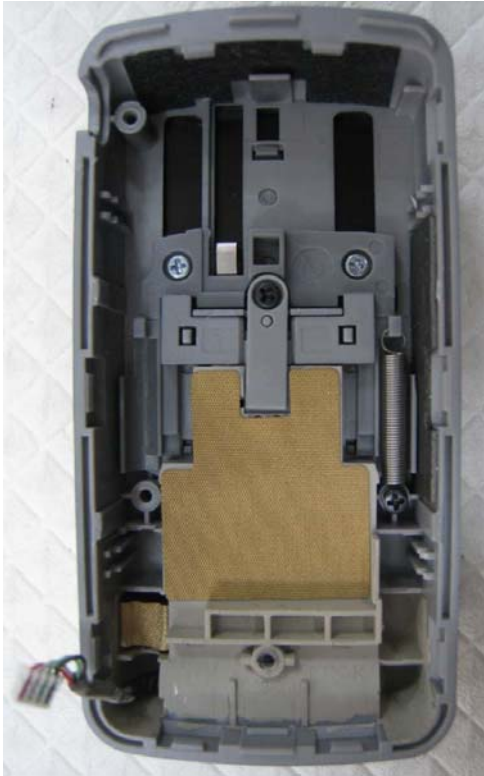
Before change (picture)

1. Operated Cell, PCS and AWS.
2. Used EMI.

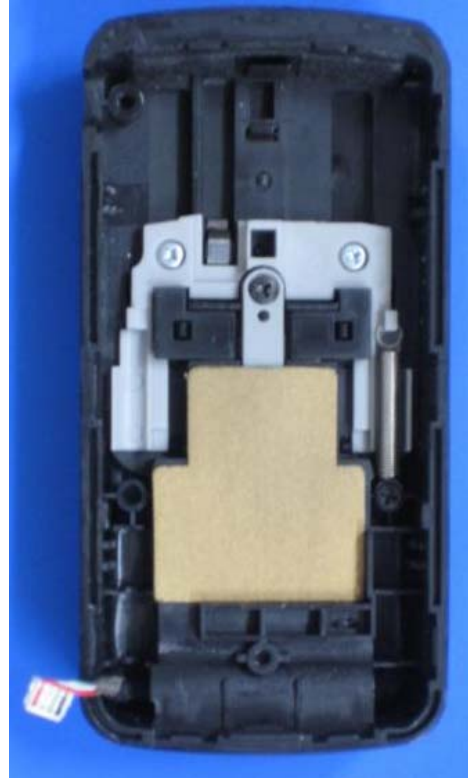
After change (picture)

1. Operated Cell and PCS.
(Be out of AWS BAND by the software)
2. Deleted EMI.
3. Changed MAIN antenna
& SUB Antenna.
