## Test setup photos for HAC Test Report

Test report no.:	Salo_HAC_0833_18	Date of report:	2008-08-21
Template version:	3.0	Number of pages:	4
Testing laboratory:	TCC Nokia Salo Laboratory P.O.Box 86 Joensuunkatu 7H / Kiila 1B FIN-24101 SALO, FINLAND Tel. +358 (0) 7180 08000 Fax. +358 (0) 7180 45220	Client:	Nokia Corporation Lise Meitner Strasse 10 89081 ULM GERMANY Tel. +49 731 1754 0 Fax. +49 731 1754 6800
Responsible test engineer:	Ari Orte	Product contact person:	Ralpf Schwarz
Measurements made by:	Ari Orte		
Tested devices:	RM-399 (Hearing aid mode active)		
FCC ID:	PPIRM-399	IC:	661U-RM399
Supplement reports:	Salo_HAC_0833_16, Salo_HAC_0833_17		
Testing has been carried out in accordance with:	<b>ANSI C63.19-2007</b> American National Standard for Methods of Measurement of Compatibility between Wireless Communications Devices and Hearing Aids		
Documentation:	The documentation of the testing performed on the tested devices is archived for 15 years at TCC Nokia.

## 1. SUMMARY OF HAC RF EMISSION TEST REPORT

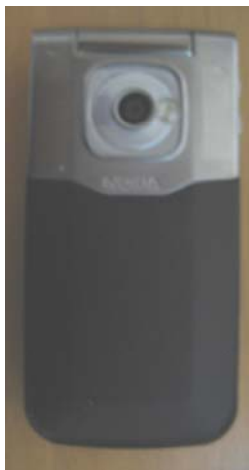
### 1.2 Picture of Device

Flip closed

Flip open

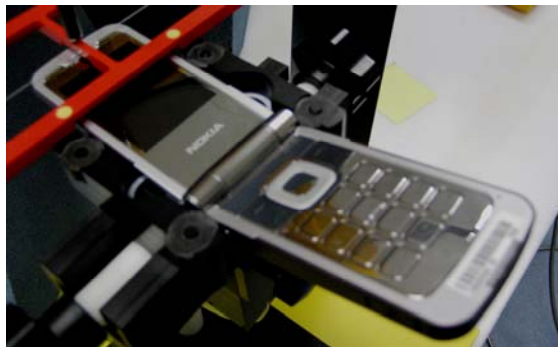
The device was positioned such that Device Reference plane was touching the bottom of the Test Arch. The scan is centered at the acoustic output by aligning the acoustic output with the intersection of the Test Arch's middle bar and dielectric wire.

Photo of the device positioned under Test Arch
