6 Photographs of the Test Set-Up

Prüfbericht - Nr.:
Test Report No.:

16026515 001

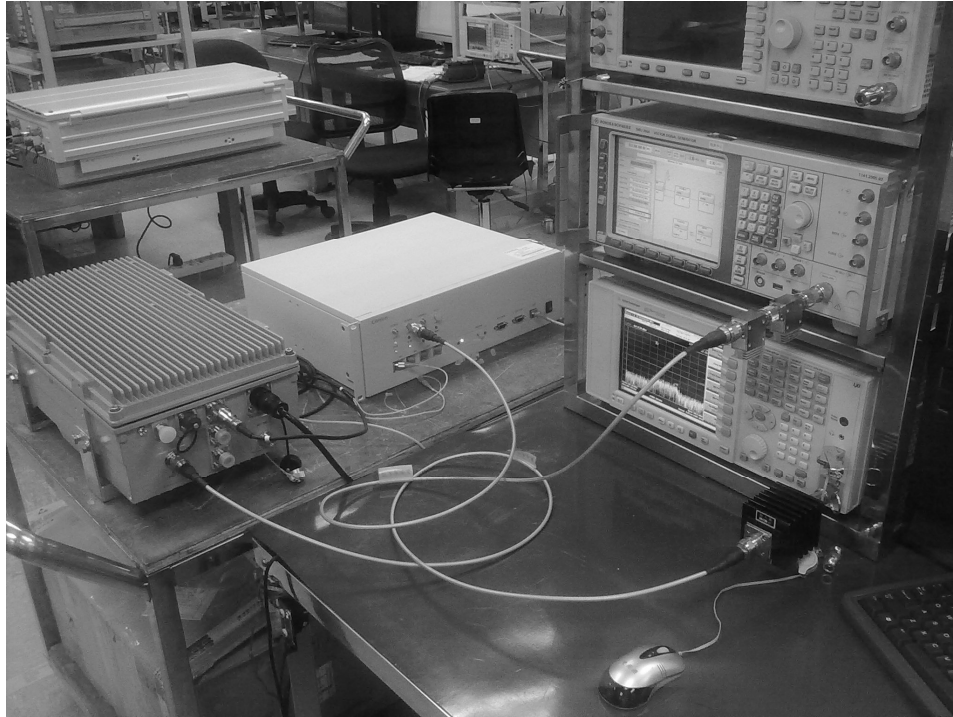
Photograph 1: Set-up for RF power, Occupied Bandwidth, Out-of-Band emissions, Intermodulation test, Spurious Emissions at antenna terminal, EVM

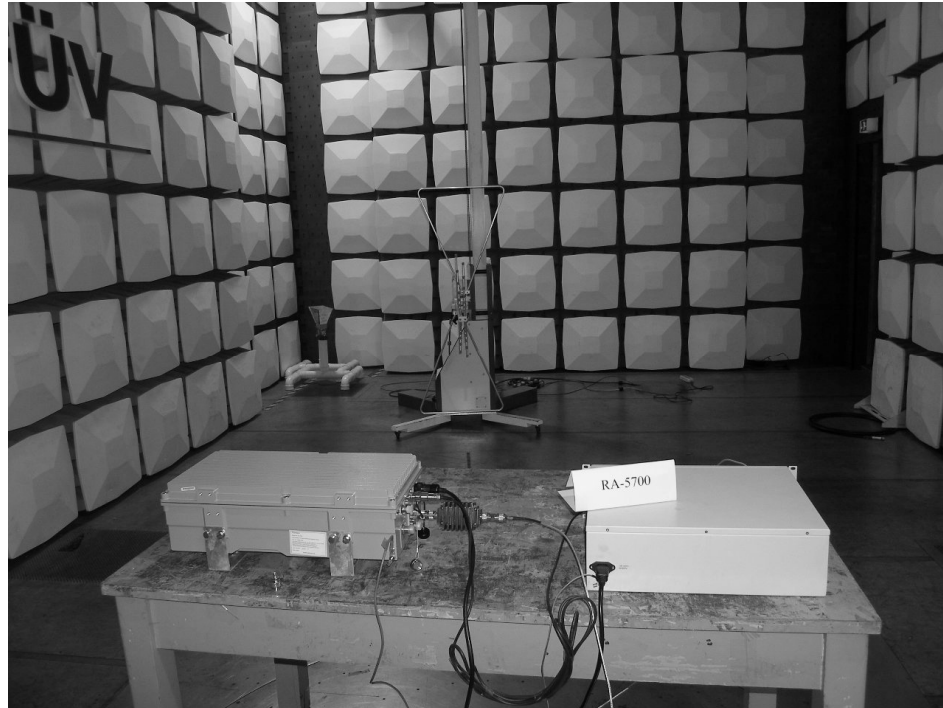
Photograph 2: Set-up for Radiation Measurement Below 1GHz

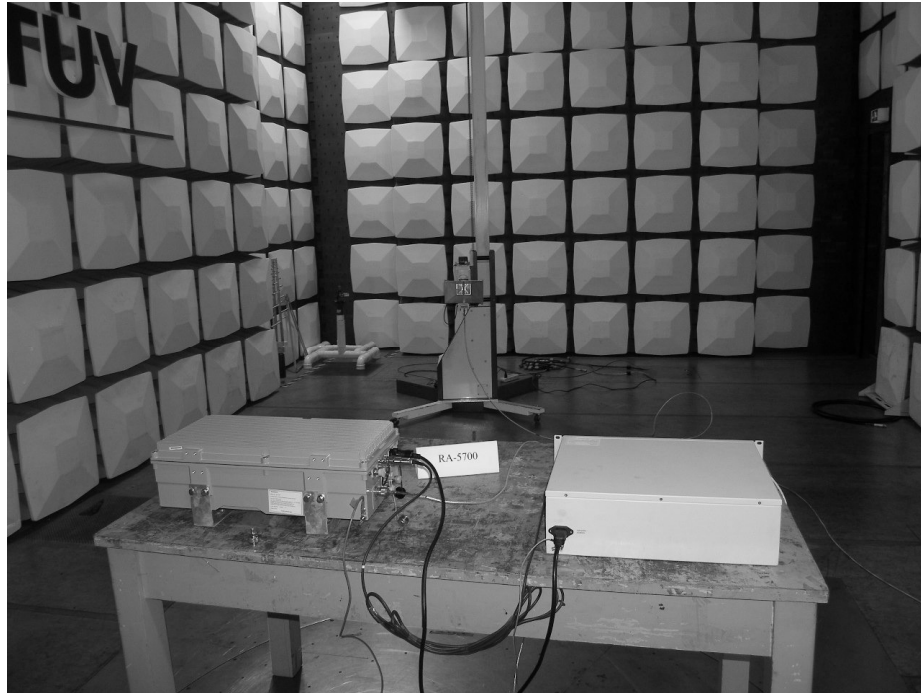
Photograph 3: Set-up for Radiation Measurement above 1GHz

1 GHz to 18 GHz

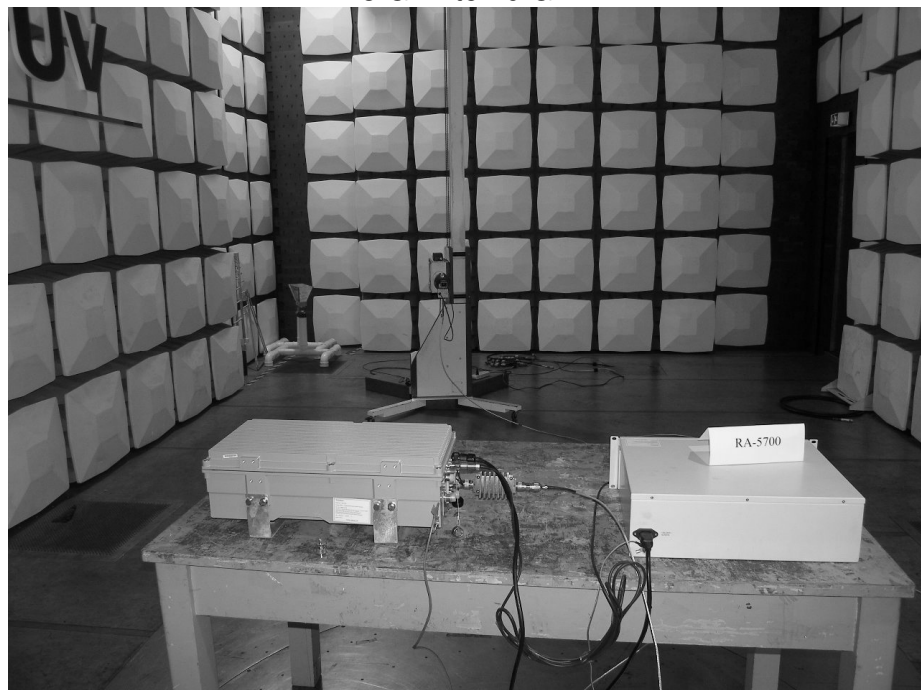
18 GHz to 20 GHz
