Appendix D. Photographs of EUT and Setup

Power Density Measurement Report

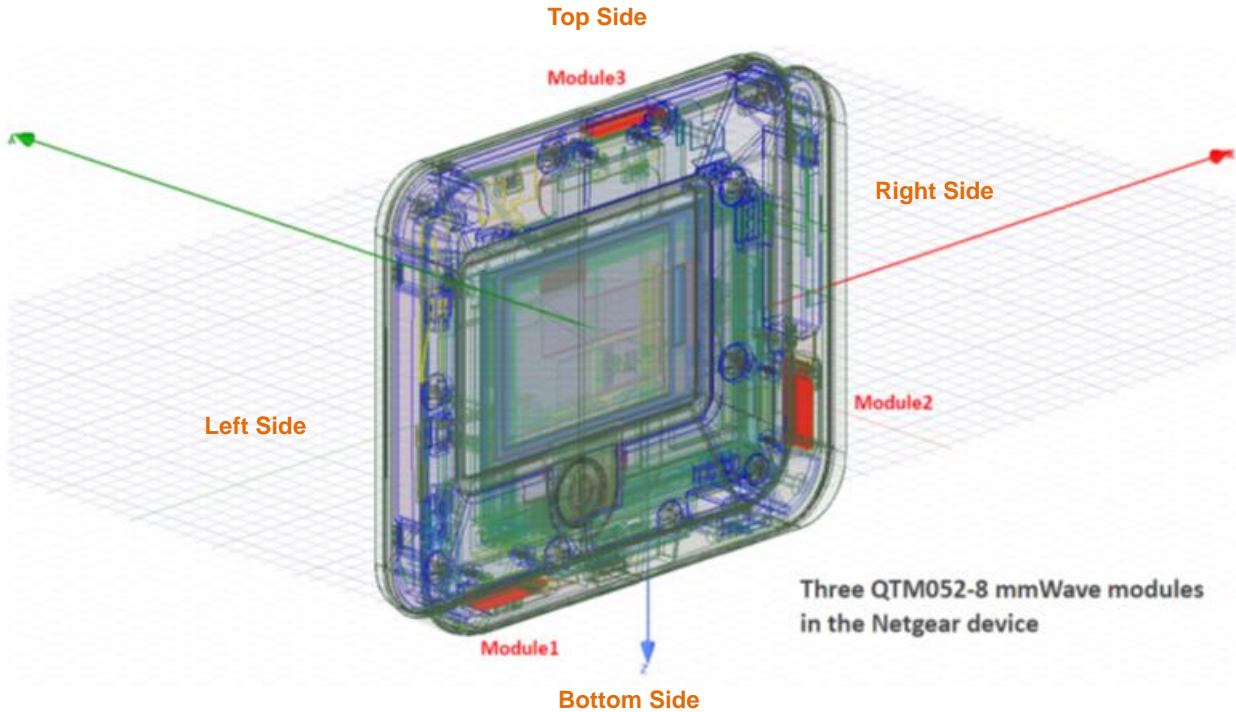
<2D View – EUT Front>

Note: The module 1 and module 3 were disabled by software. Only module 2 is active.
