Report No. :FA7O0620-01

Issued Date: Jan. 08, 2018 Form version. : 170509 FCC ID: PY7-13007N Page D1 of D3

## Appendix D. SAR Test Setup Photos

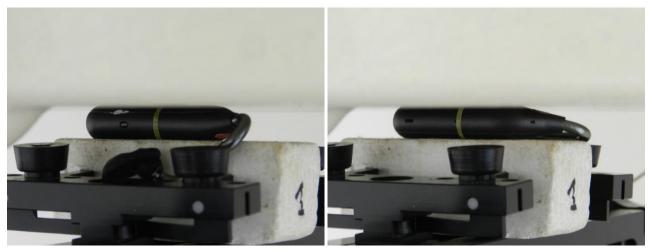
**Bottom Face, Test Separation 0 mm**

Front Face, Test Separation 0 mm

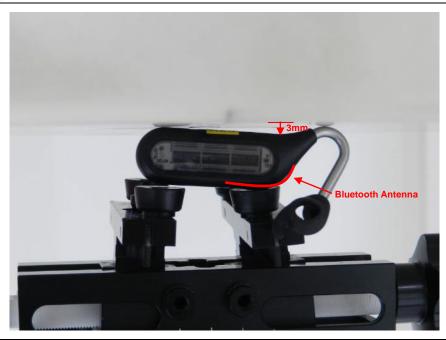
Note: Since the devices with form factors that do not conform to a flat phantom, and iron tube gets in the way of Right Side positioning, therefore the whole Right Side of Bluetooth headset was slant and touch the flat phantom for the SAR testing, additional separation introduced by the SAR peak location against to flat phantom is <5 mm and 1g reported SAR is relative low and <1.2W/kg, therefore, the back SAR test position is compliance with RF exposure

Right side (Flat phantom), additional separation introduced by the contour against a surface of the Flat phantom is 3 mm
