Order Number:	11139405	Report Number:	R11139405C-E2	Page	15 of 29
FCC ID:	PY7-PM0942	-		-	
Client Name:	Sony Mobile Communications Inc.		lssued: 2016-04-25

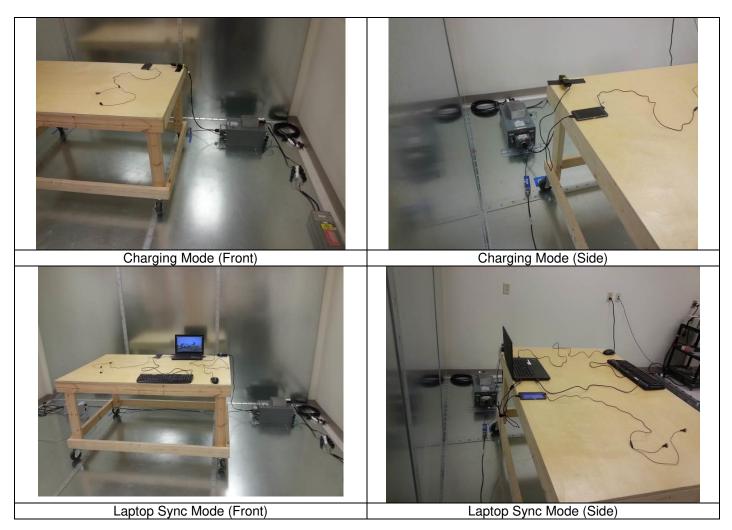
Figure 1 Test Setup for Conducted Emissions

Note: Laptop Ethernet was plugged into facility wall jack that was connected to facility switch, running ping session.

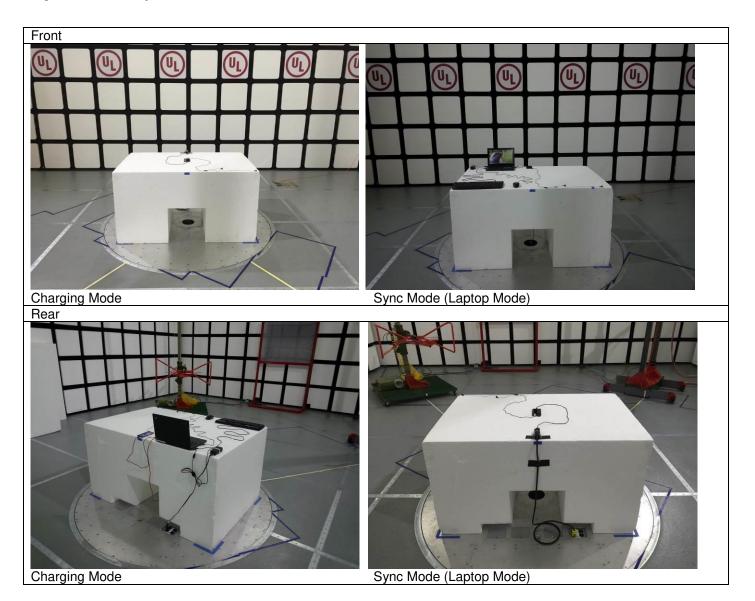
Figure 4 Test setup for Radiated Emissions < 1GHz

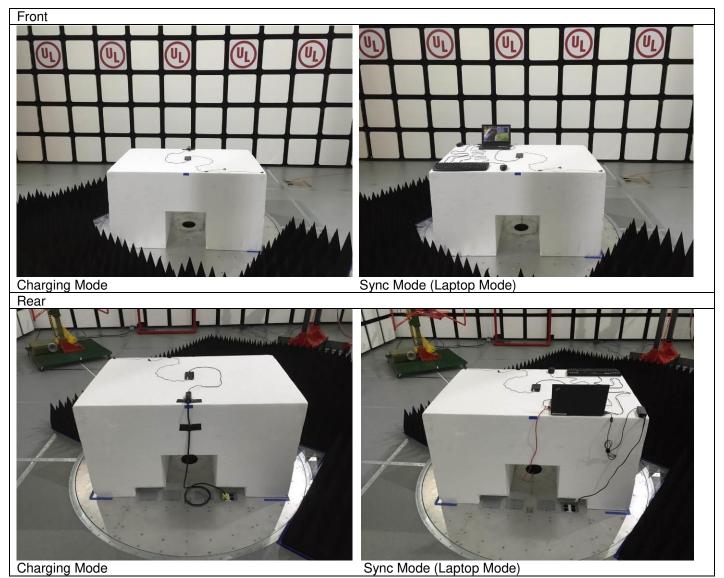
Figure 5 Test setup for Radiated Emissions > 1GHz
