Order Number: 11139405 Report Number: R11139405A-E5 Page 15 of 28

FCC ID: PY7-PM0944

Client Name: Sony Mobile Communications Inc. Issued: 2016-04-22

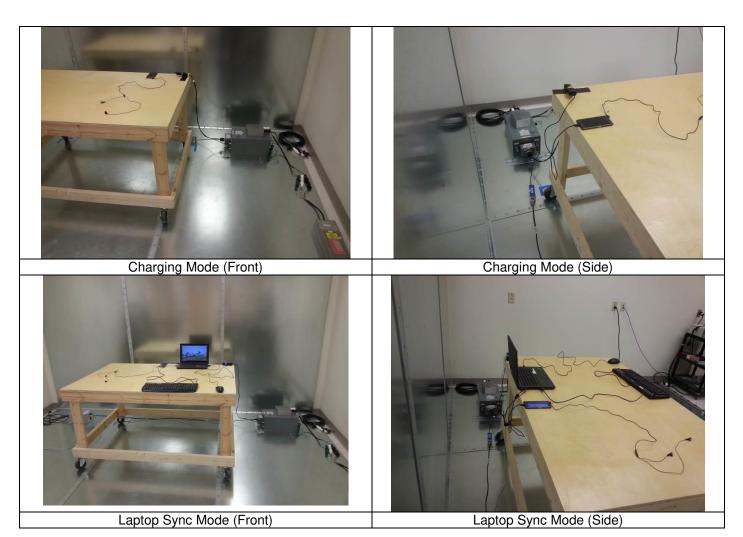
Figure 1 Test Setup for Conducted Emissions

Note: Laptop Ethernet was plugged into facility wall jack that was connected to facility switch, running ping session.

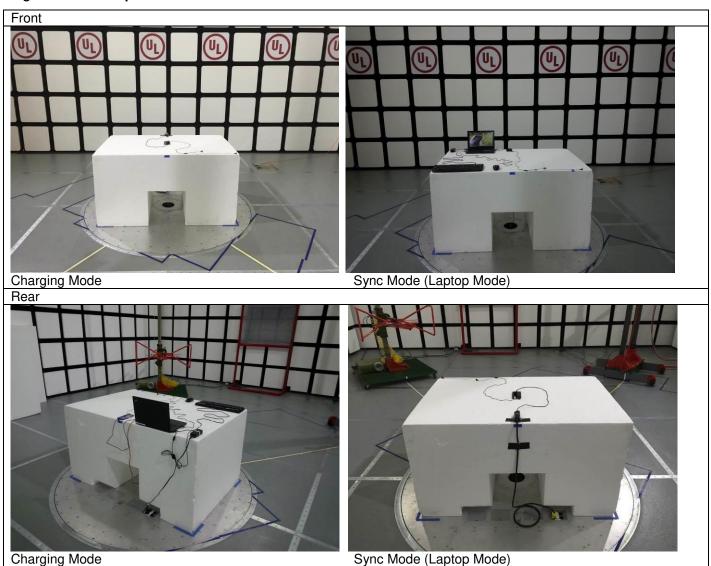
Figure 4 Test setup for Radiated Emissions < 1GHz

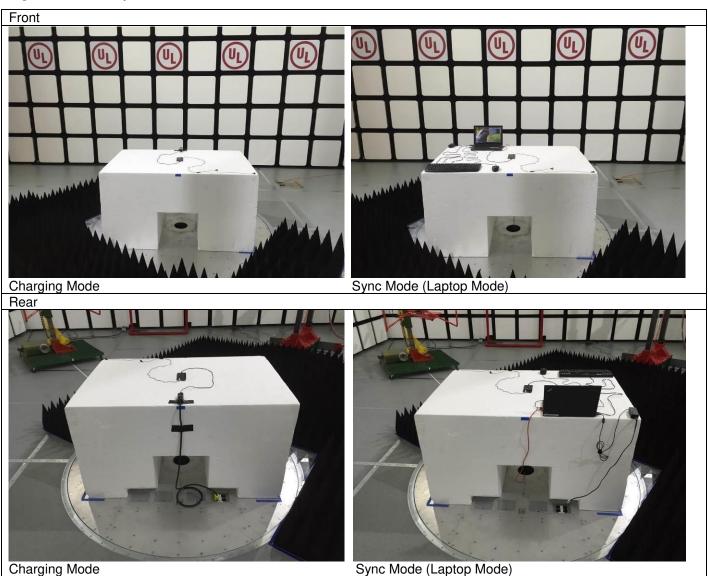
Figure 5 Test setup for Radiated Emissions > 1GHz
