Test report no.
 : 2-4883-60-05/08-A

Type identification
 : AAD-3252081-BV

Test specification
 : IEEE 1528-2003

Annex 3 Photo documentation

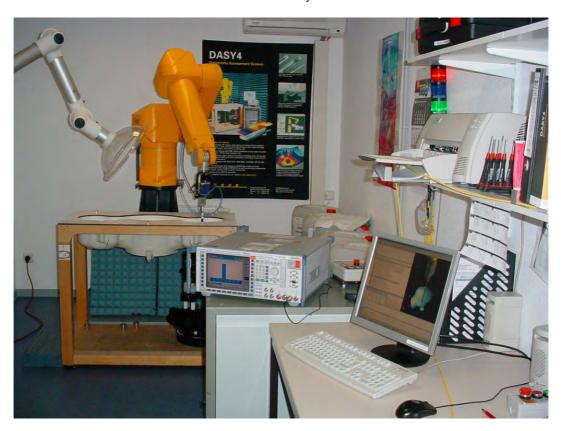
Photo 1: Measurement System DASY 4

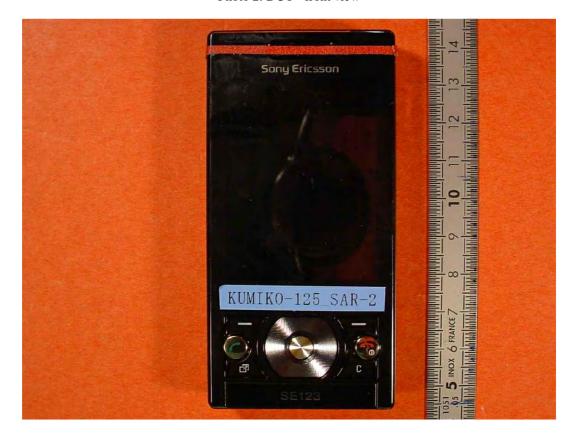
Photo 2: DUT - front view

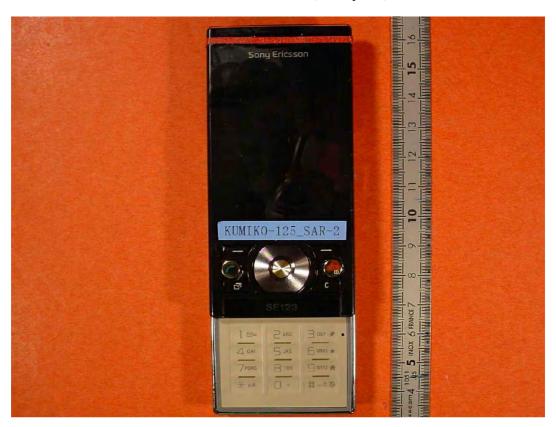
Photo 3: DUT - front view (slide opened)

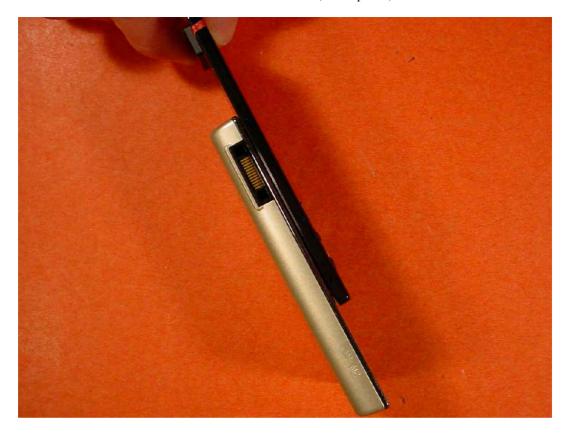
Photo 4: DUT - side view (slide opened)

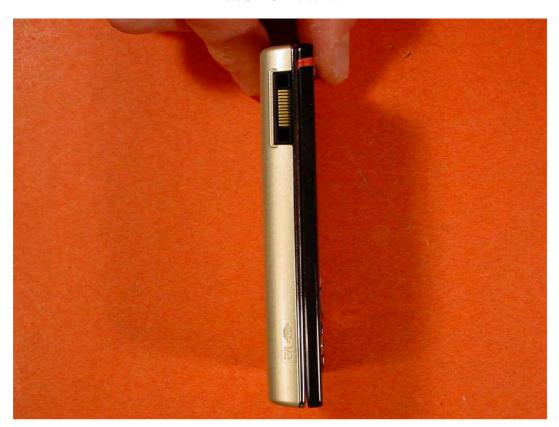
Photo 5: DUT - side view

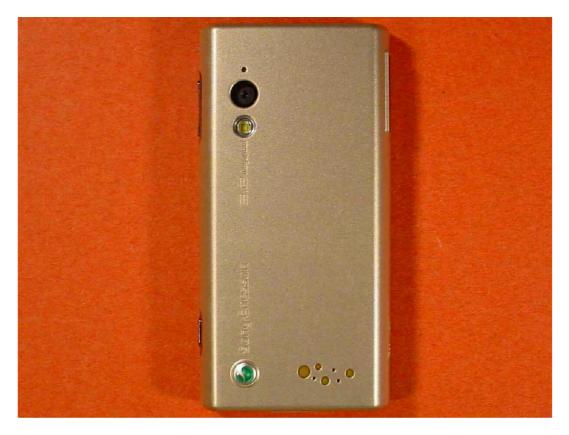
Photo 6: DUT - rear view

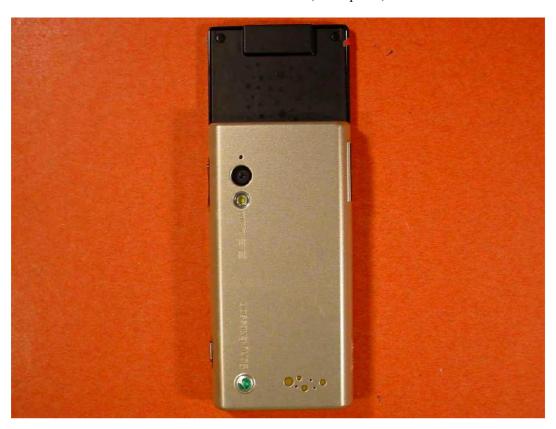
Photo 7: DUT - rear view (slide opened)

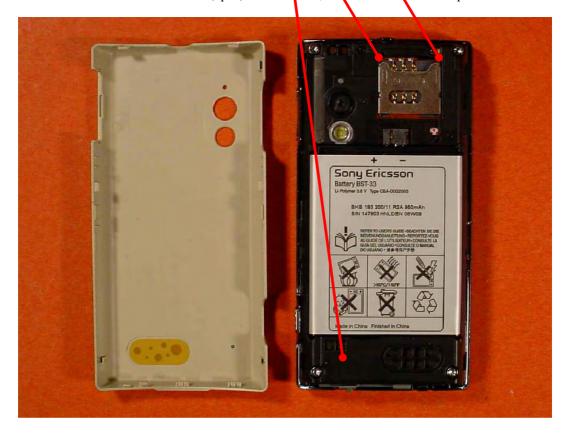
Photo 8: DUT - rear view (open) with WWAN, WLAN and BT antenna position

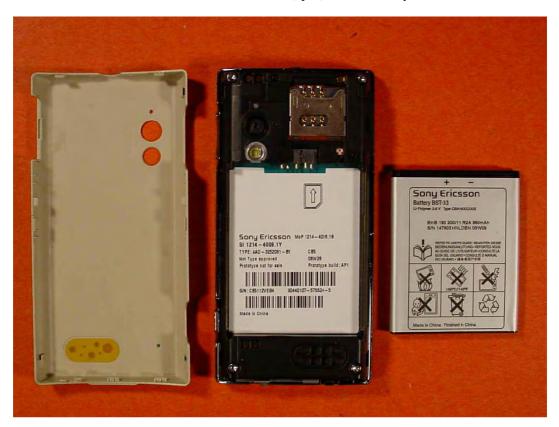
Photo 9: DUT - rear view (open) without battery

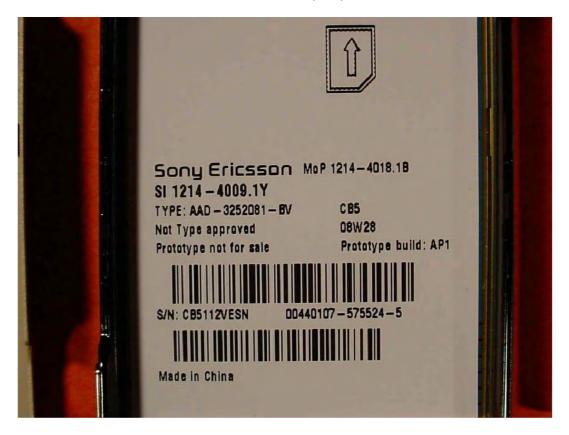
Photo 10: DUT (label)

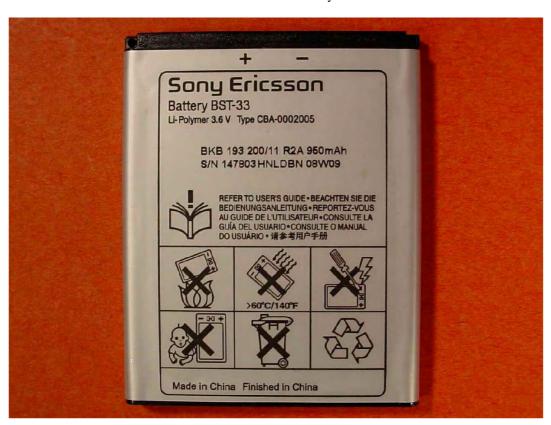
Photo 11: The battery

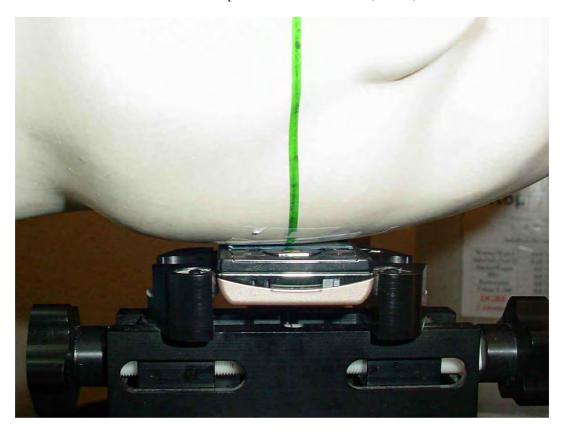
Photo 12: Test position left hand touched (slide in)

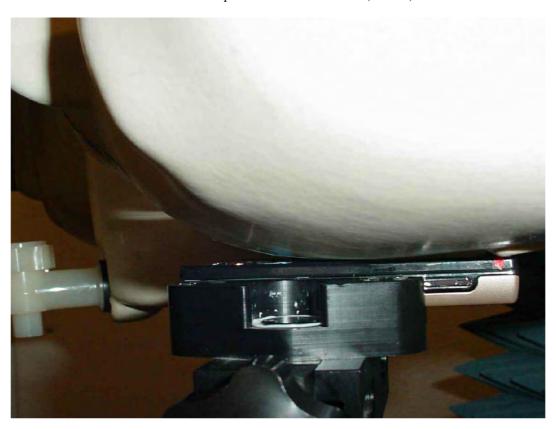
Photo 13: Test position left hand touched (slide in)

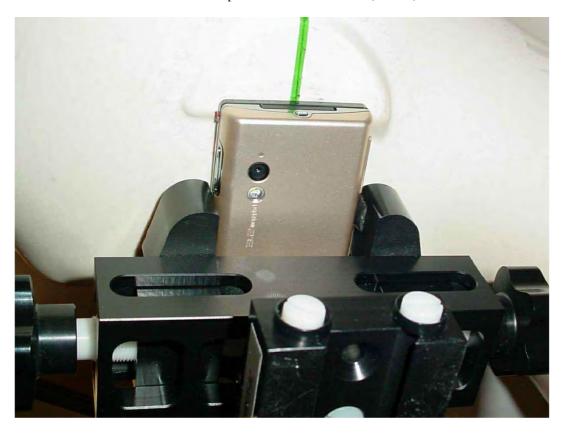
Photo 14: Test position left hand touched (slide in)

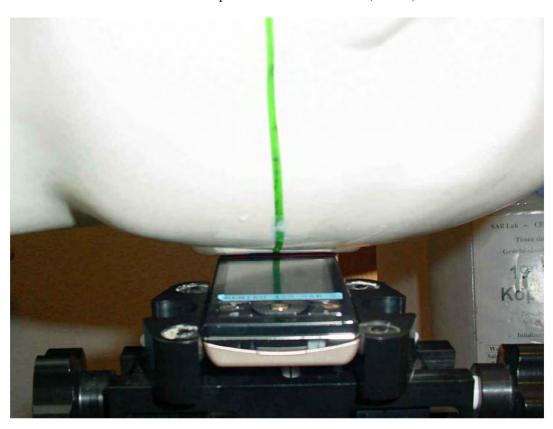
Photo 15: Test position left hand tilted 15° (slide in)

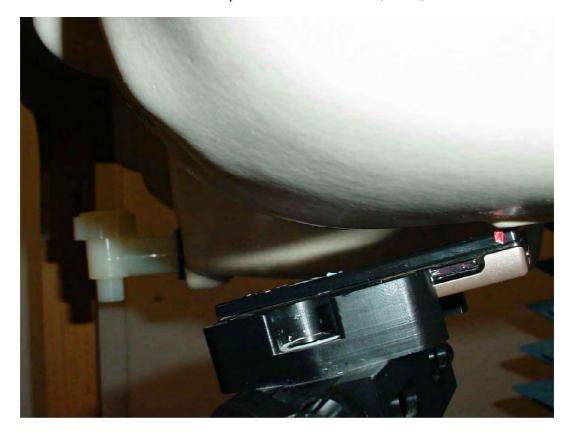
Photo 16: Test position left hand tilted 15° (slide in)

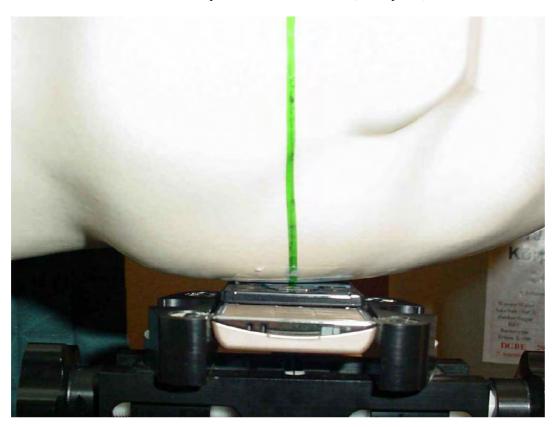
Photo 17: Test position left hand touched (slide opened)

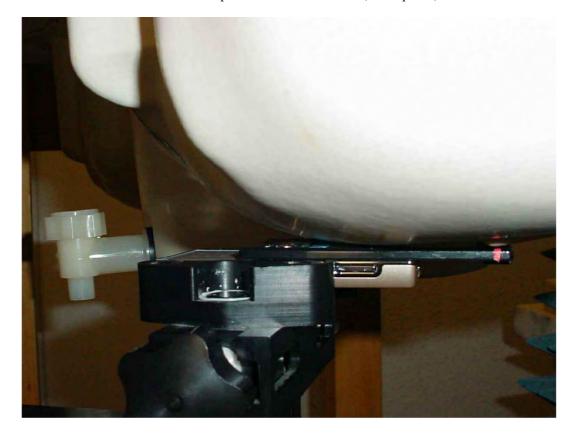
Photo 18: Test position left hand touched (slide opened)

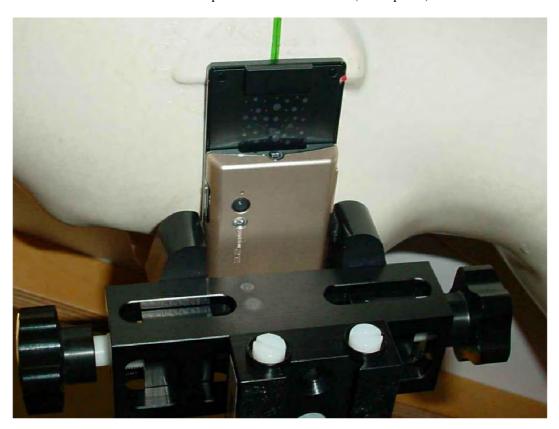
Photo 19: Test position left hand touched (slide opened)

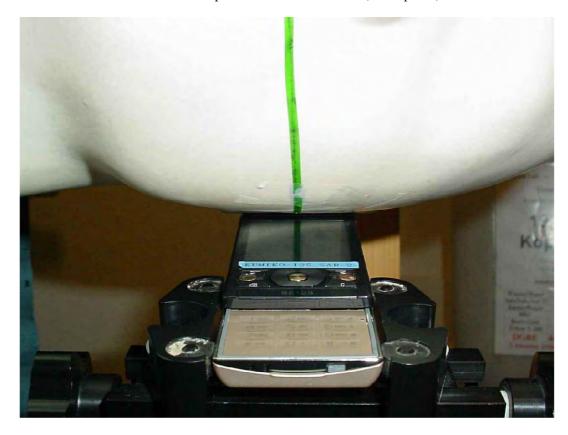
Photo 20: Test position left hand tilted 15° (slide opened)

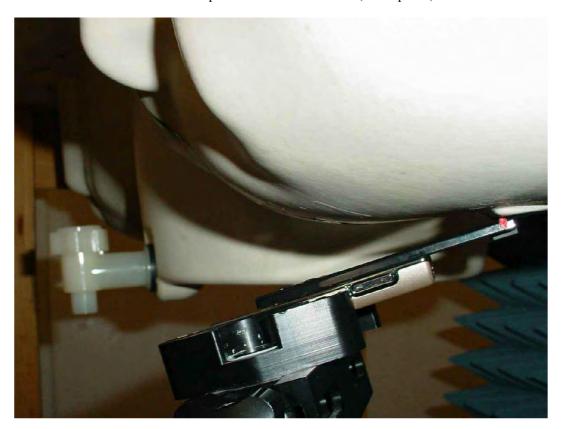
Photo 21: Test position left hand tilted 15° (slide opened)

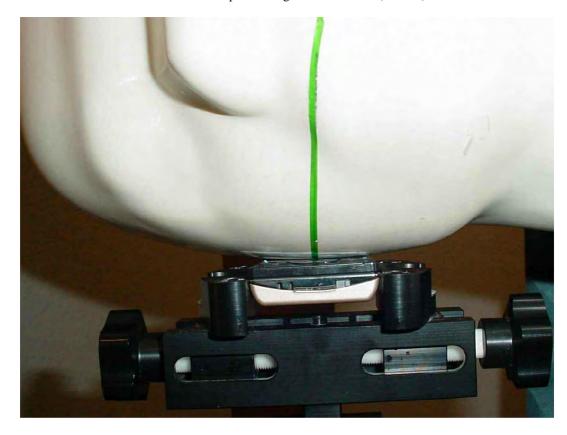
Photo 22: Test position right hand touched (slide in)

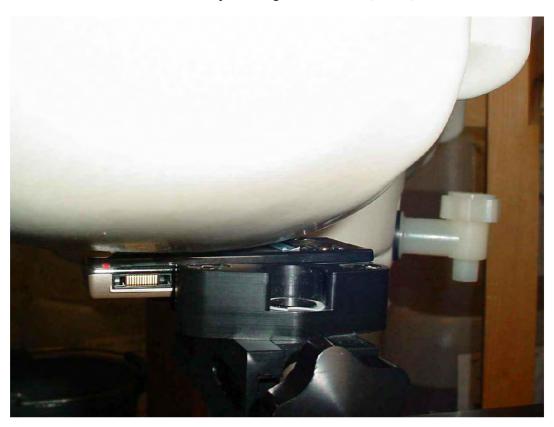
Photo 23: Test position right hand touched (slide in)

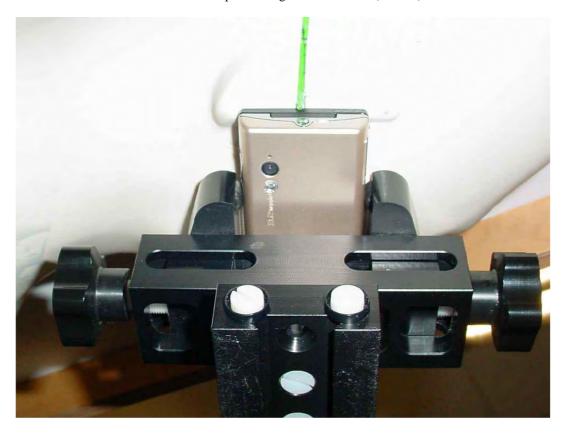
Photo 24: Test position right hand touched (slide in)

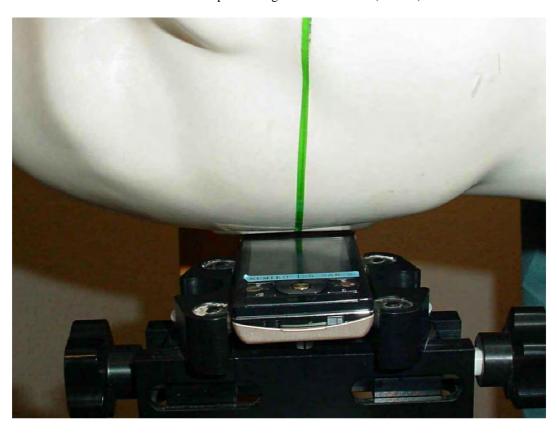
Photo 25: Test position right hand tilted 15° (slide in)

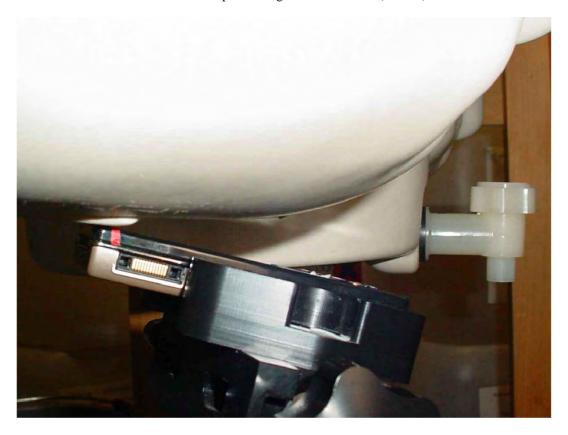
Photo 26: Test position right hand tilted 15° (slide in)

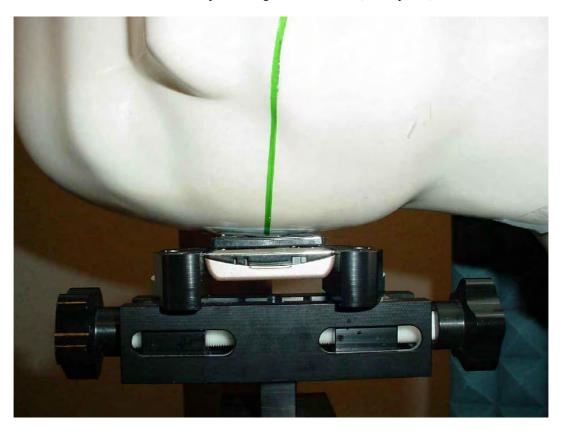
Photo 27: Test position right hand touched (slide opened)

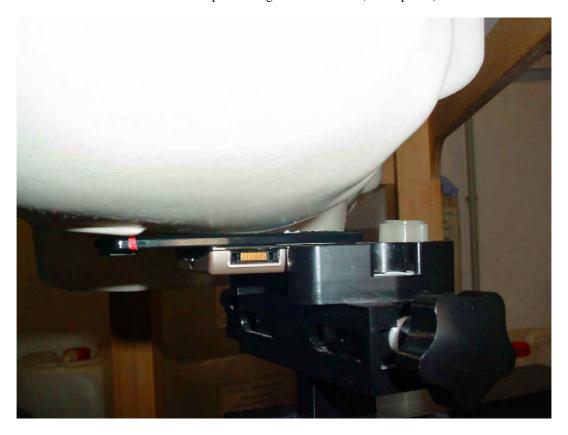
Photo 28: Test position right hand touched (slide opened)

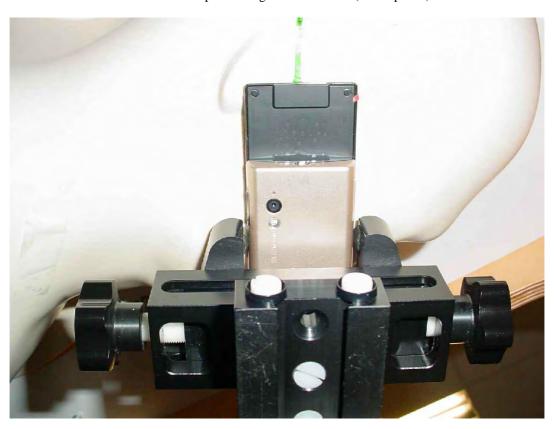
Photo 29: Test position right hand touched (slide opened)

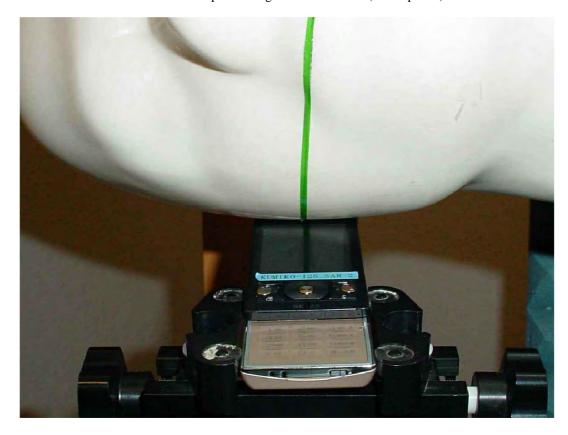
Photo 30: Test position right hand tilted 15° (slide opened)

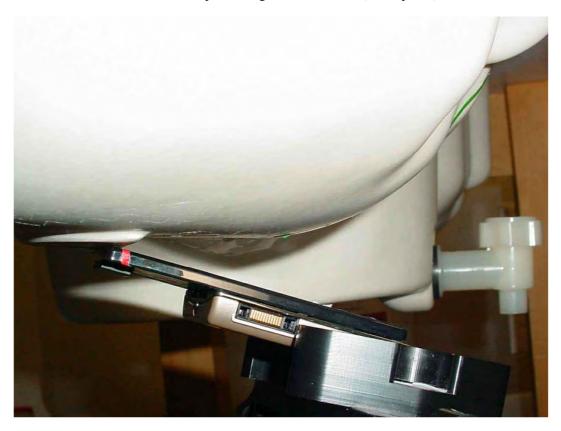
Photo 31: Test position right hand tilted 15° (slide opened)

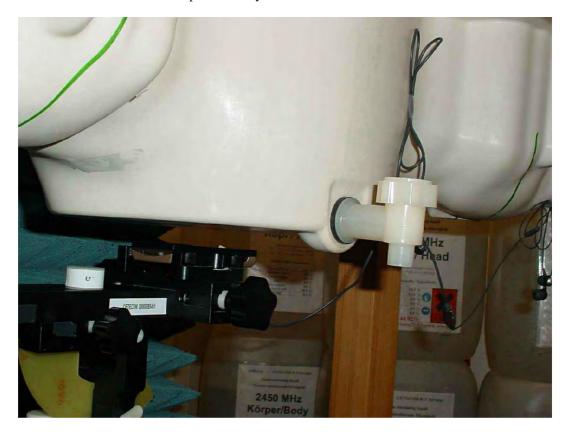
Photo 32: Test position body worn front side with 15 mm distance

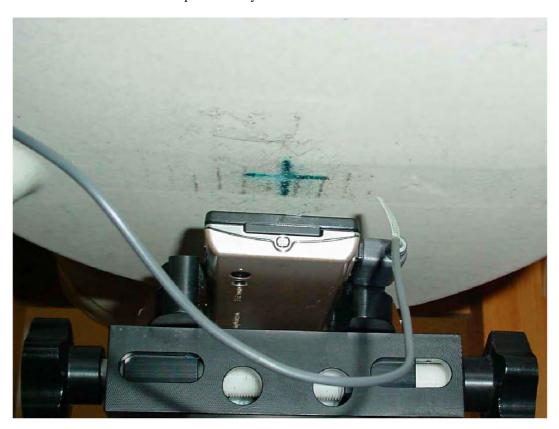
Photo 33: Test position body worn front side with 15 mm distance

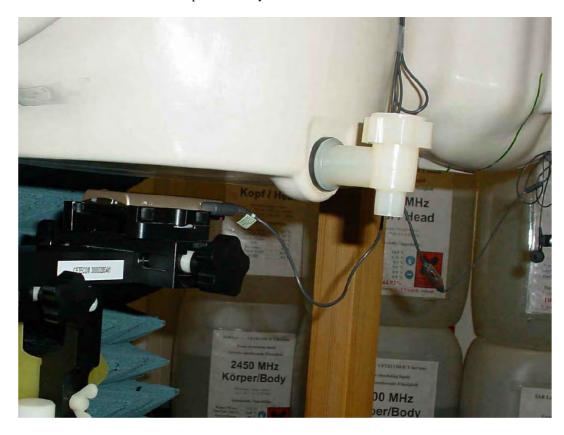
Photo 34: Test position body worn rear side with 15 mm distance

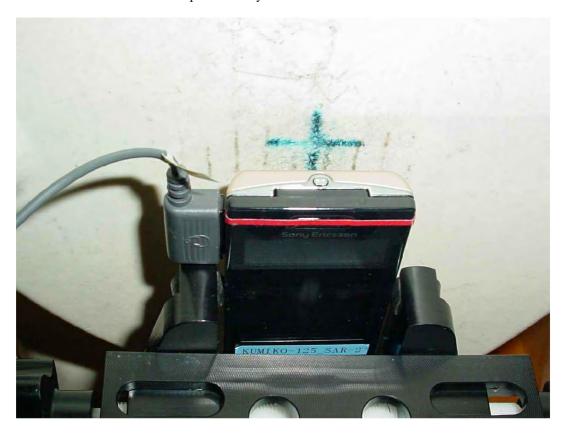
Photo 35: Test position body worn rear side with 15 mm distance

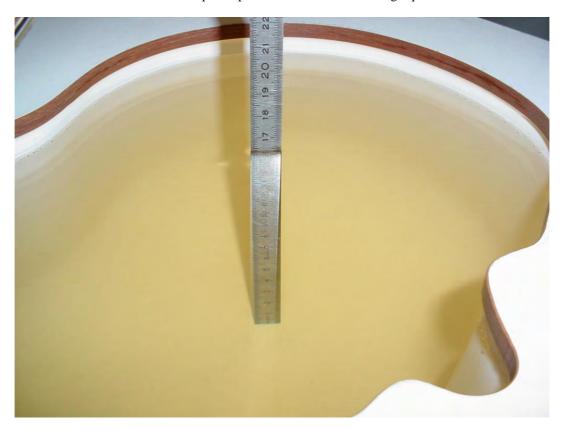
Photo 36: Liquid depth 850 MHz head simulating liquid

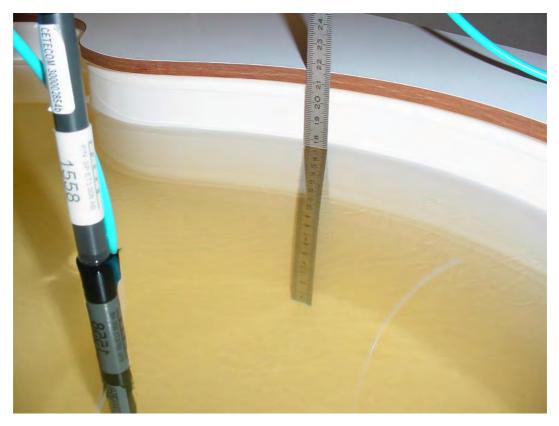
Photo 37: Liquid depth 850 MHz body simulating liquid

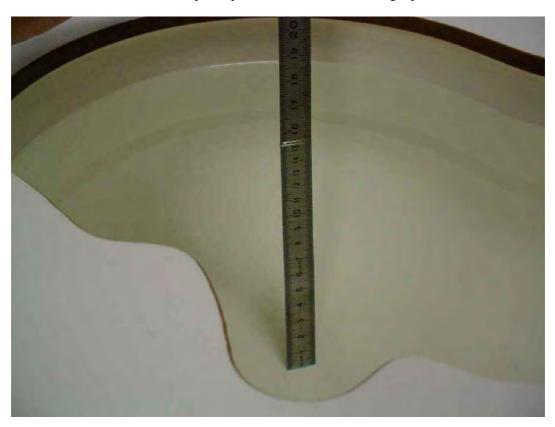
Photo 38: Liquid depth 1900 MHz head simulating liquid

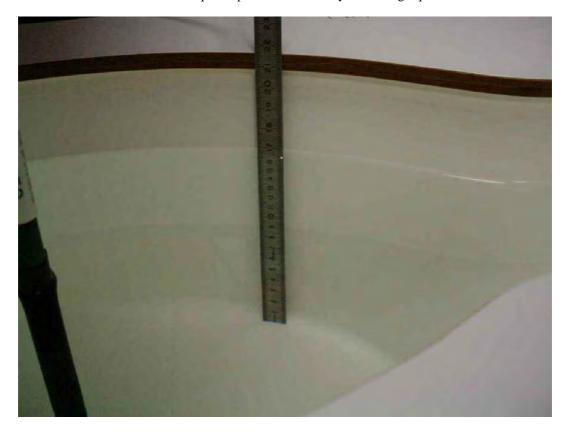
Photo 39: Liquid depth 1900 MHz body simulating liquid

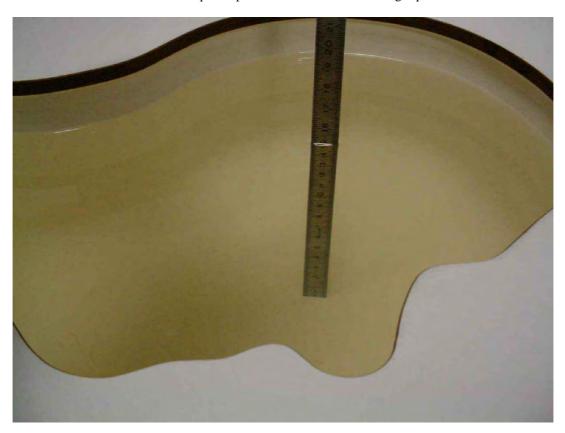
Photo 40: Liquid depth 2450 MHz head simulating liquid

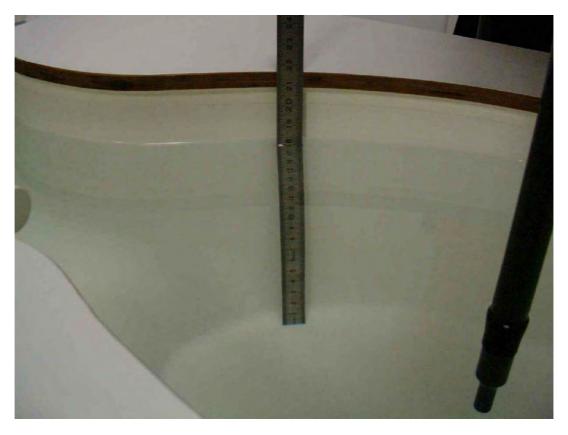
Photo 41: Liquid depth 2450 MHz body simulating liquid
