Annex C Photo documentation

Appendix to Test Report No.: 1-6965/13-19-02

CETECOM ICT Services GmbH

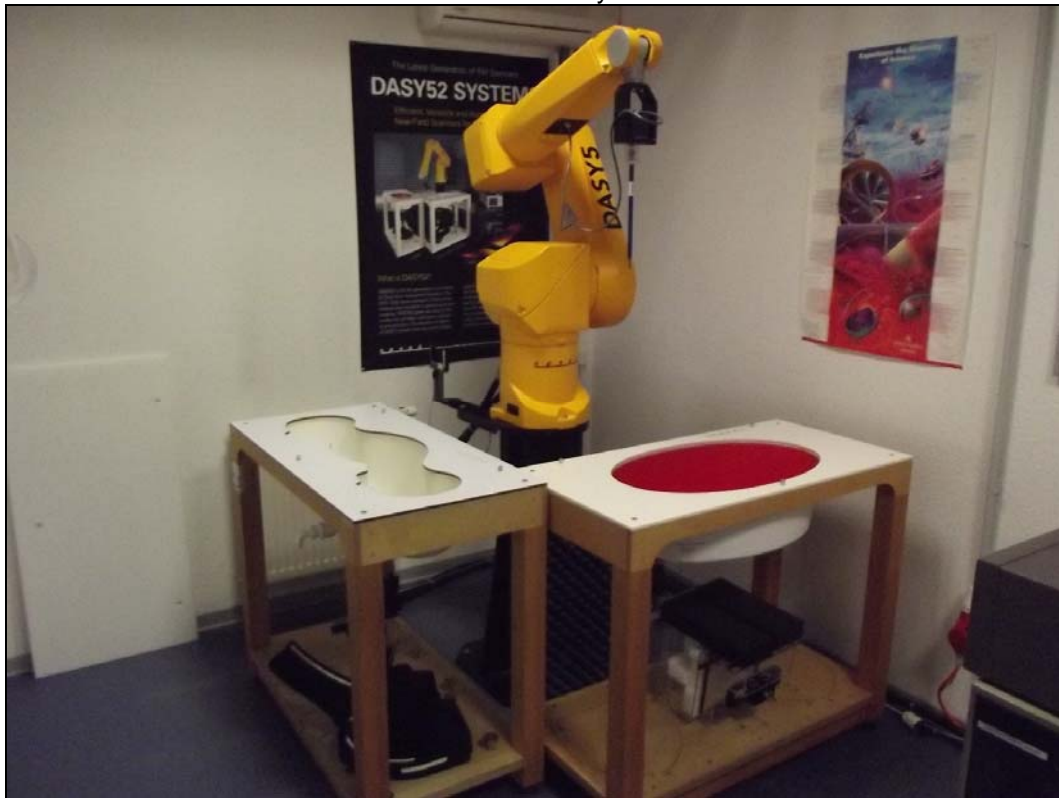
Photo 1: Measurement System DASY 5

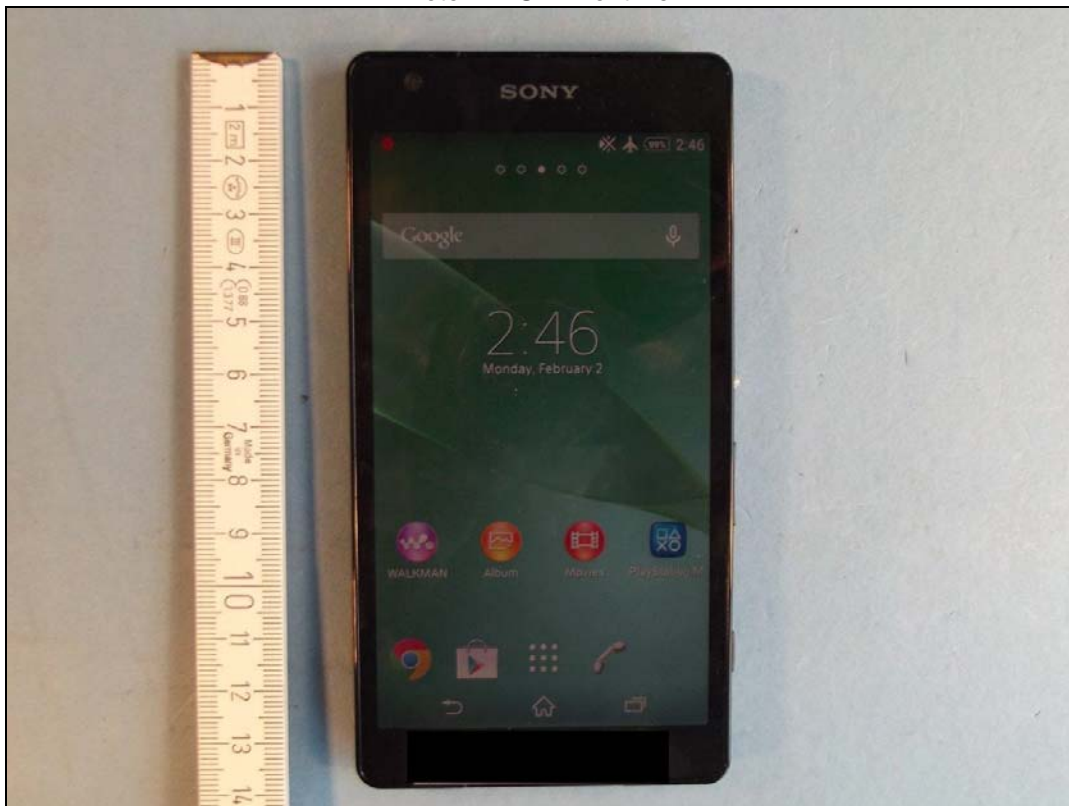
Photo 2: DUT - front view

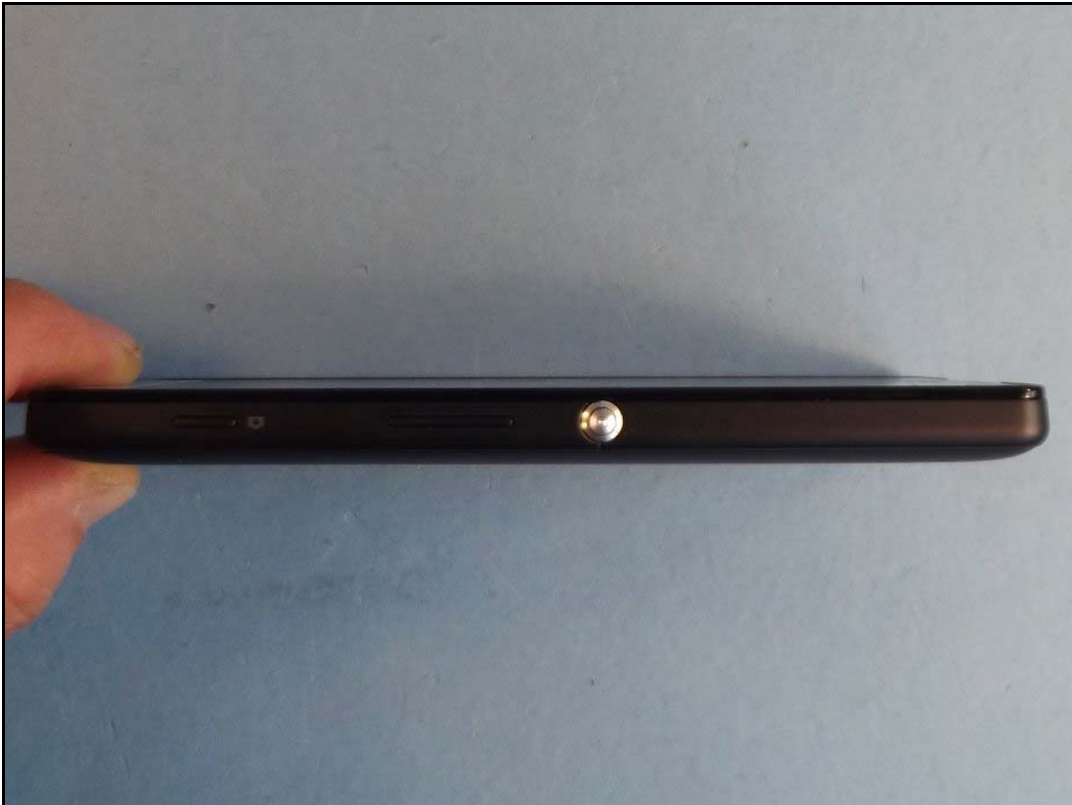
Photo 3: DUT - side view

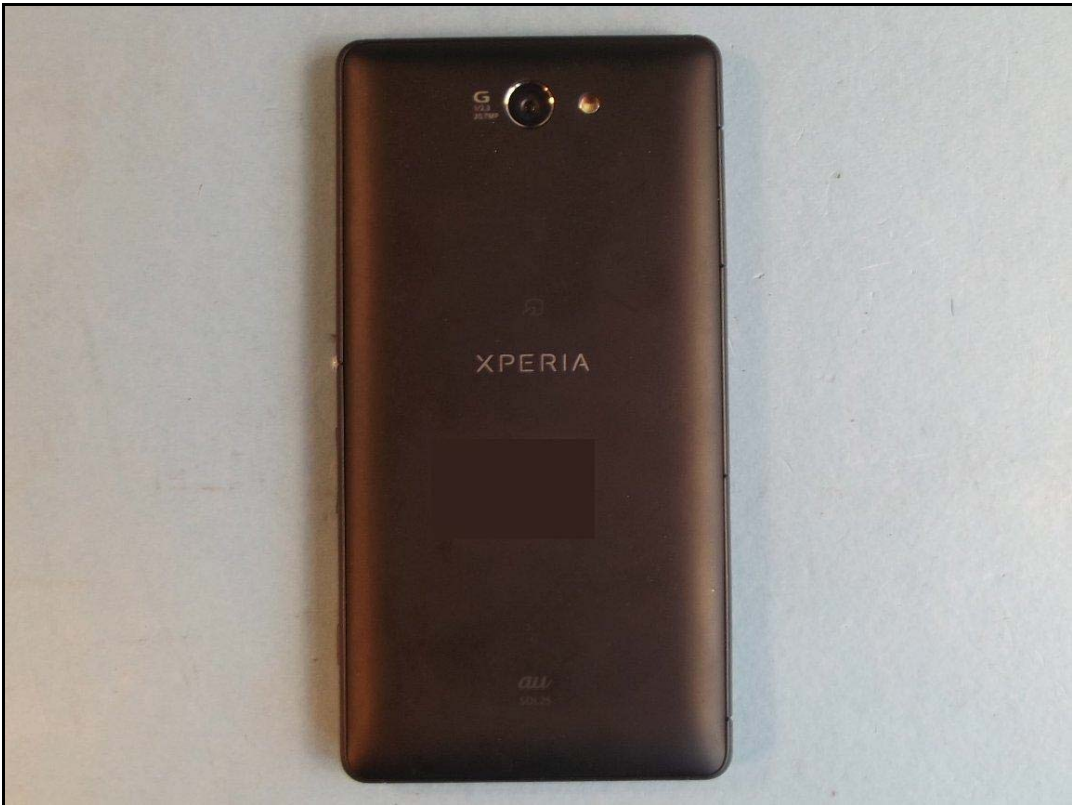
Photo 4: DUT - rear view

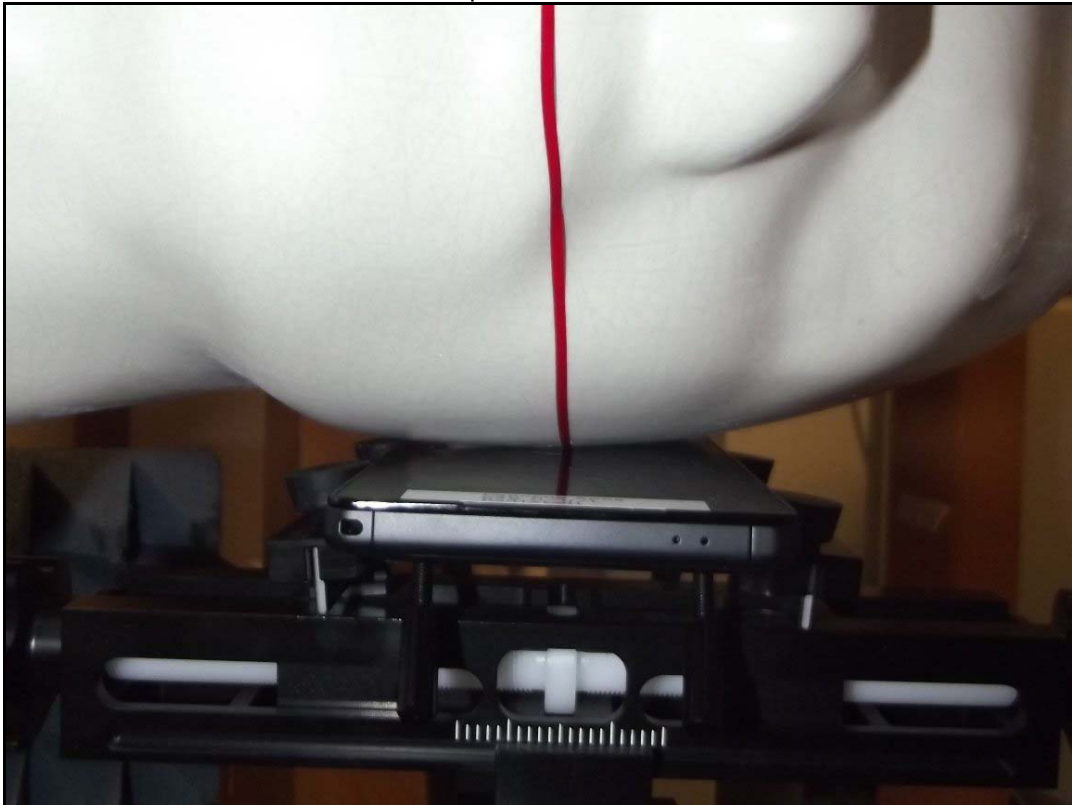
Photo 5: Test position left hand touched

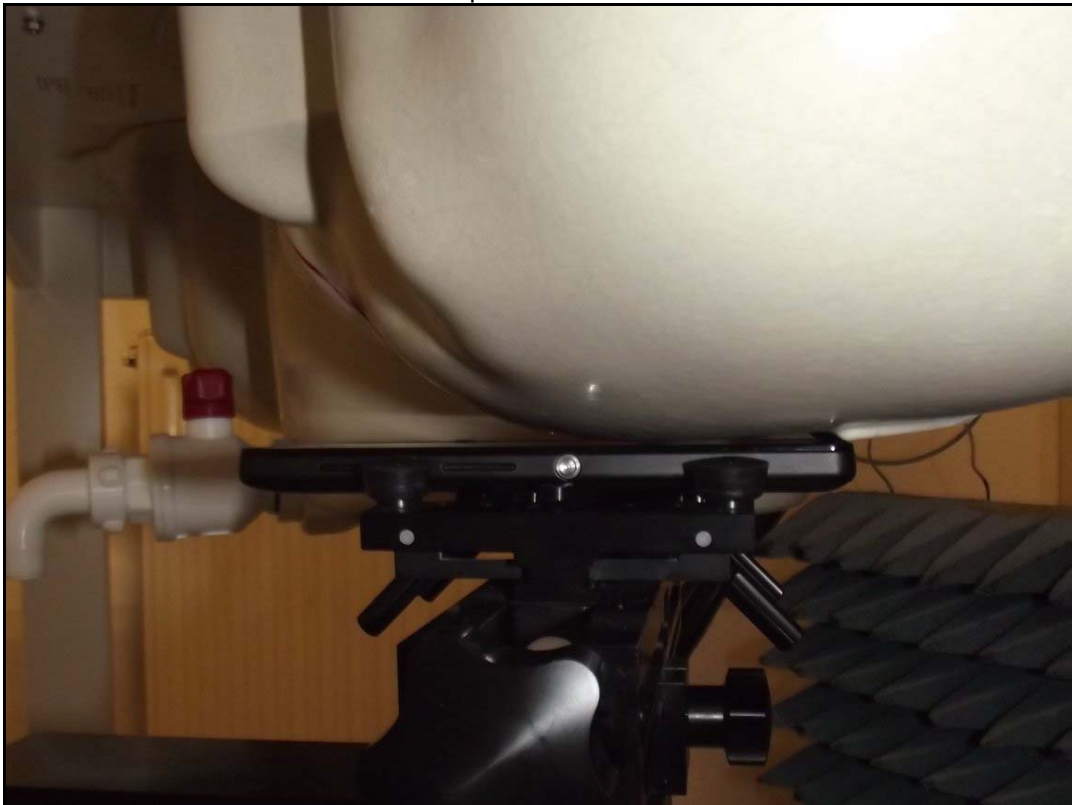
Photo 6: Test position left hand touched

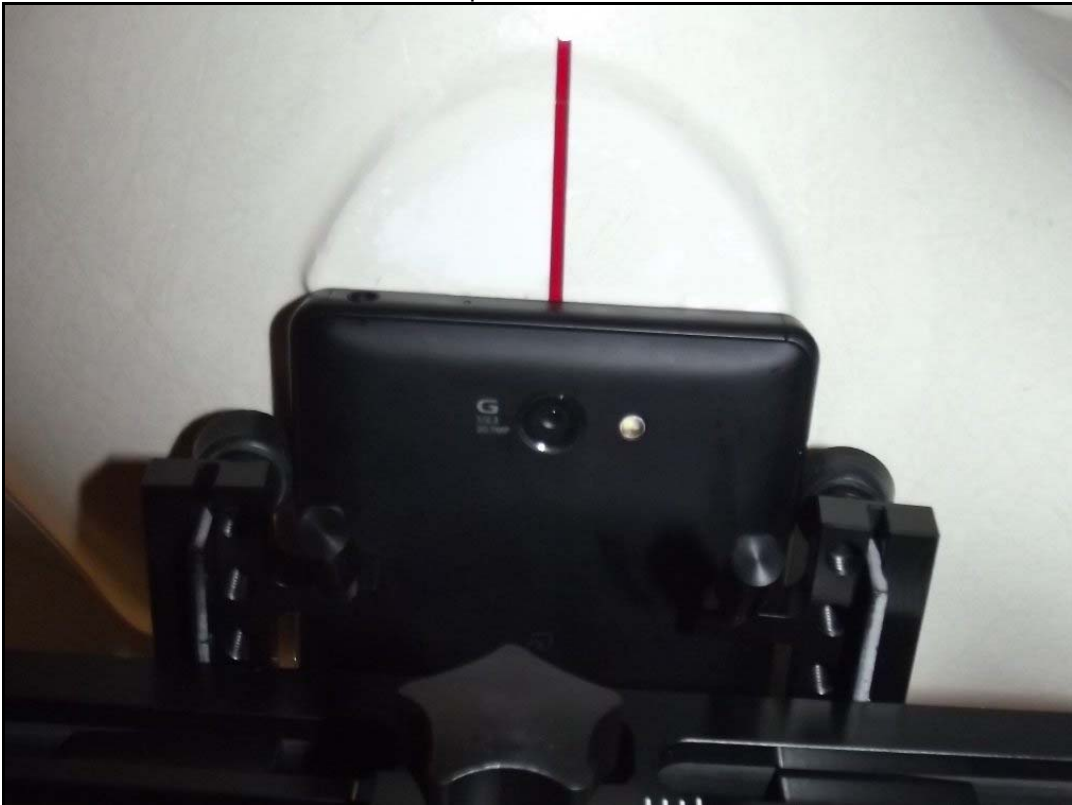
Photo 7: Test position left hand touched

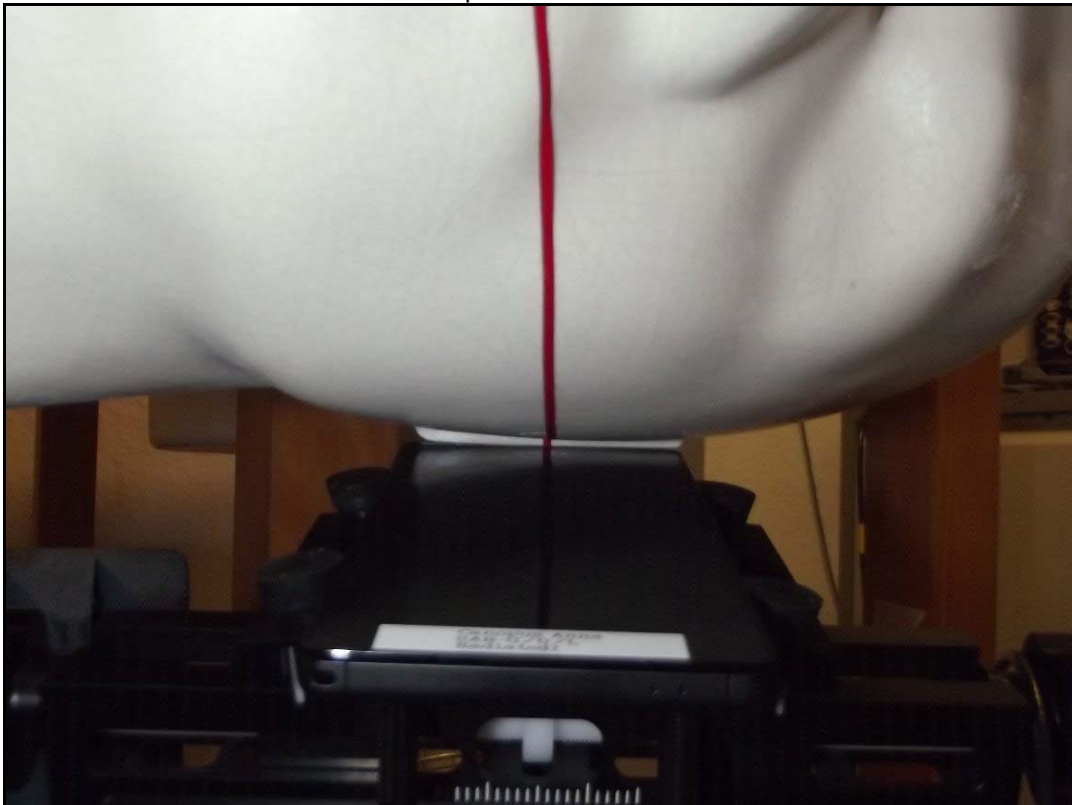
Photo 8: Test position left hand tilted 15°

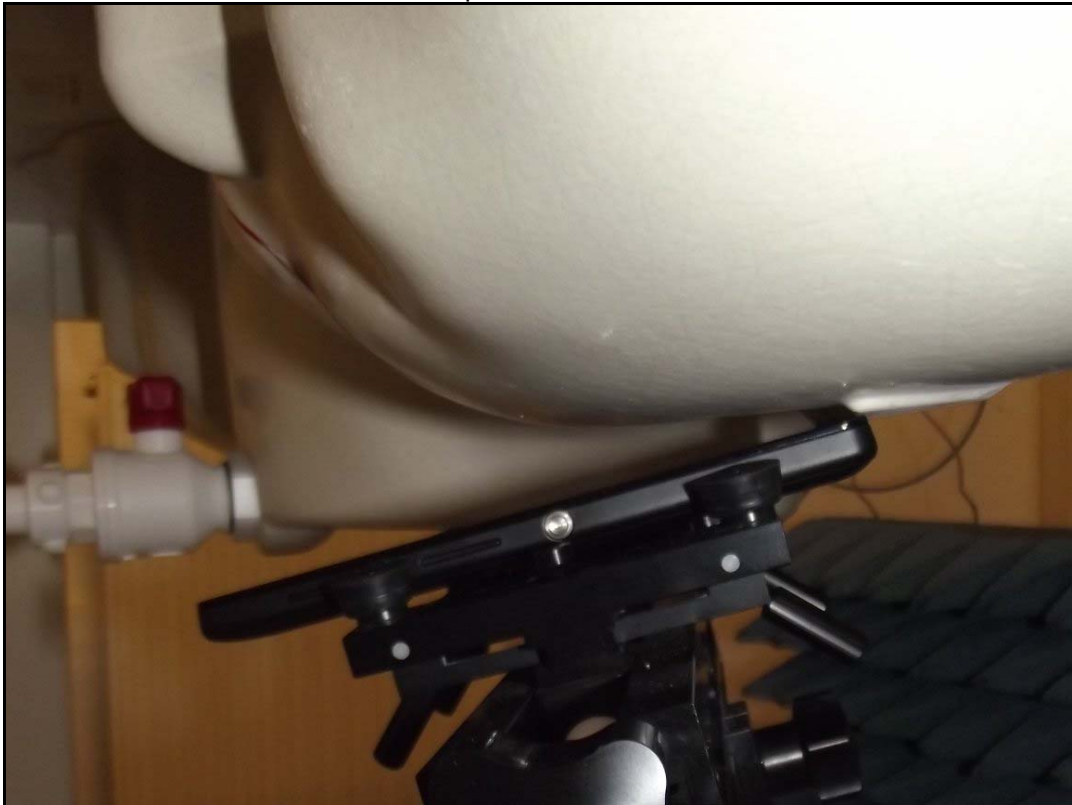
Photo 9: Test position left hand tilted 15°

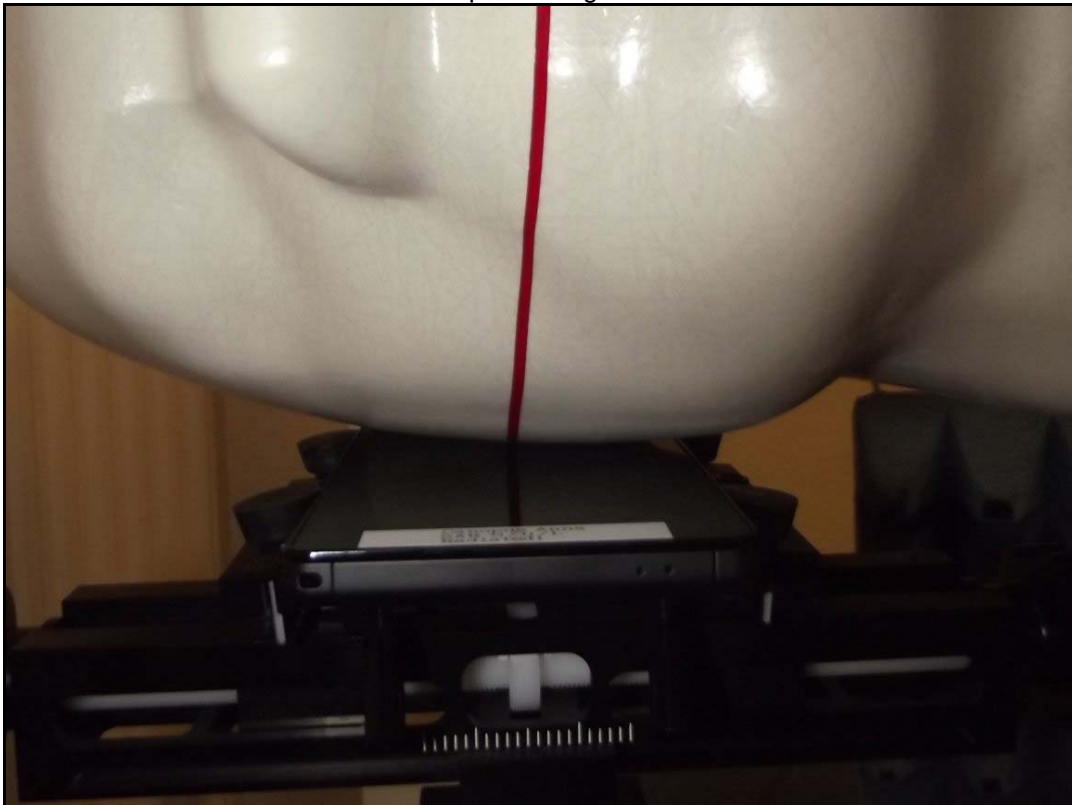
Photo 10: Test position right hand touched

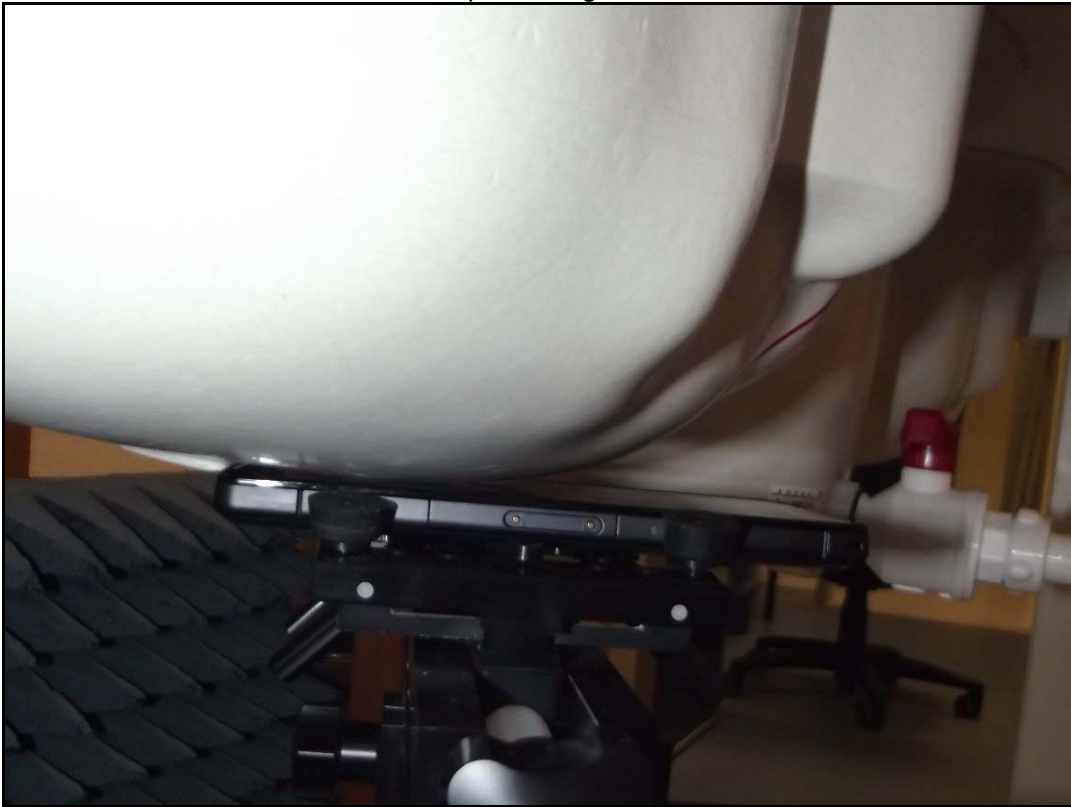
Photo 11: Test position right hand touched

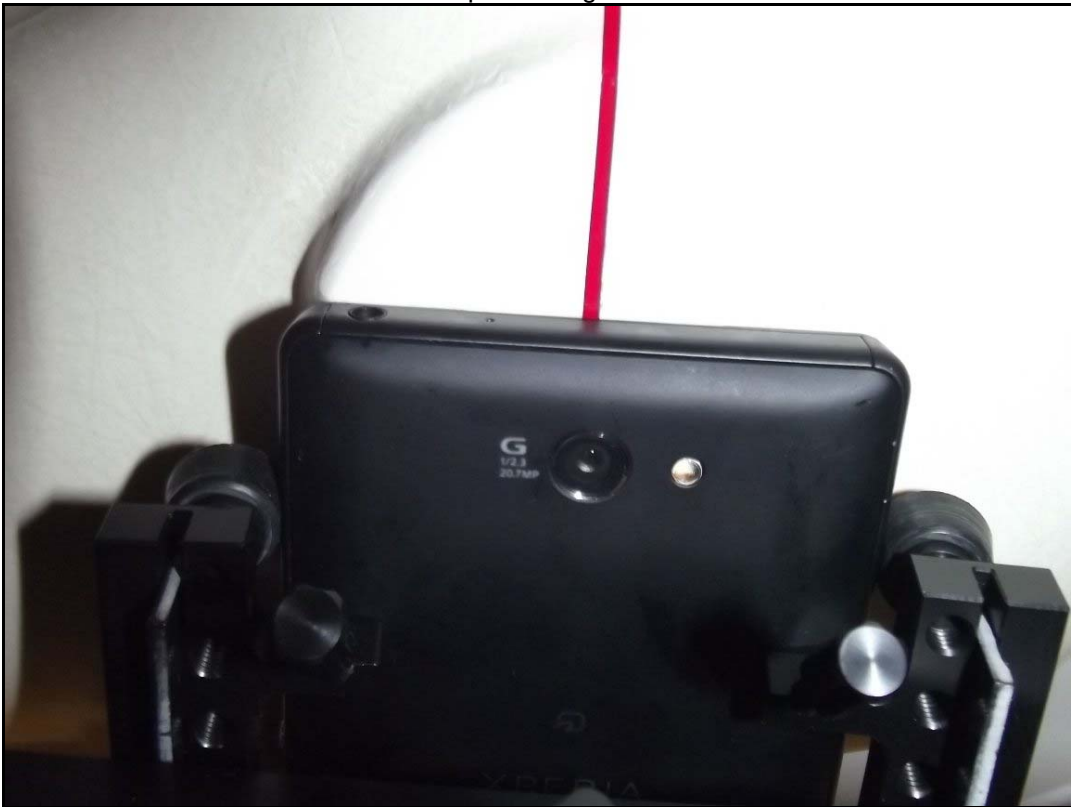
Photo 12: Test position right hand touched

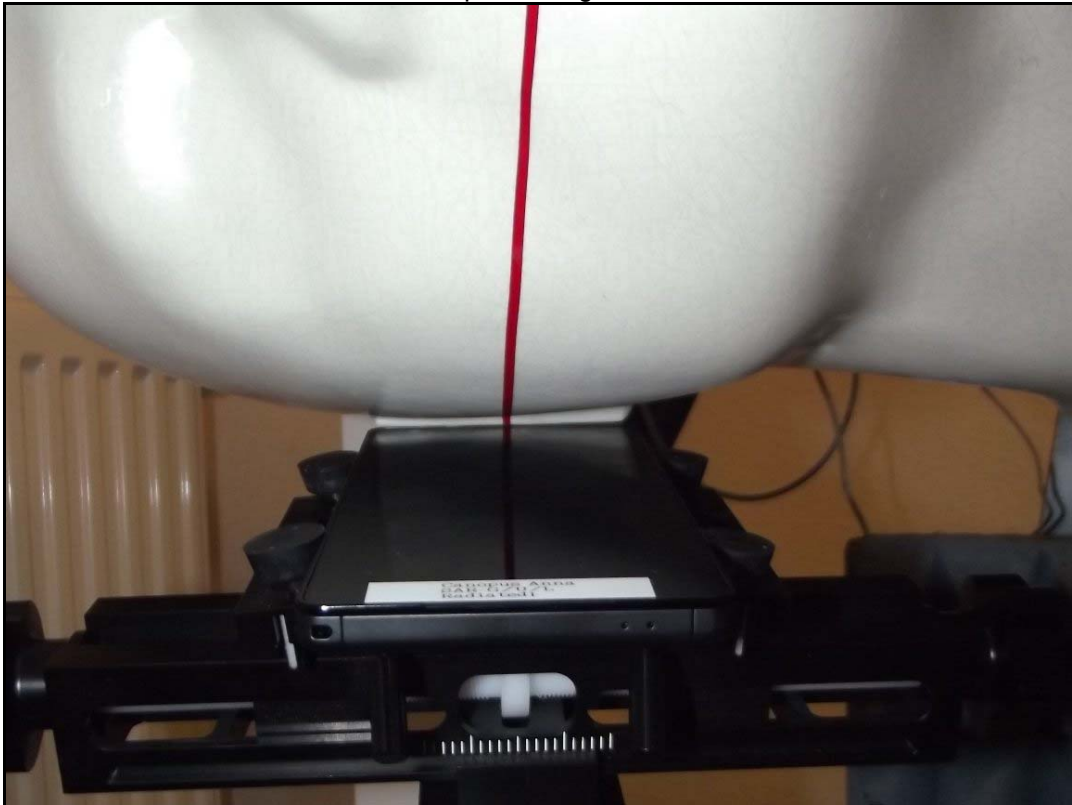
Photo 13: Test position right hand tilted 15°

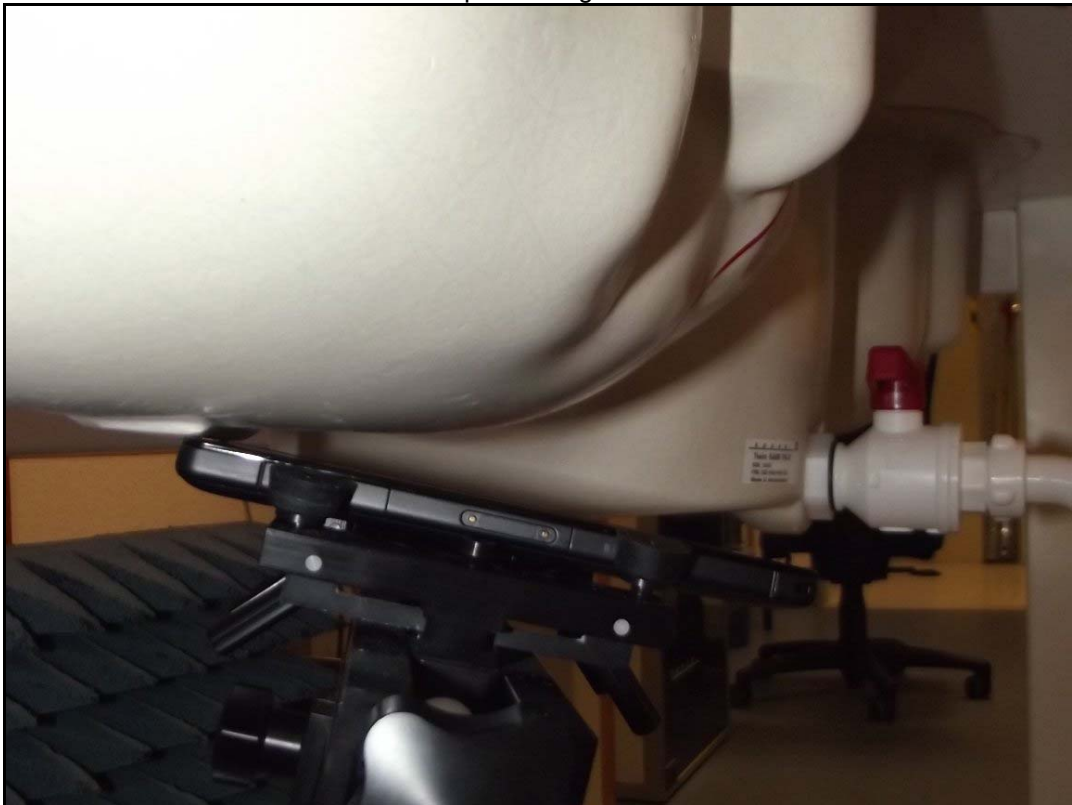
Photo 14: Test position right hand tilted 15°

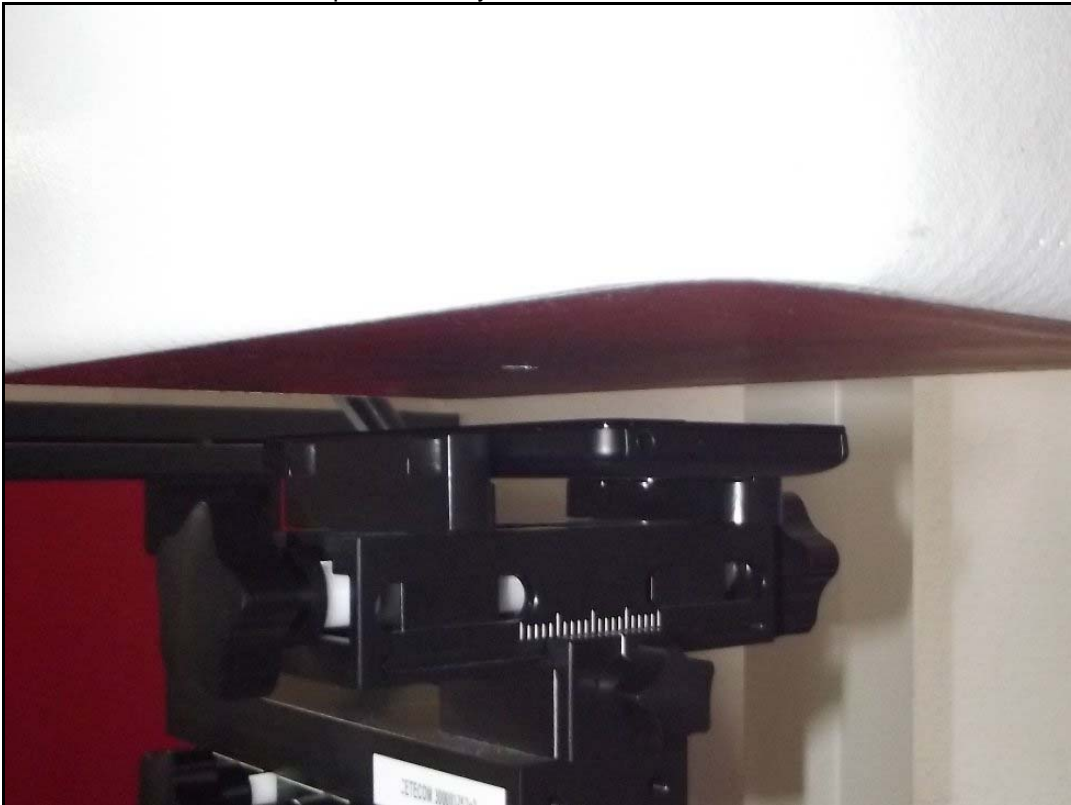
Photo 15: Test position body worn front side with 15 mm distance

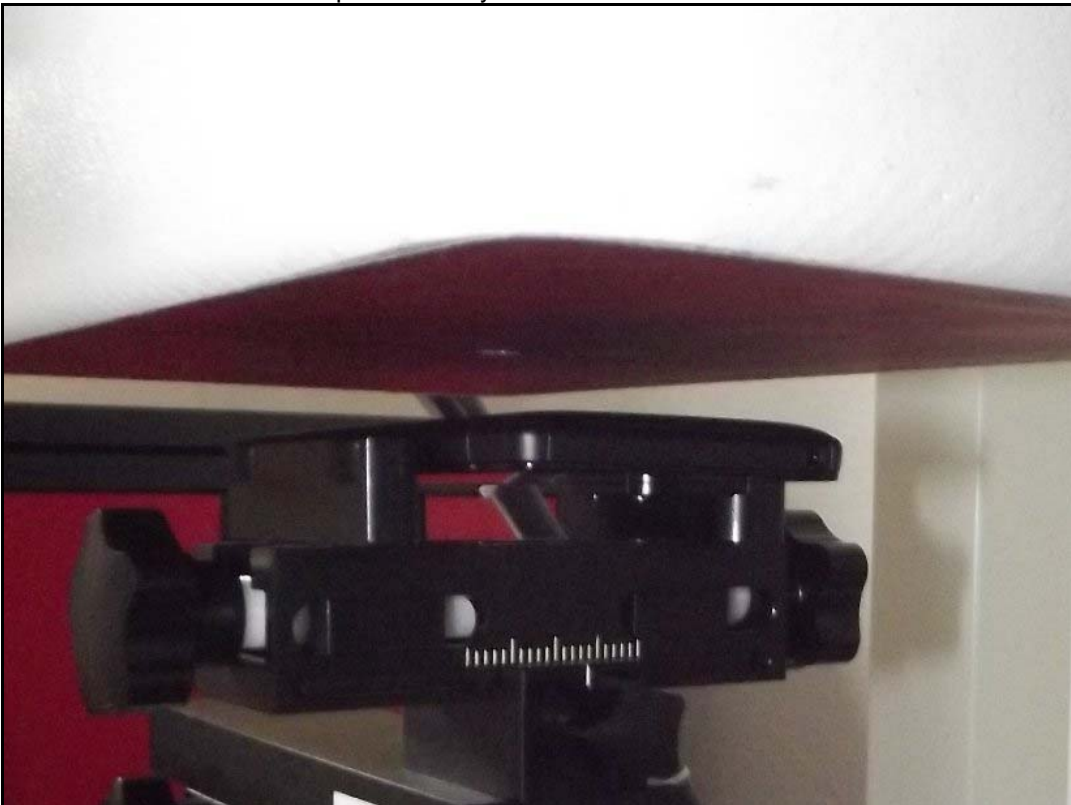
Photo 16: Test position body worn rear side with 15 mm distance

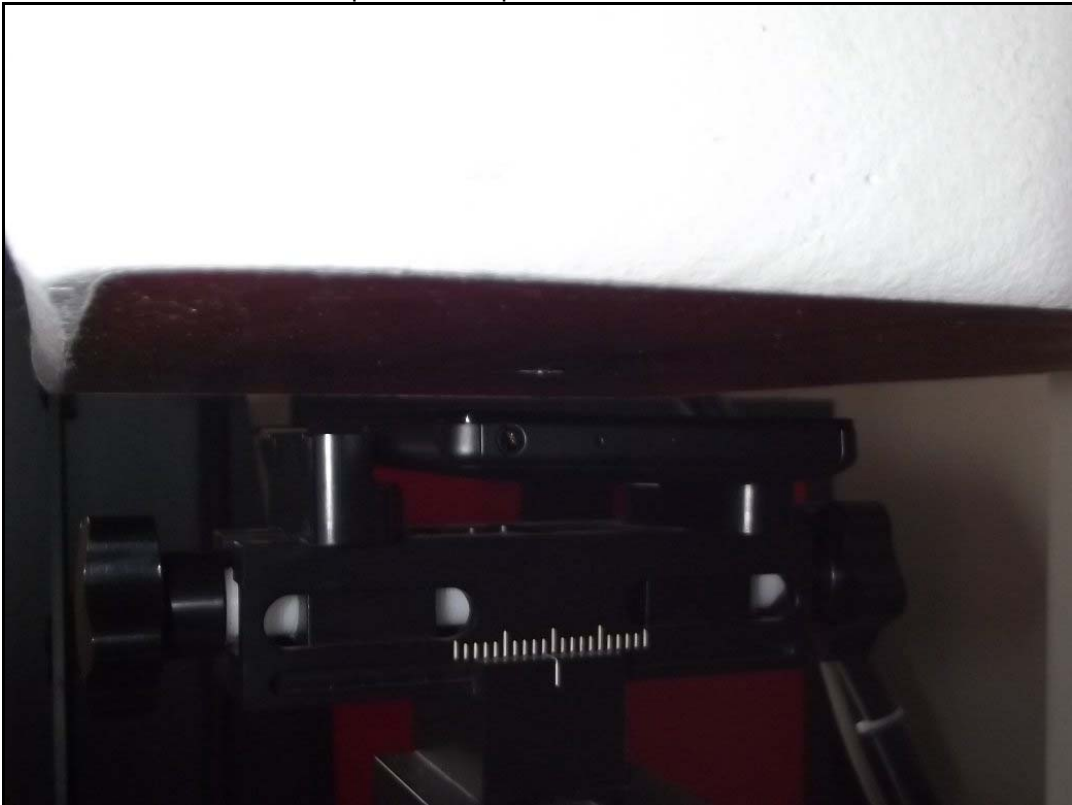
Photo 17: Test position hotspot front side with 10 mm distance

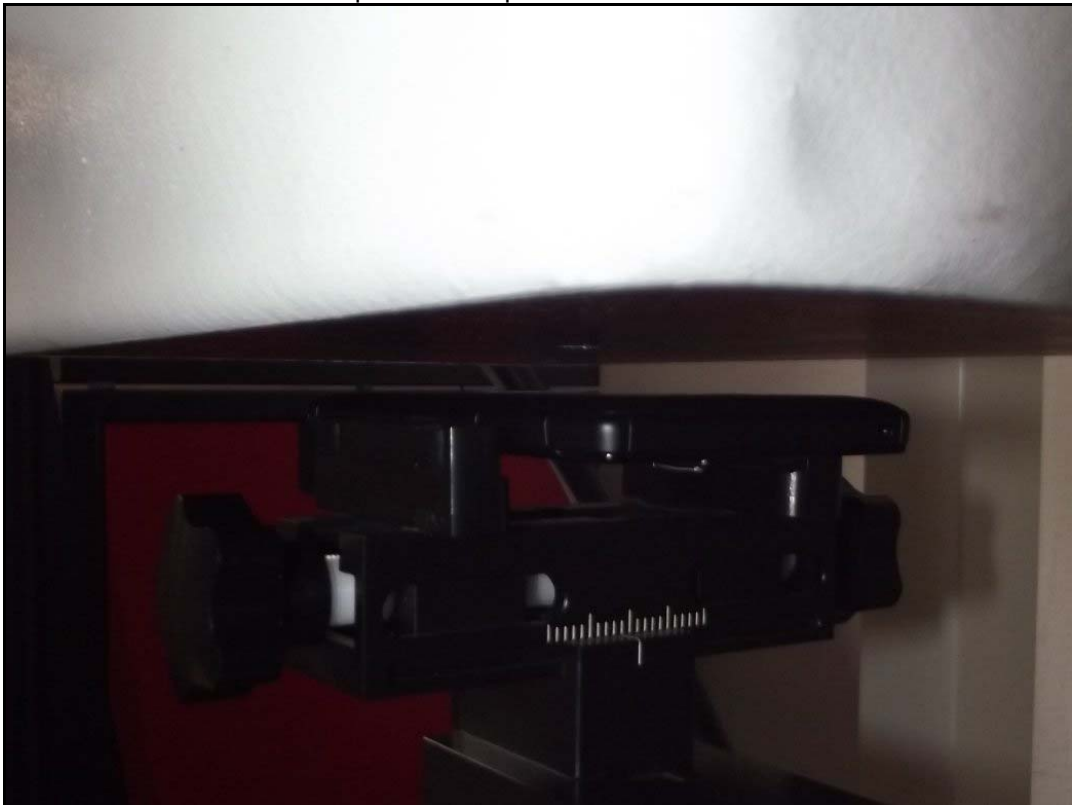
Photo 18: Test position hotspot rear side with 10 mm distance

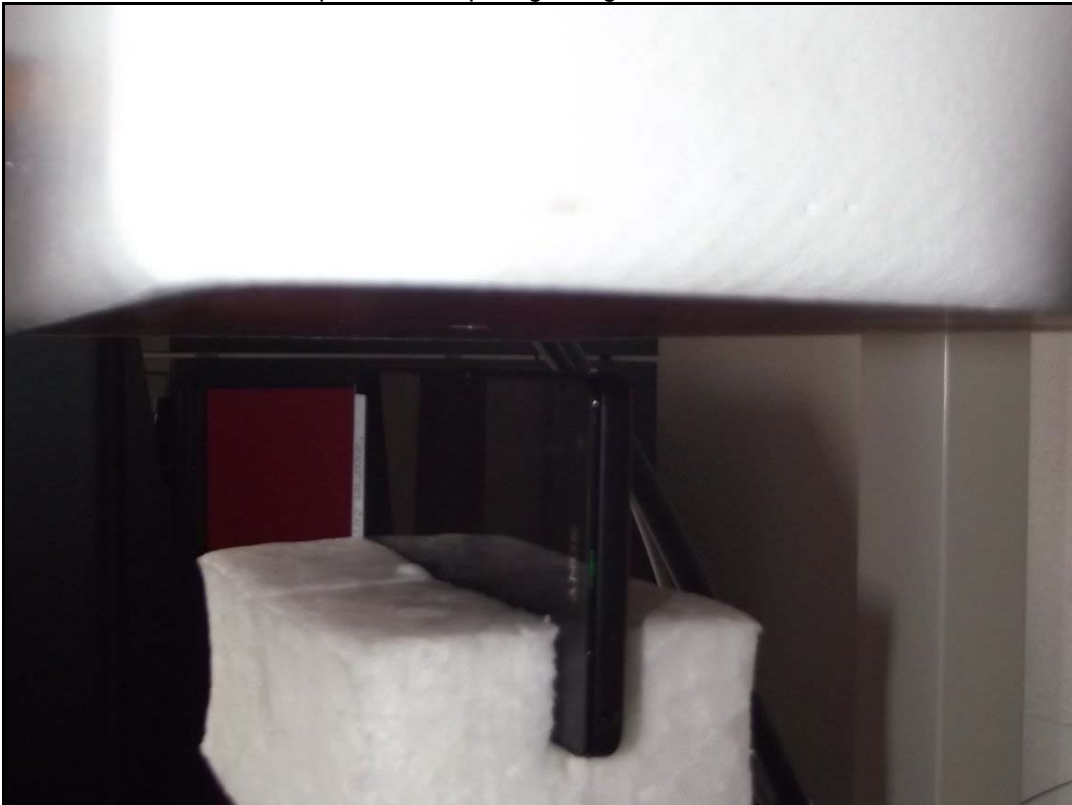
Photo 19: Test position hotspot right edge side with 10 mm distance

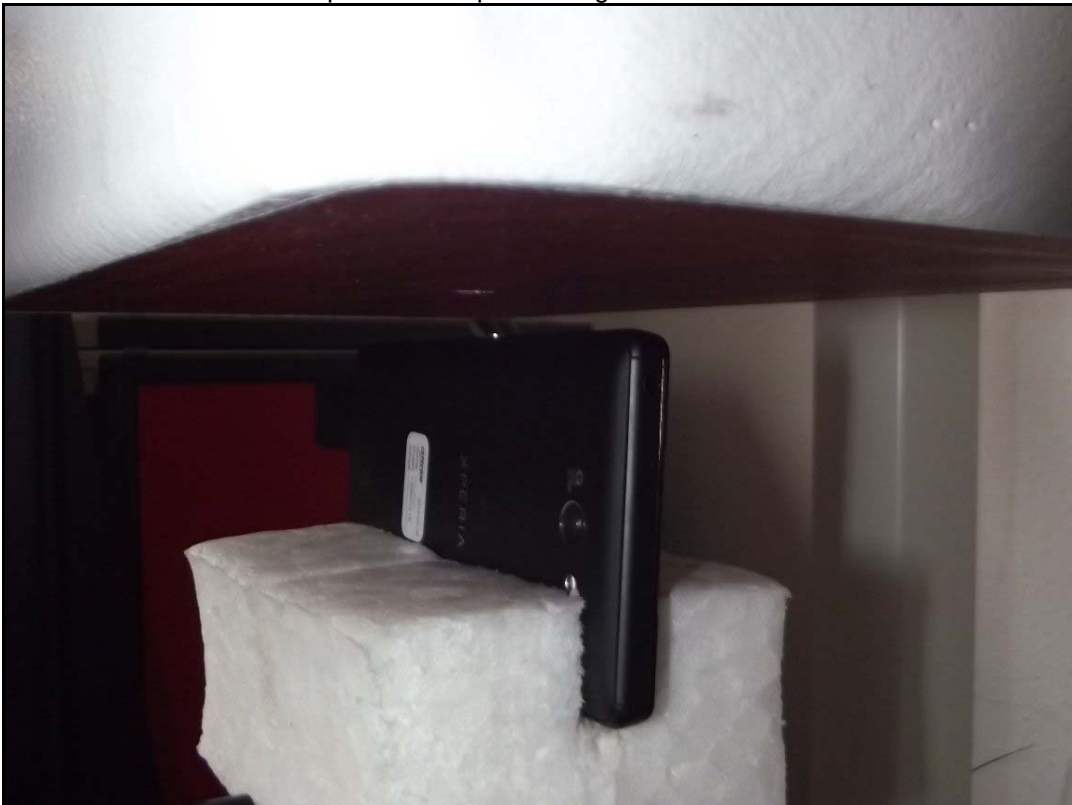
Photo 20: Test position hotspot left edge side with 10 mm distance

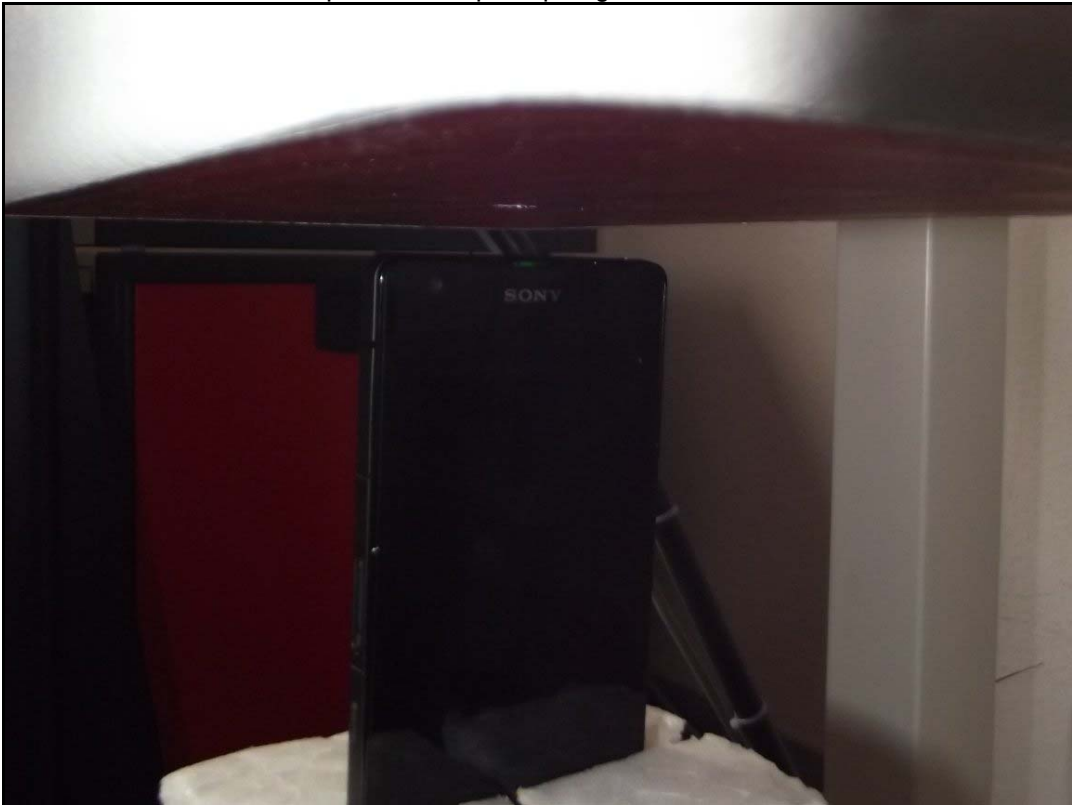
Photo 21: Test position hotspot top edge side with 10 mm distance

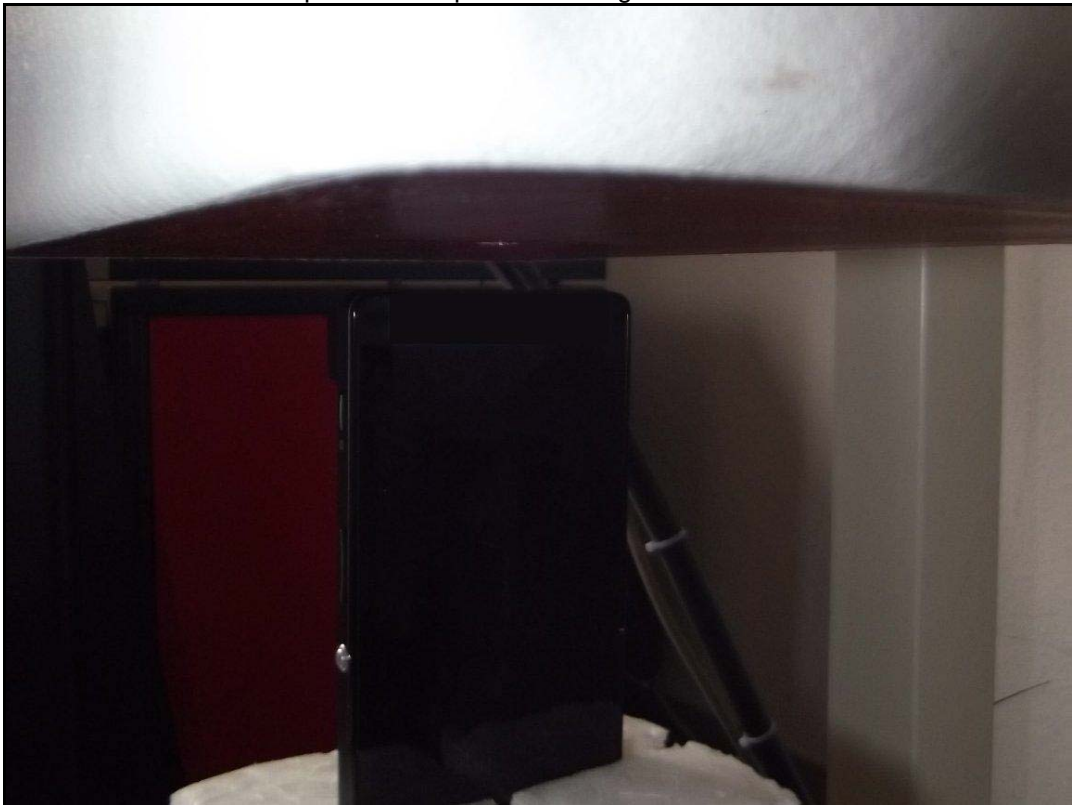
Photo 22: Test position hotspot bottom edge side with 10 mm distance
