## Annex C Photo documentation

Appendix to Test Report No.: 1-9303/15-01-02-A

#### **CETECOM ICT Services GmbH**

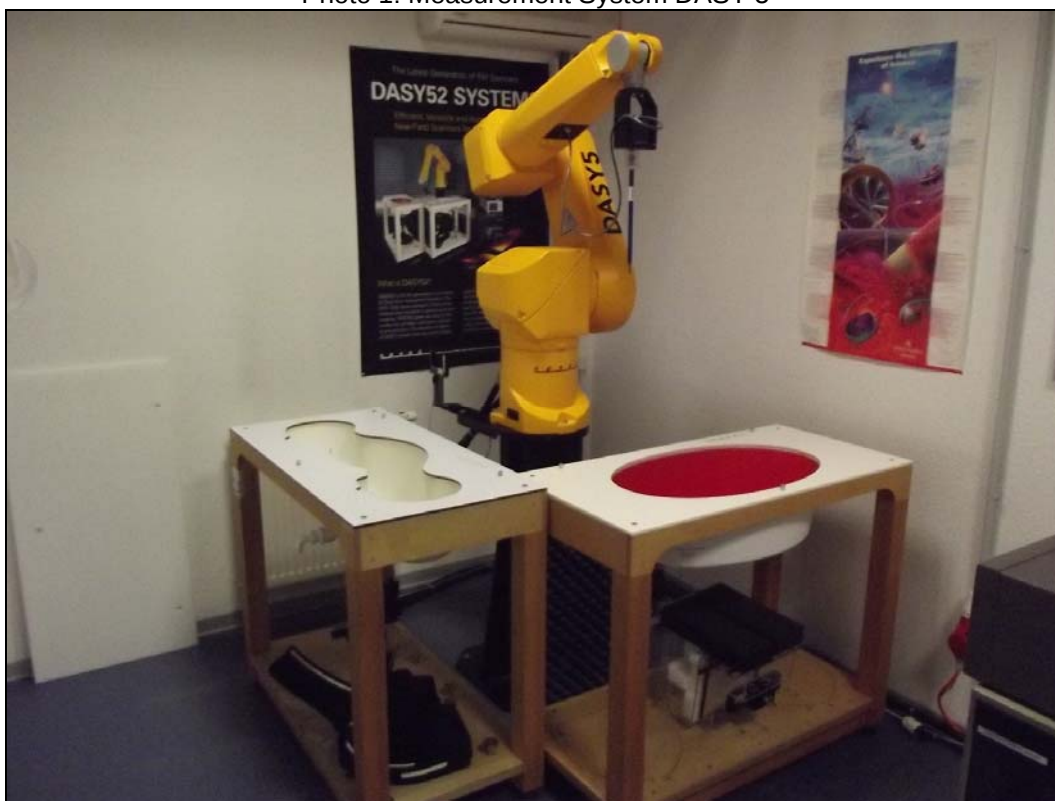
Photo 1: Measurement System DASY 5

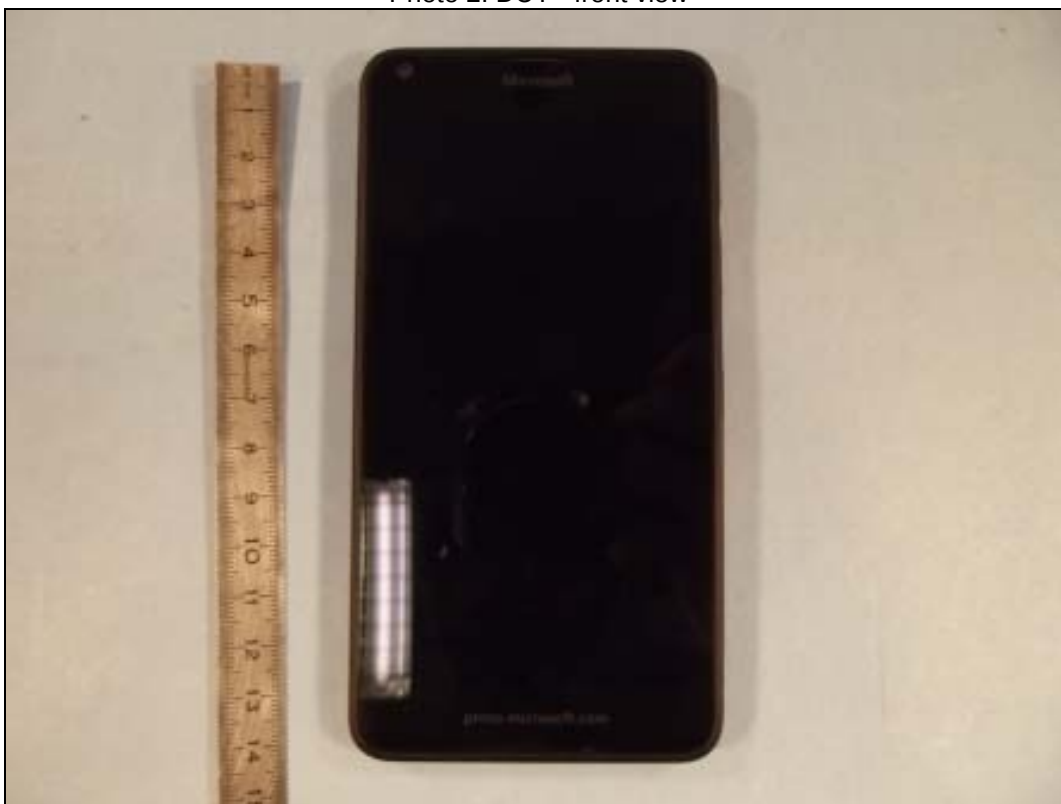
Photo 2: DUT - front view

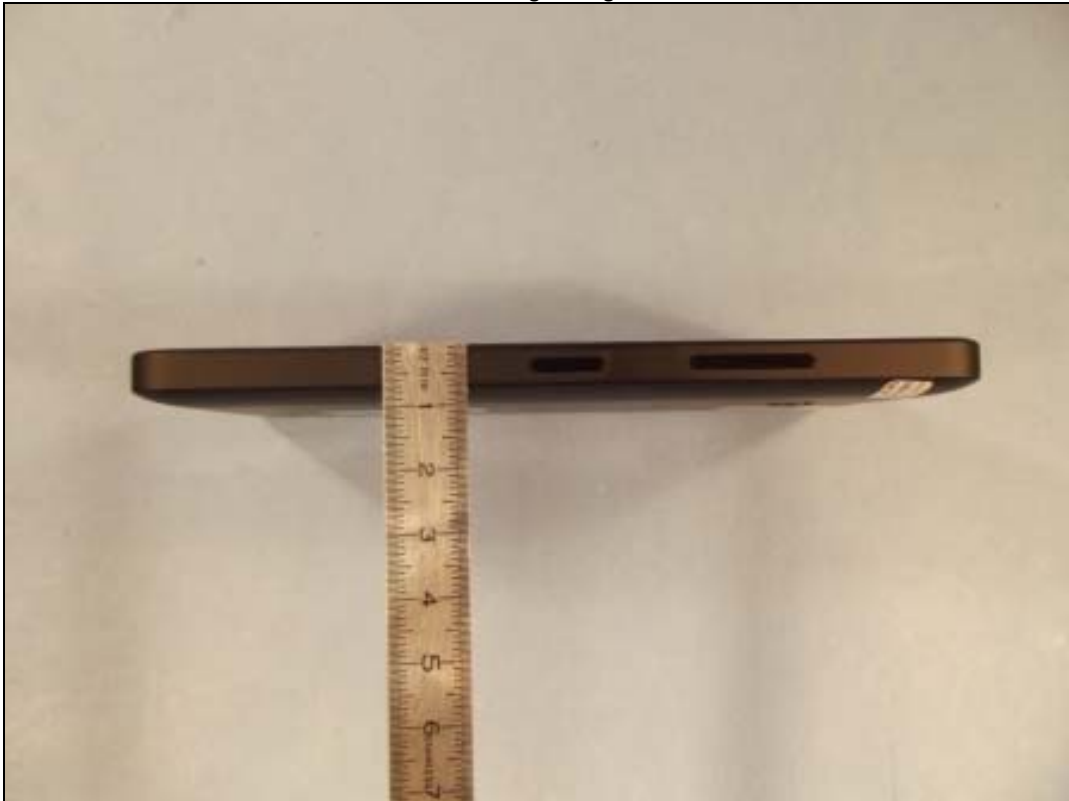
Photo 3: DUT - right edge side view

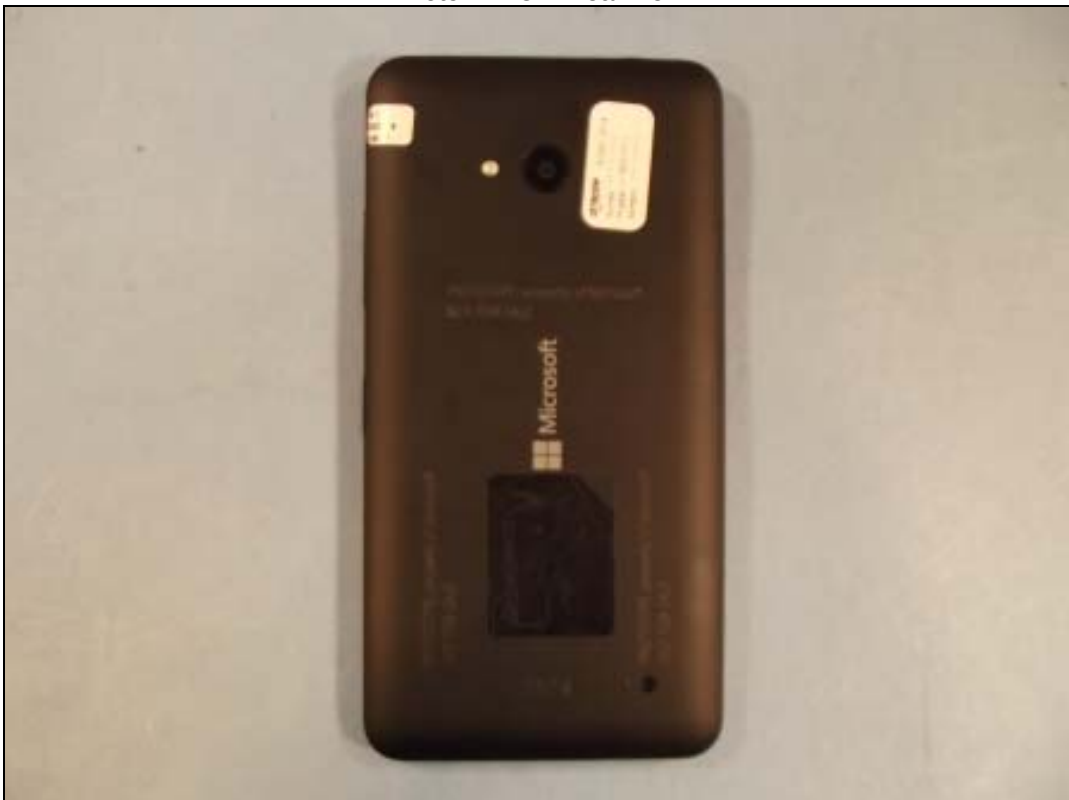
Photo 4: DUT - rear view

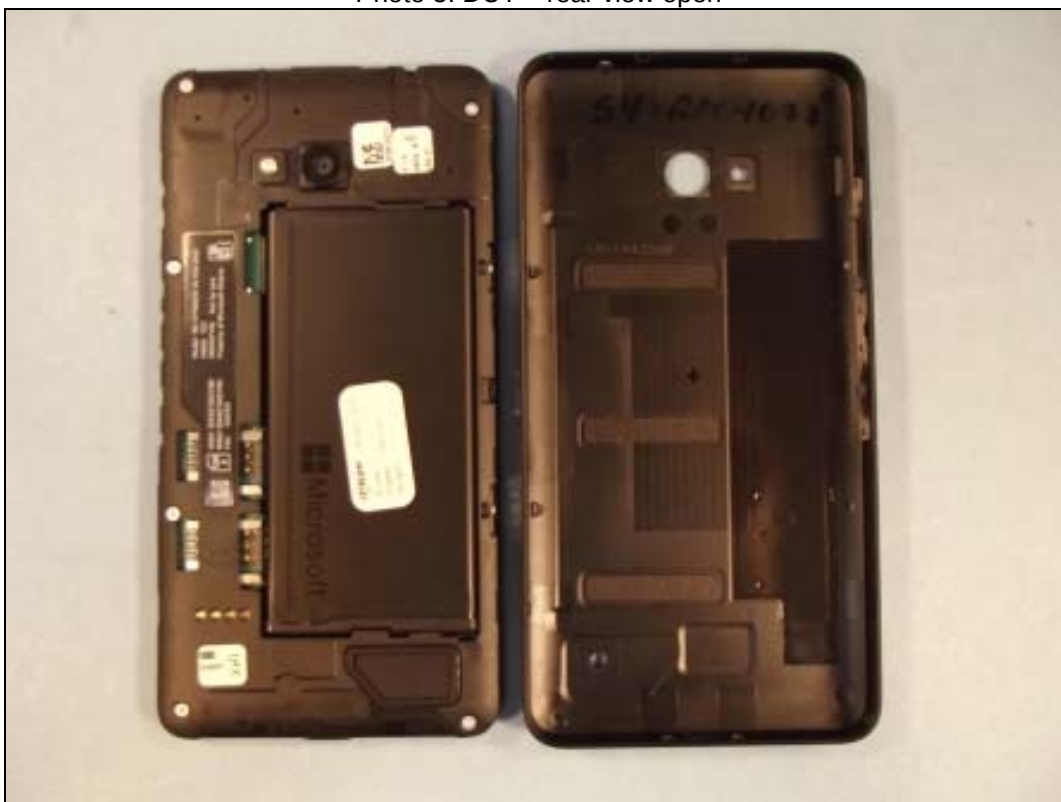
Photo 5: DUT – rear view open

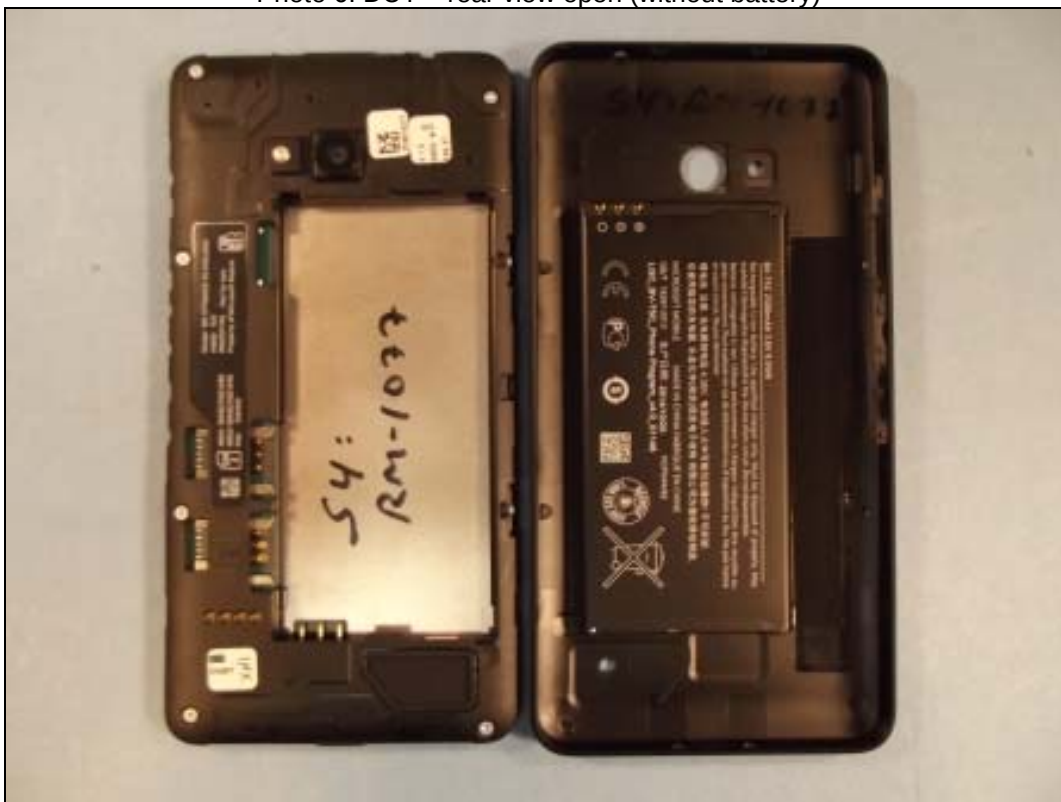
Photo 6: DUT – rear view open (without battery)

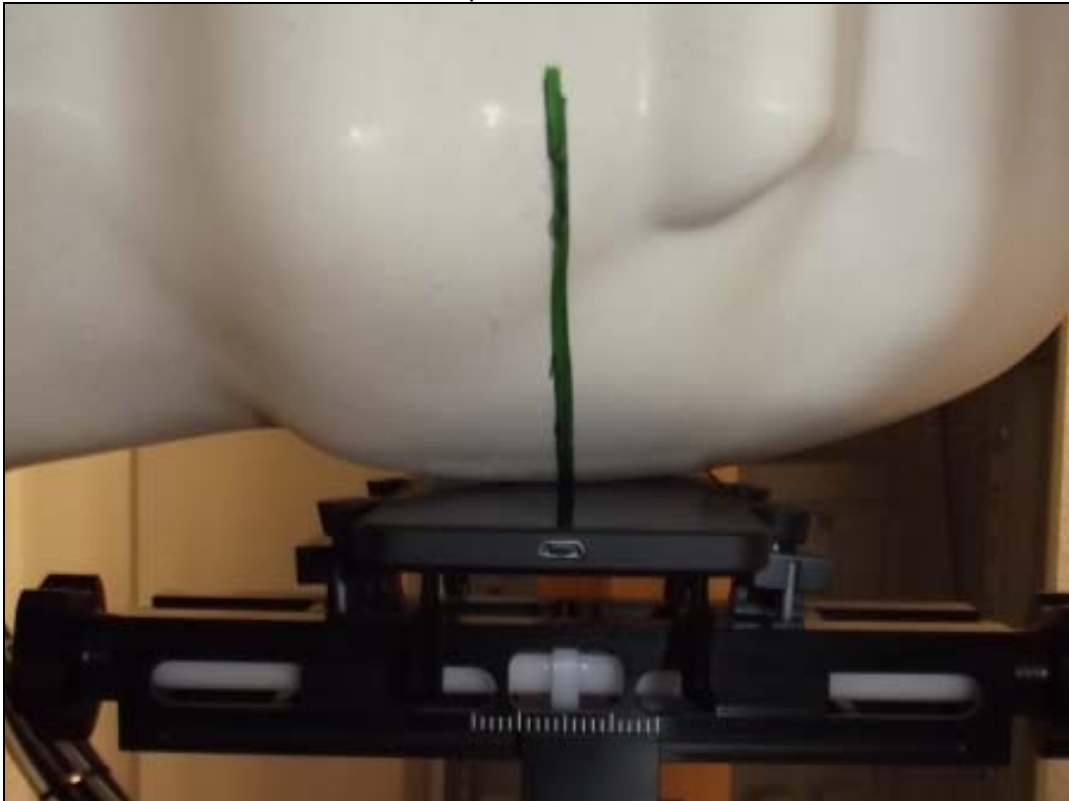
Photo 7: Test position left hand touched

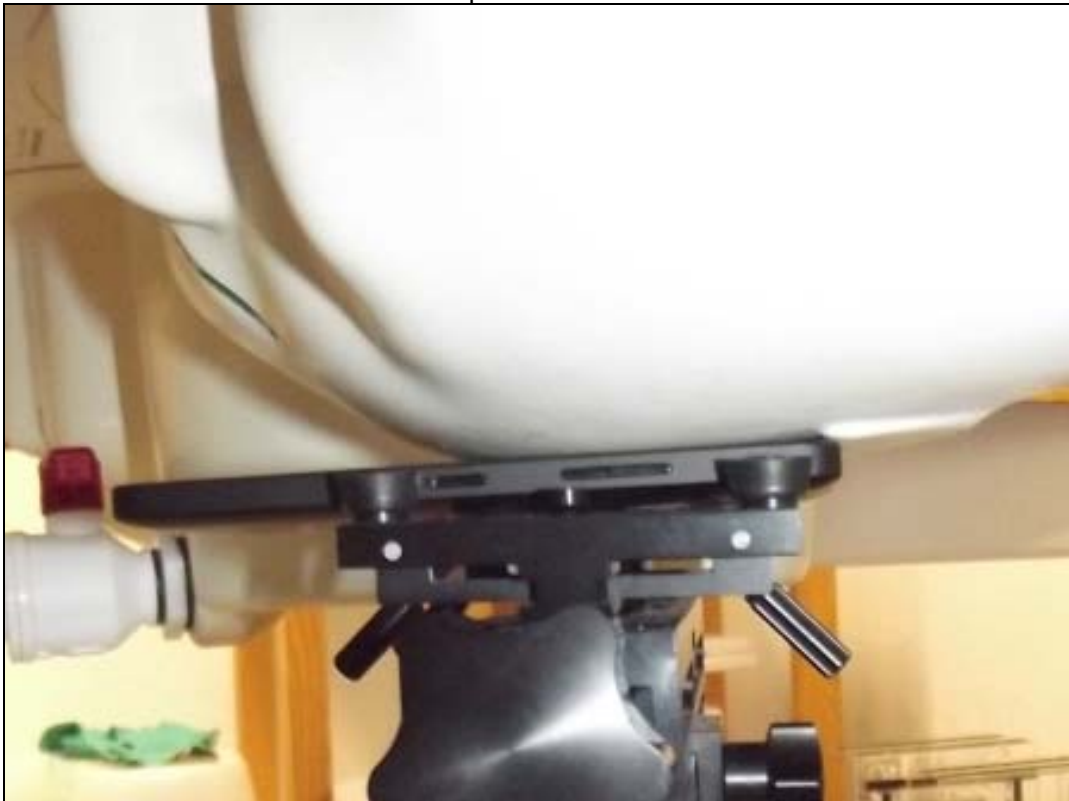
Photo 8: Test position left hand touched

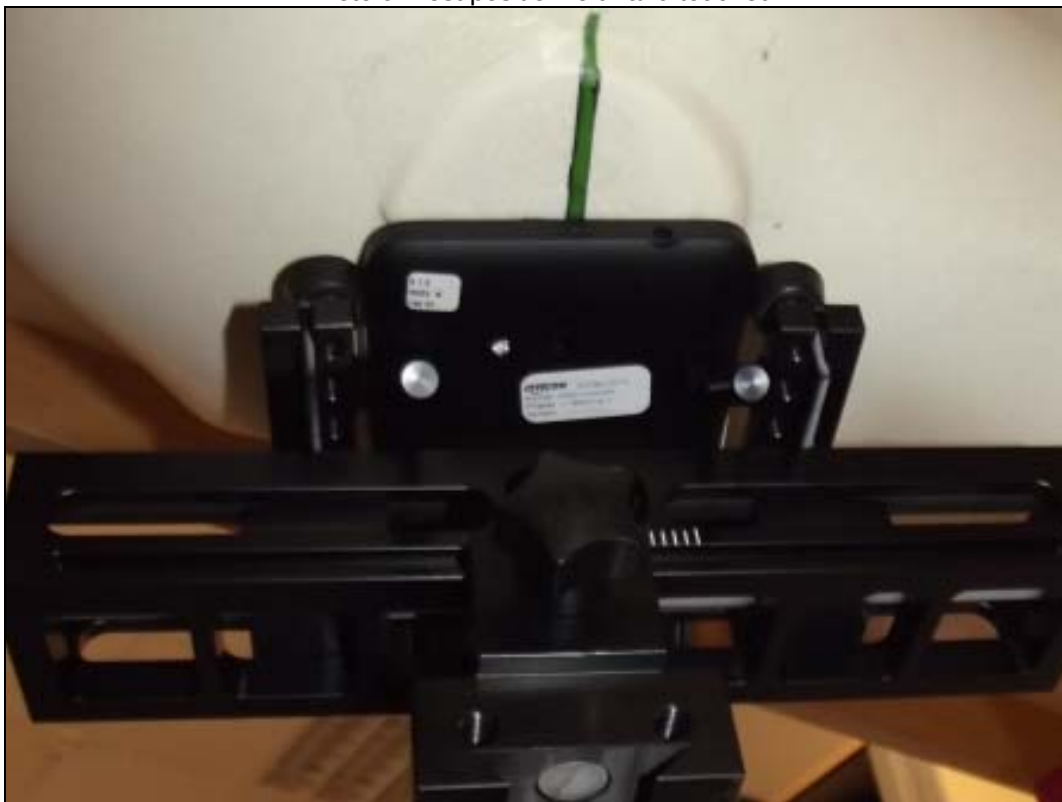
Photo 9: Test position left hand touched

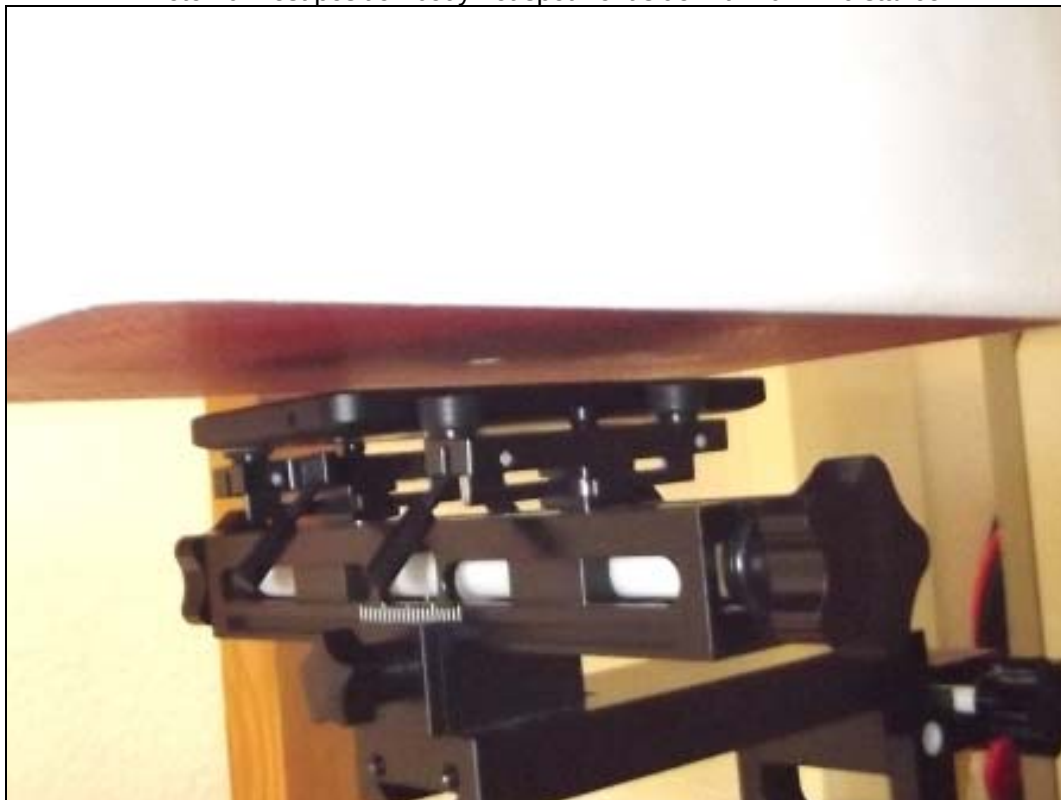
Photo 10: Test position body hot spot front side with 10 mm distance

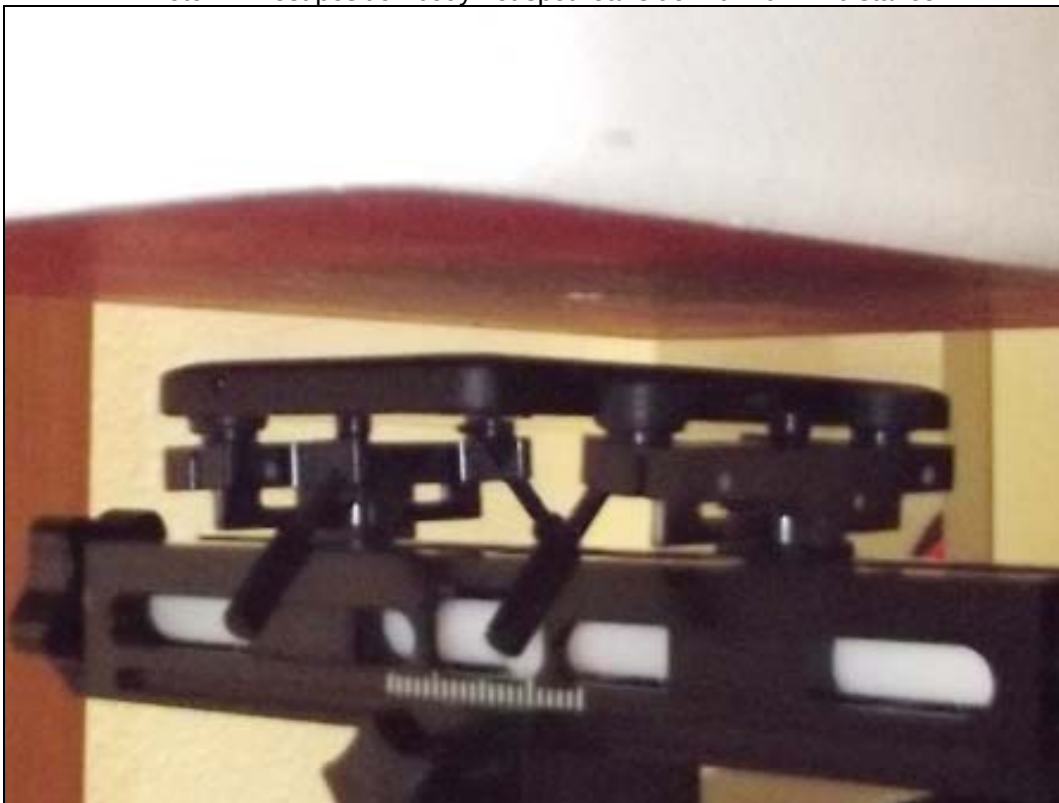
Photo 11: Test position body hot spot rear side with 10 mm distance

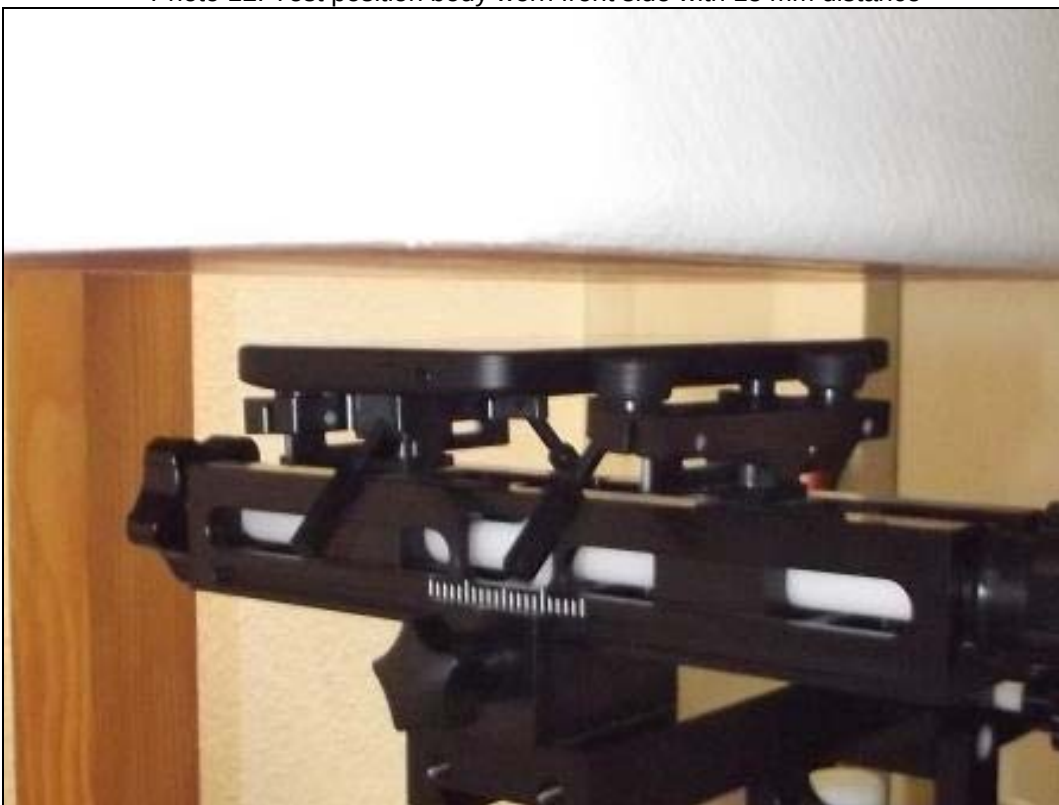
Photo 12: Test position body worn front side with 15 mm distance

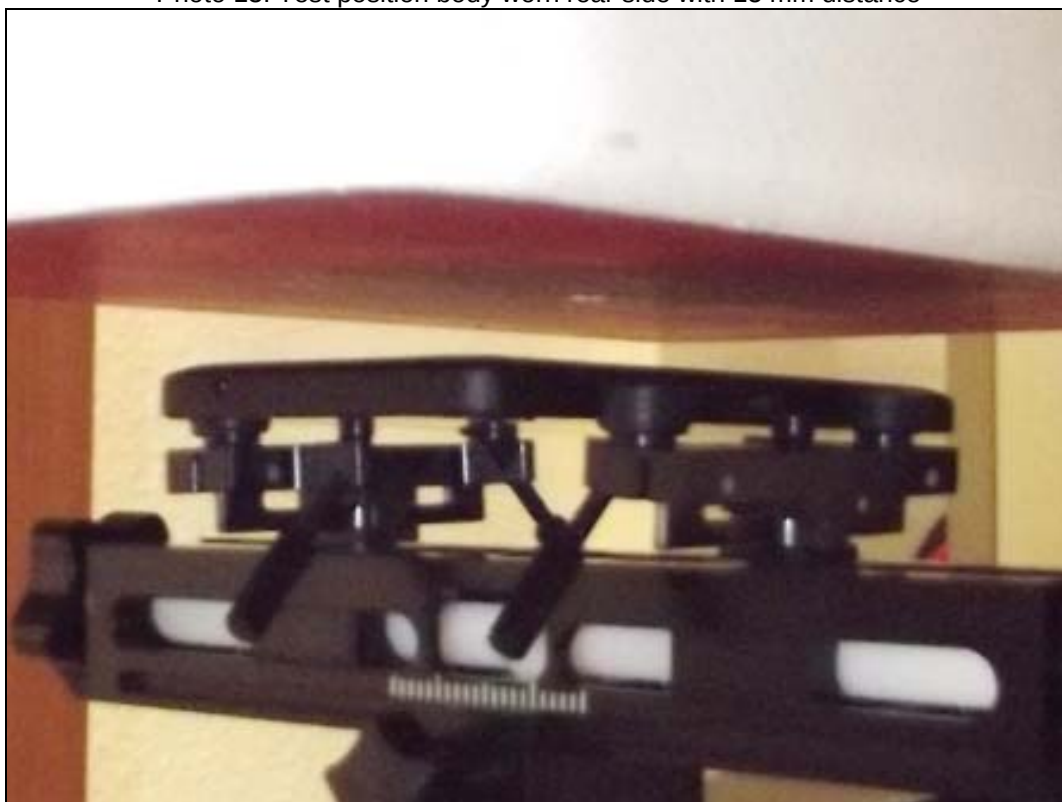
Photo 13: Test position body worn rear side with 15 mm distance

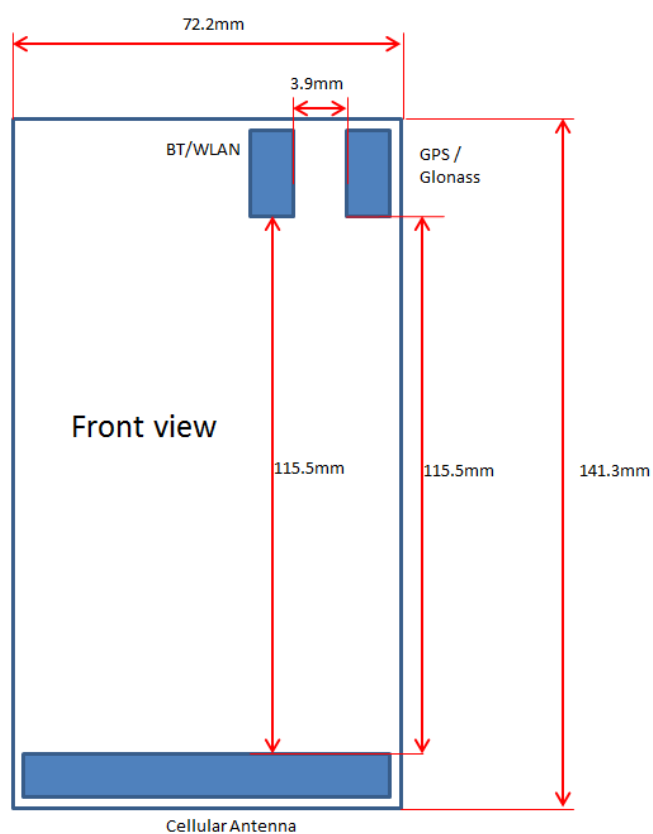
Photo 14: Antenna location
