**Setup photos for HAC RF Emissions
and T-Coil Test Report**

Test report no.:	HAC_Photo_RM-1128_03	Date of report:	2015-09-16
Template version:	4.0	Number of pages:	3
Testing laboratory:	TCC Microsoft Salo Laboratory P.O.Box 303 Joensuunkatu 7E FIN-24101 SALO, FINLAND Tel. +358 71 800 8000 Fax. +358 71 80 44122	Client:	Microsoft P.O. Box 68 Sinitaival 5 FIN-33721 TAMPERE, FINLAND Tel. +358 (0) 7180 08000 Fax. +358 (0) 7180 46880
Responsible test engineer:	Janne Hirsimäki	Product contact person:	Tero Huhtala
Measurements made by:	Sami Savela		
Tested devices:	RM-1128		
FCC ID:	PYARM-1128	IC:	661X-RM1128
Supplement reports:	RF_RM-1128_01, T-Coil_RM-1128_02		
Testing has been carried out in accordance with:	<p>ANSI C63.19-2011 American National Standard for Methods of Measurement of Compatibility between Wireless Communications Devices and Hearing Aids</p> <p>CTIA Test Plan for Hearing Aid Compatibility, Revision 3.0, November 2013</p>		
Documentation:	The documentation of the testing performed on the tested devices is archived for 15 years at TCC Microsoft.

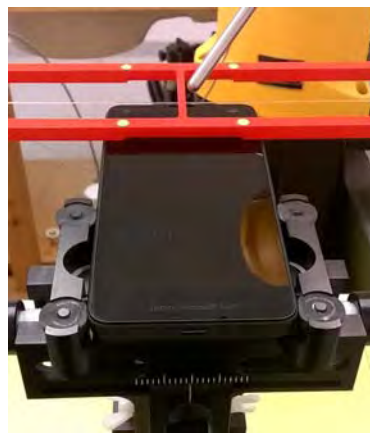
The device was positioned such that Device Reference plane was touching the bottom of the Test Arch. The scan is centered at the acoustic output by aligning the acoustic output with the intersection of the Test Arch's middle bar and dielectric wire.

Photo of the device positioned under Test Arch
