**Setup photos for HAC RF Emissions
and T-Coil Test Report**

Test report no.:	HAC_Photo_RM-1150_03	Date of report:	2015-12-02
Template version:	4.0	Number of pages:	3
Testing laboratory:	TCC Microsoft Salo Laboratory P.O.Box 303 Joensuunkatu 7E FIN-24101 SALO, FINLAND Tel. +358 71 800 8000 Fax. +358 71 80 44122	Client:	Microsoft P.O. Box 68 Sinitaival 5 FIN-33721 TAMPERE, FINLAND Tel. +358 (0) 7180 08000 Fax. +358 (0) 7180 46880
Responsible test engineer:	Janne Hirsimäki	Product contact person:	Juha Paukku
Measurements made by:	Janne Hirsimäki		
Tested devices:	RM-1150, HW: 1520		
FCC ID:	PYARM-1150	IC:	N/A
Supplement reports:	RF_RM-1150_01, T-Coil_RM-1150_02		
Testing has been carried out in accordance with:	<p>ANSI C63.19-2011 American National Standard for Methods of Measurement of Compatibility between Wireless Communications Devices and Hearing Aids</p> <p>CTIA Test Plan for Hearing Aid Compatibility, Revision 3.0, November 2013</p>		
Documentation:	The documentation of the testing performed on the tested devices is archived for 15 years at TCC Microsoft.

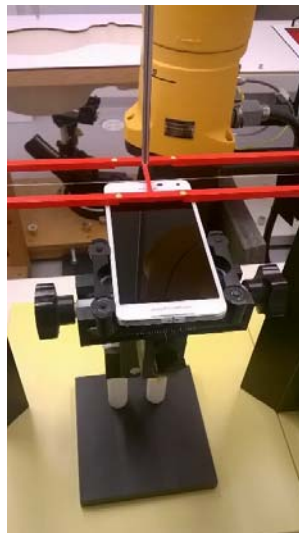
The device was positioned such that Device Reference plane was touching the bottom of the Test Arch. The scan is centered at the acoustic output by aligning the acoustic output with the intersection of the Test Arch's middle bar and dielectric wire.

Photo of the device positioned under Test Arch
