**Setup photos for HAC RF Emissions  
and T-Coil Test Report**

<b>Test report no.:</b>	HAC_Photo_RM-1152_03	<b>Date of report:</b>	2015-11-11
<b>Template version:</b>	4.0	<b>Number of pages:</b>	3
<b>Testing laboratory:</b>	TCC Microsoft Salo Laboratory P.O.Box 303 Joensuunkatu 7E FIN-24101 SALO, FINLAND Tel. +358 71 800 8000 Fax. +358 71 80 44122	<b>Client:</b>	Microsoft P.O. Box 68 Sinitaival 5 FIN-33721 TAMPERE, FINLAND Tel. +358 (0) 7180 08000 Fax. +358 (0) 7180 46880
<b>Responsible test engineer:</b>	Janne Hirsimäki	<b>Product contact person:</b>	Juha Paukku
<b>Measurements made by:</b>	Janne Hirsimäki, Jani Tuomela		
<b>Tested devices:</b>	RM-1152, HW: 1540		
<b>FCC ID:</b>	PYARM-1152	<b>IC:</b>	-
<b>Supplement reports:</b>	RF_RM-1152_01, T-Coil_RM-1152_02		
<b>Testing has been carried out in accordance with:</b>	<p><b>ANSI C63.19-2011</b> American National Standard for Methods of Measurement of Compatibility between Wireless Communications Devices and Hearing Aids</p> <p><b>CTIA Test Plan for Hearing Aid Compatibility, Revision 3.0, November 2013</b></p>

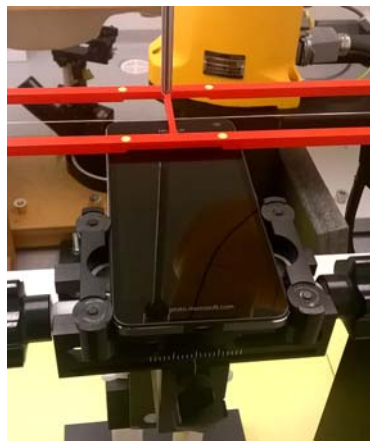
The device was positioned such that Device Reference plane was touching the bottom of the Test Arch. The scan is centered at the acoustic output by aligning the acoustic output with the intersection of the Test Arch's middle bar and dielectric wire.

Photo of the device positioned under Test Arch
