## Test setup photos for HAC Test Report

| Test report no.: | Salo_HAC_0851_07 | Date of report: | 2008-12-19 |
| Tested devices: | RM-413 | | |
| Testing has been carried out in accordance with: | <b>ANSI C63.19-2007</b><br>American National Standard for Methods of Measurement of Compatibility between Wireless Communications Devices and Hearing Aids | | |

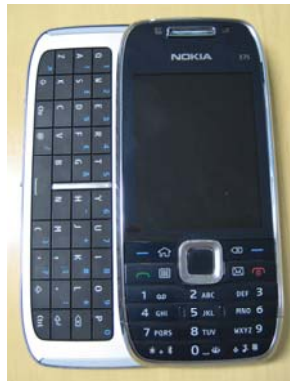
Flip closed

Flip open

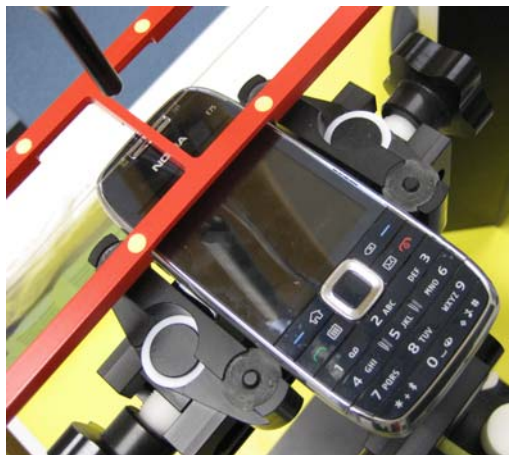
The device was positioned such that Device Reference plane was touching the bottom of the Test Arch. The scan is centered at the acoustic output by aligning the acoustic output with the intersection of the Test Arch's middle bar and dielectric wire.

Photo of the device positioned under Test Arch
