**Setup photos for HAC RF Emissions  
and T-Coil Test Report**

<b>Test report no.:</b>	HAC_Photo_RM-1127_03	<b>Date of report:</b>	2015-09-07
<b>Template version:</b>	4.0	<b>Number of pages:</b>	3
<b>Testing laboratory:</b>	TCC Microsoft Salo Laboratory P.O.Box 303 Joensuunkatu 7E FIN-24101 SALO, FINLAND Tel. +358 71 800 8000 Fax. +358 71 80 44122	<b>Client:</b>	Microsoft P.O. Box 68 Sinitaival 5 FIN-33721 TAMPERE, FINLAND Tel. +358 (0) 7180 08000 Fax. +358 (0) 7180 46880
<b>Responsible test engineer:</b>	Janne Hirsimäki	<b>Product contact person:</b>	Tero Huhtala
<b>Measurements made by:</b>	Janne Hirsimäki		
<b>Tested devices:</b>	RM-1127		
<b>FCC ID:</b>	PYARM-1127	IC:	-
<b>Supplement reports:</b>	RF_RM-1127_01, T-Coil_RM-1127_02		
<b>Testing has been carried out in accordance with:</b>	<p><b>ANSI C63.19-2011</b> American National Standard for Methods of Measurement of Compatibility between Wireless Communications Devices and Hearing Aids</p> <p><b>CTIA Test Plan for Hearing Aid Compatibility, Revision 3.0, November 2013</b></p>

### 1.1 Picture of Device

### 1.2 Test Positions

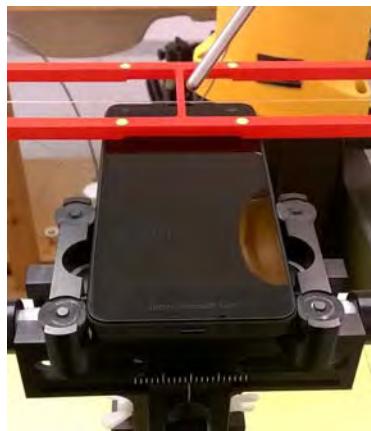
The device was positioned such that Device Reference plane was touching the bottom of the Test Arch. The scan is centered at the acoustic output by aligning the acoustic output with the intersection of the Test Arch's middle bar and dielectric wire.

Photo of the device positioned under Test Arch
