# Test Setup Photographs

## Photograph of Radiated Emissions Test Setup

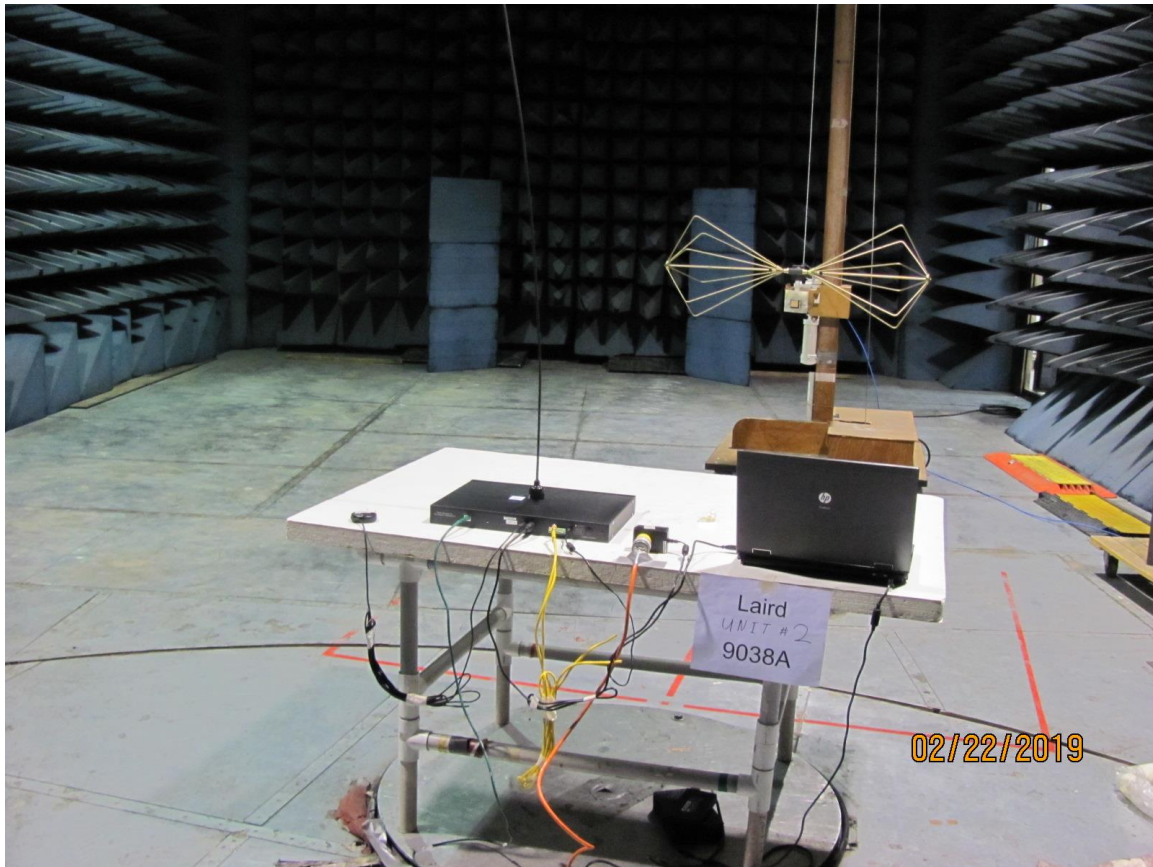
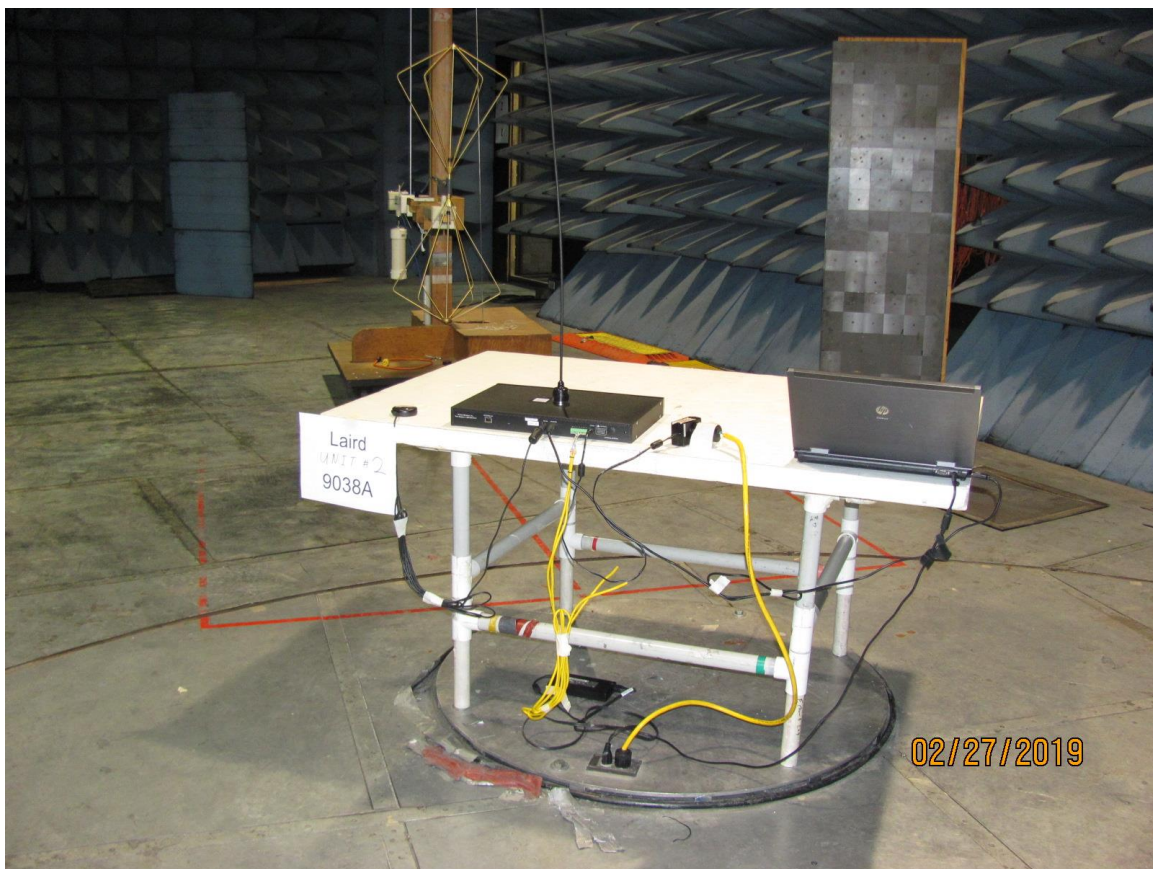
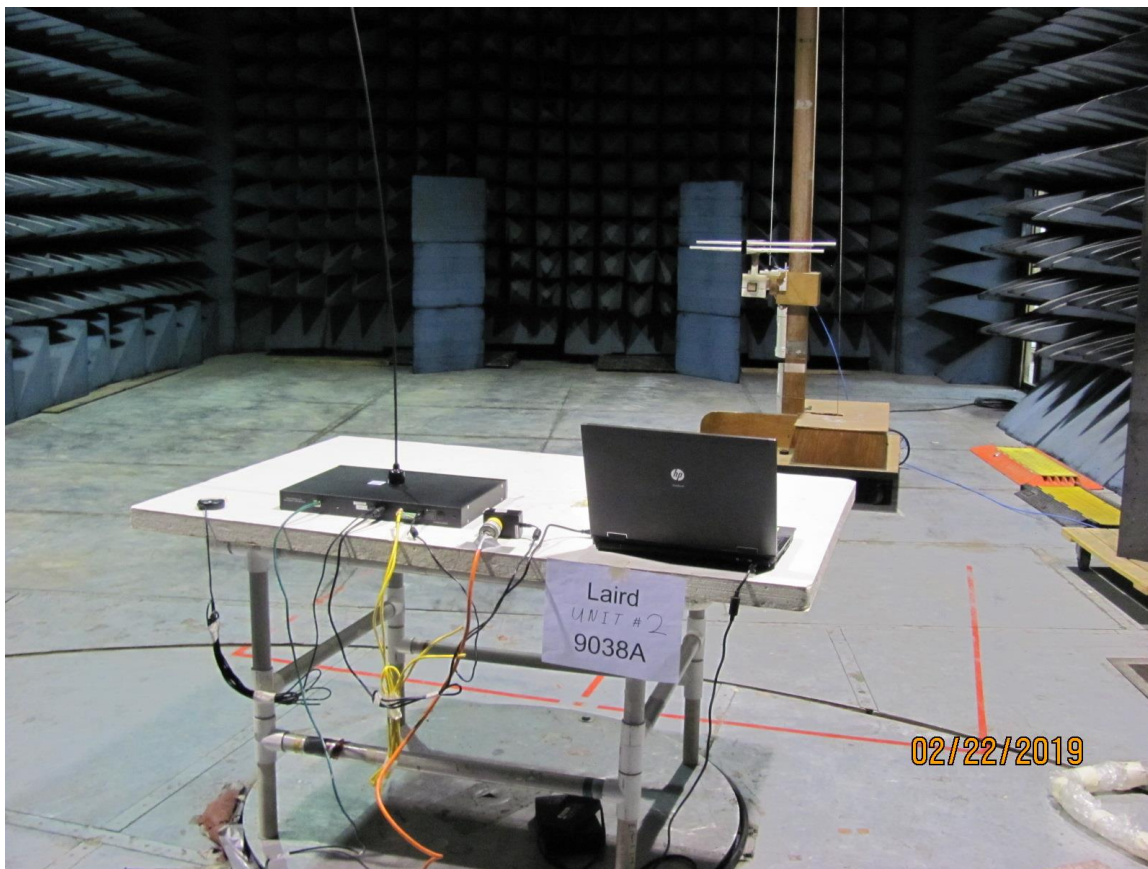
The transmit mode was tested with a load in place of the monopole antenna with no low pass filter. The load was installed inside the the case of the transmitter.

Receive mode was tested with the monopole antenna installed as normal, with no Low pass filter.
