APPENDIX 1: Photographs of test setup

Radiated emission

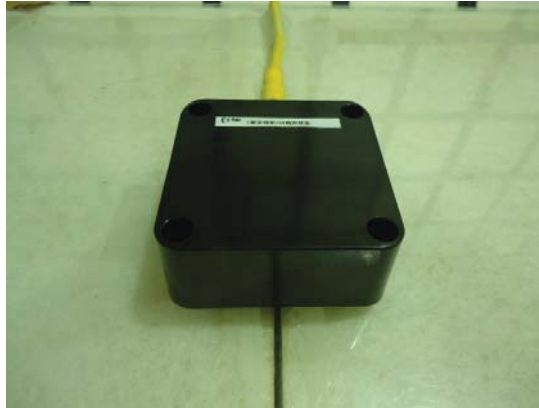
Worst Case Position

Below 30MHz Y-axis
Above 30MHz Horizontal:X-axis / Vertical:Y-axis

X-axis

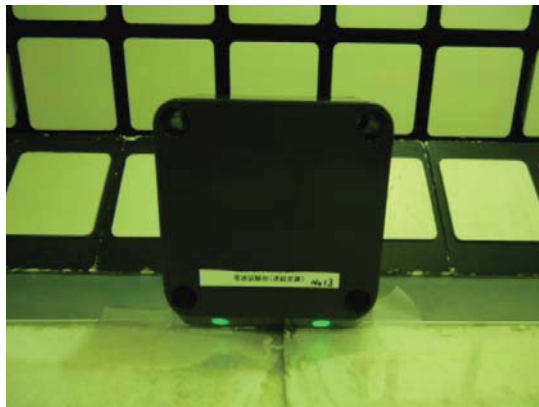
Y-axis

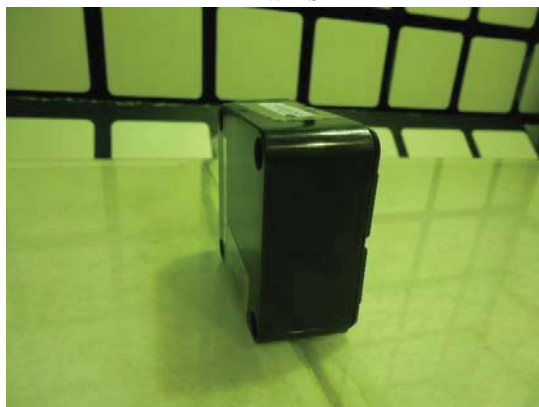
Z-axis

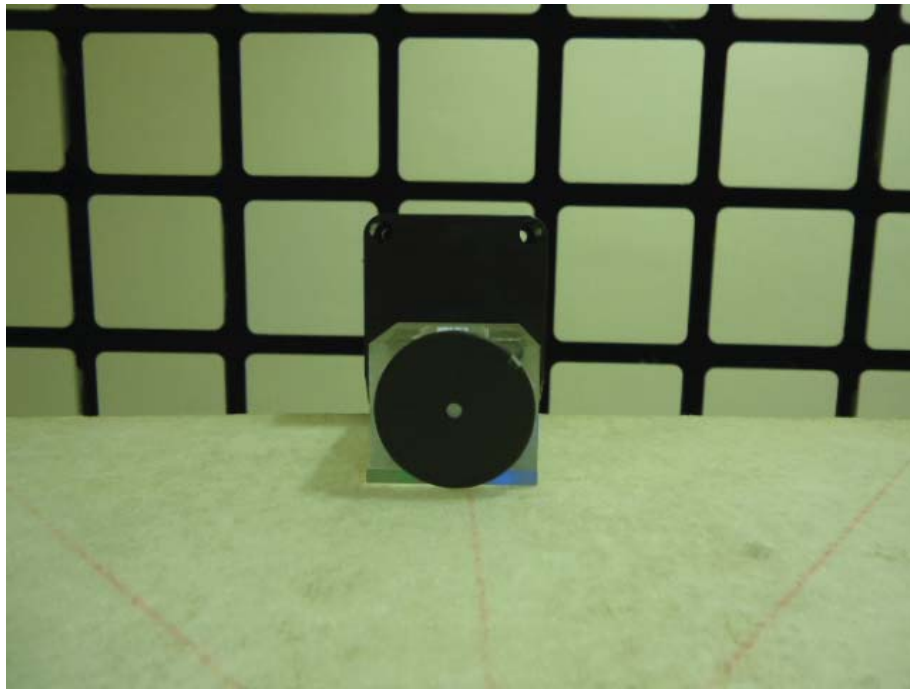
With/Without Tag

With Tag

* Spacer: 0mm was compared with Spacer: 85mm at the pre-check and the test was performed with higher emission level one.

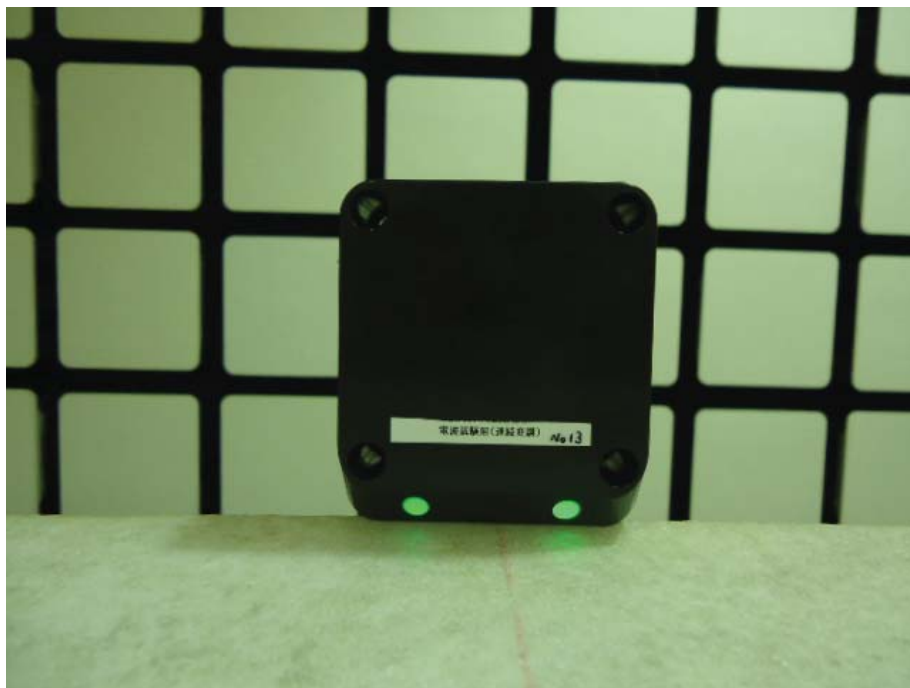
Without Tag
