Appendix D. SAR Test Setup Photos

Report No.: FA431032

FCC ID: QDS-BRCM1079

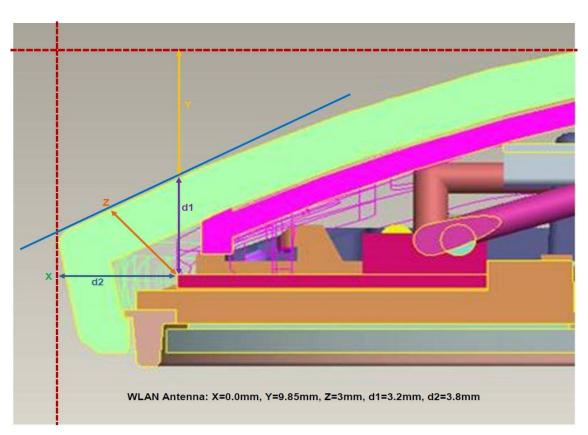
The additional separation between the device exterior and the phantom surface introduced by the contour is > 5 mm.
