Setup photos for HAC RF Emissions and T-Coil Test Report

Test report no.:	HAC_Photo_RM-497_03	Date of report:	2009-07-02
Template version:	1.1	Number of pages:	3
Testing laboratory:	TCC Salo P.O. Box 86 Joensuunkatu 7H / Kiila 1B FIN-24101 SALO, FINLAND Tel. +358 (0) 7180 08000 Fax. +358 (0) 7180 45220	Client:	Nokia Corporation Frederikskaj 1790 COPENHAGEN V DENMARK Tel. +45 33 292929 Fax. +45 33 292934
Responsible test engineer:	Heikki Kuusela	Product contact person:	Mohammad El-Haj
Measurements made by:	Heikki Kuusela		
Tested devices:	RM-497 (Hearing aid mode active)		
FCC ID:	QTKRM-497		
Supplement reports:	RF_RM-497_01, T-Coil_RM-497_02		
Testing has been carried out in accordance with:	ANSI C63.19-2007 American National Standard for Methods of Measurement of Compatibility between Wireless Communications Devices and Hearing Aids		
Documentation:	The documentation of the testing performed on the tested devices is archived for 15 years at TCC Nokia.

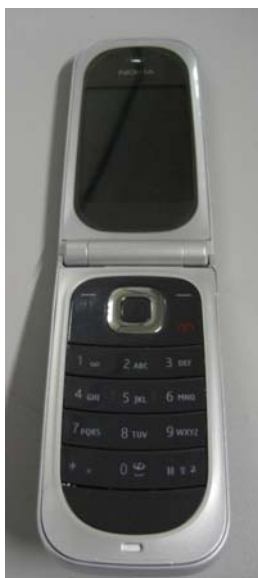
1.1 Picture of Device

Flip open

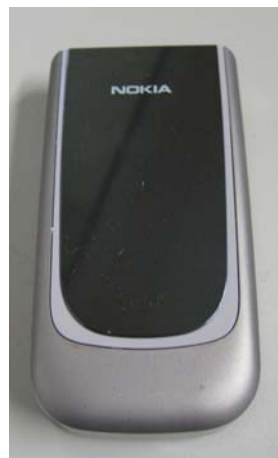
Flip closed

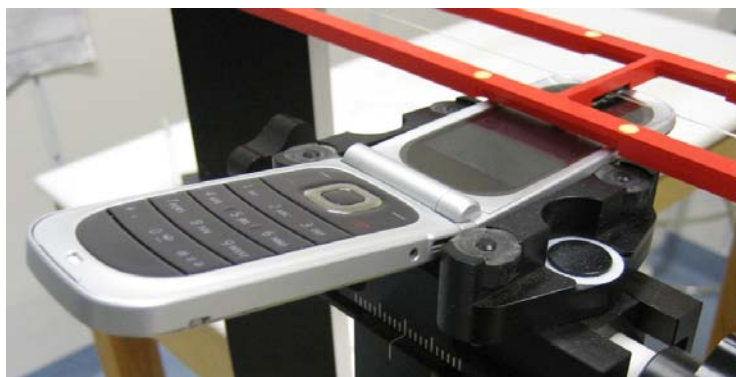
1.2.1 Scan area centered at the acoustic output

The device was positioned such that Device Reference plane was touching the bottom of the Test Arch. The scan is centered at the acoustic output by aligning the acoustic output with the intersection of the Test Arch's middle bar and dielectric wire.

Photo of the device positioned under Test Arch
