## Setup photos for HAC RF Emissions and T-Coil Test Report

| Test report no.: | HAC_Photo_RM-720_03 | Date of report: | 2010-11-05 |
| Tested devices: | RM-720 | | |
| Testing has been carried out in accordance with: | <b>ANSI C63.19-2007</b><br>American National Standard for Methods of Measurement of Compatibility between Wireless Communications Devices and Hearing Aids | | |

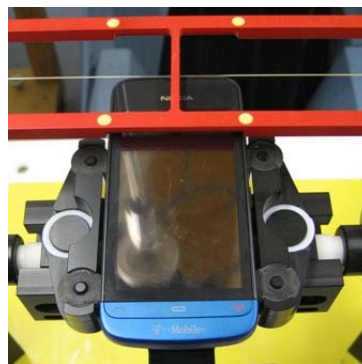
The device was positioned such that Device Reference plane was touching the bottom of the Test Arch. The scan is centered at the acoustic output by aligning the acoustic output with the intersection of the Test Arch's middle bar and dielectric wire.

Photo of the device positioned under Test Arch
