## Setup Photos for HAC RF Emissions Test Report

| Test report no.: | Salo_HAC_0913_03 | Date of report: | 2009-04-03 |
| Tested devices: | RM-507 (Hearing aid mode active) | | |
| Testing has been carried out in accordance with: | <b>ANSI C63.19-2007</b><br>American National Standard for Methods of Measurement of Compatibility between Wireless Communications Devices and Hearing Aids | | |

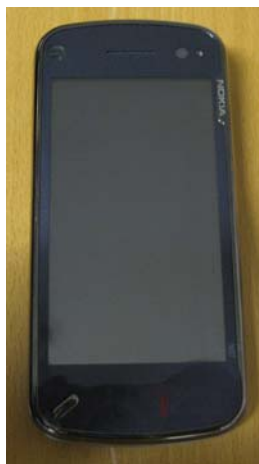
Slide closed

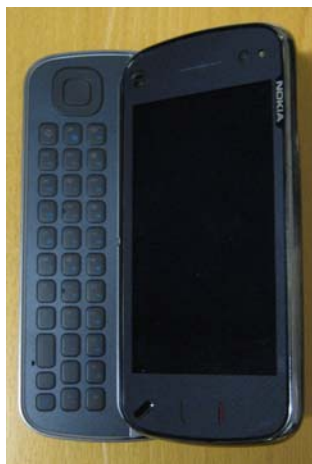
Slide open

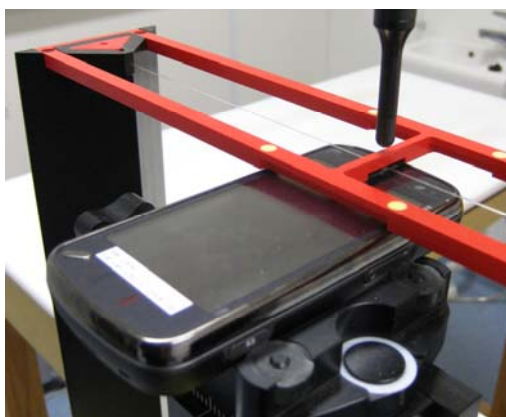
The device was positioned such that Device Reference plane was touching the bottom of the Test Arch. The scan is centered at the acoustic output by aligning the acoustic output with the intersection of the Test Arch's middle bar and dielectric wire.

Photo of the device positioned under Test Arch
