# Photo Report on Test Setups

**Report Reference:** MDE\_PEIKER\_1801\_FCC03/04\_Photo\_Setups

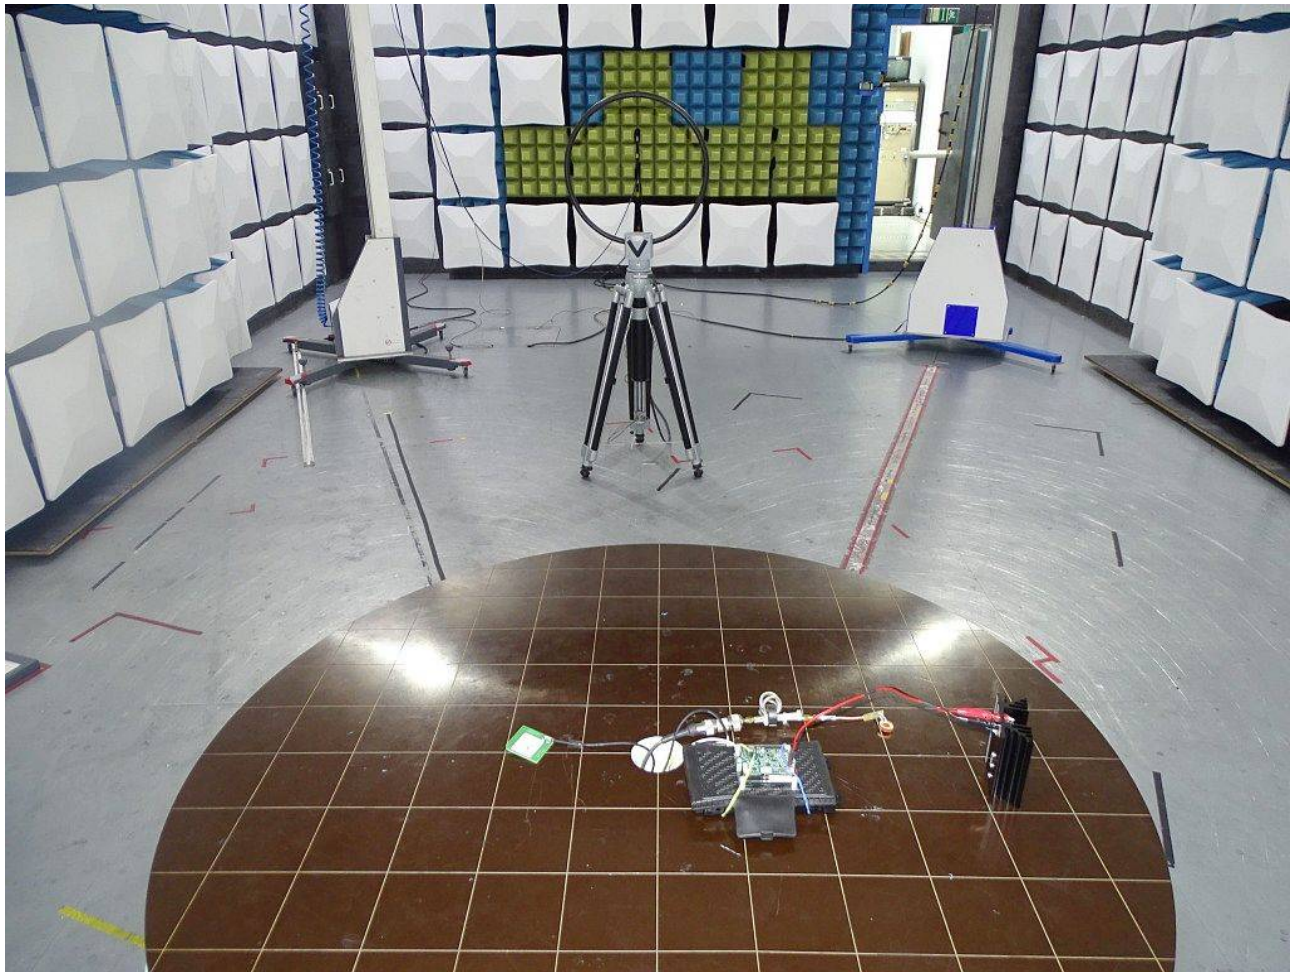
**Photo 1:** Test setup for radiated measurements (Enclosure, semi-anechoic chamber, 9 kHz to 30 MHz, intentional radiator §15, ANSI C63.10)  
EUT horizontal, WPT

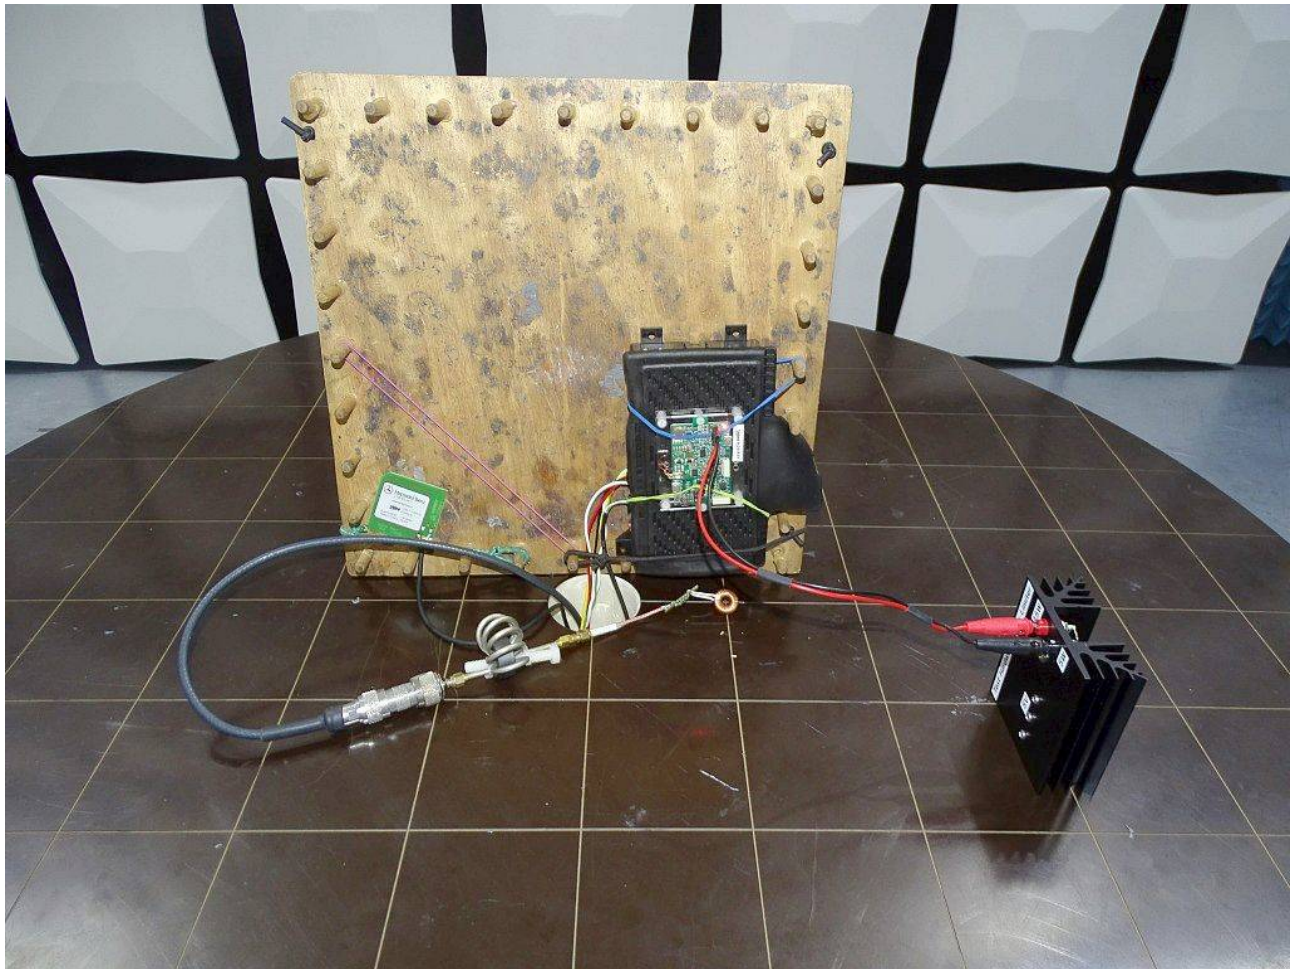
**Photo 2:** Test setup for radiated measurements (Enclosure, semi-anechoic chamber, 9 kHz to 30 MHz, intentional radiator §15, ANSI C63.10)  
EUT vertical, WPT

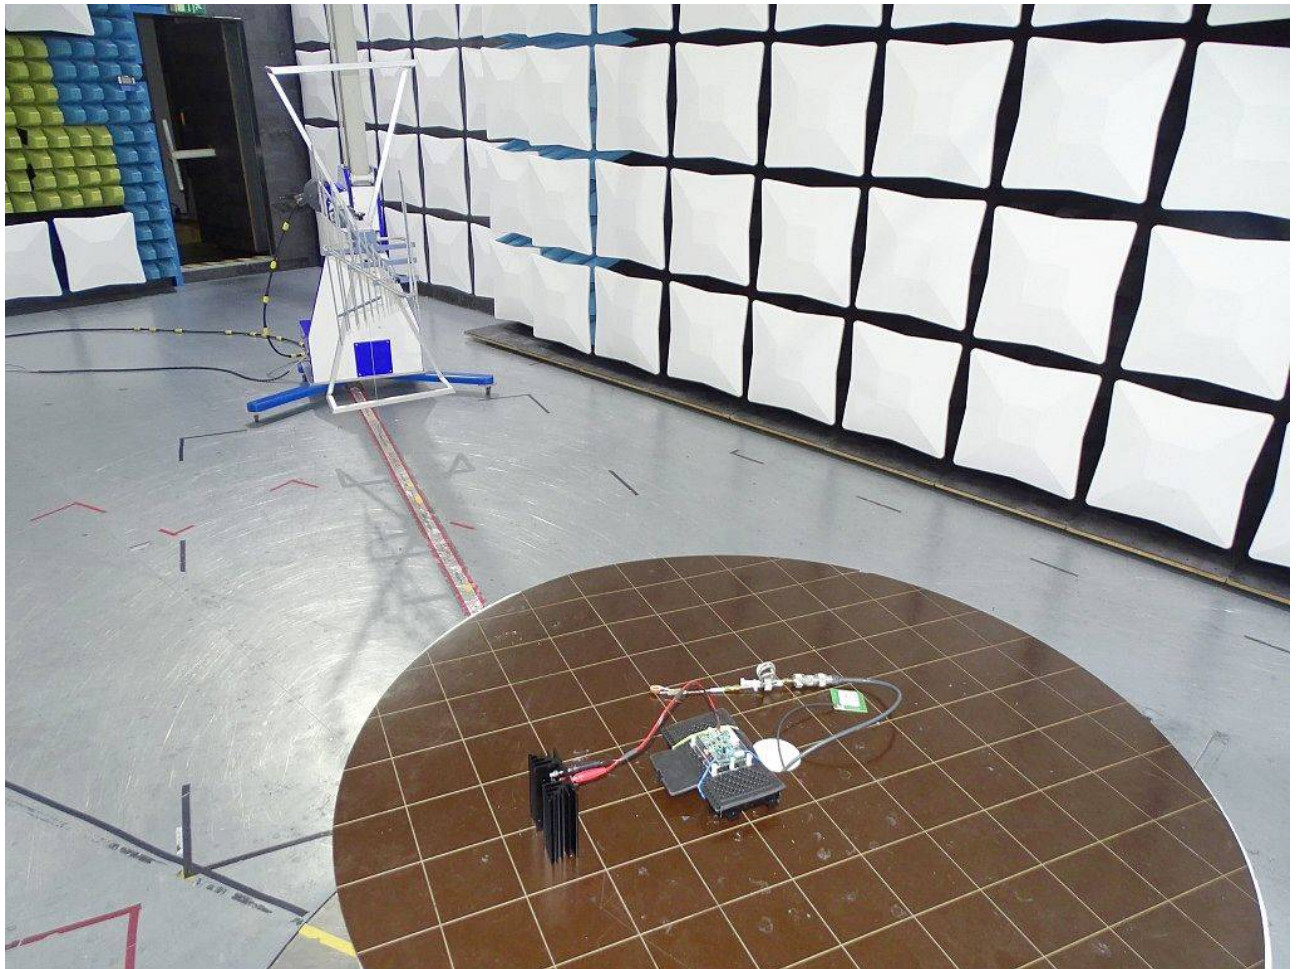
**Photo 3:** Test setup for radiated measurements (Enclosure, semi-anechoic chamber, 30 MHz to 1 GHz, intentional radiator §15, ANSI C63.10) WPT

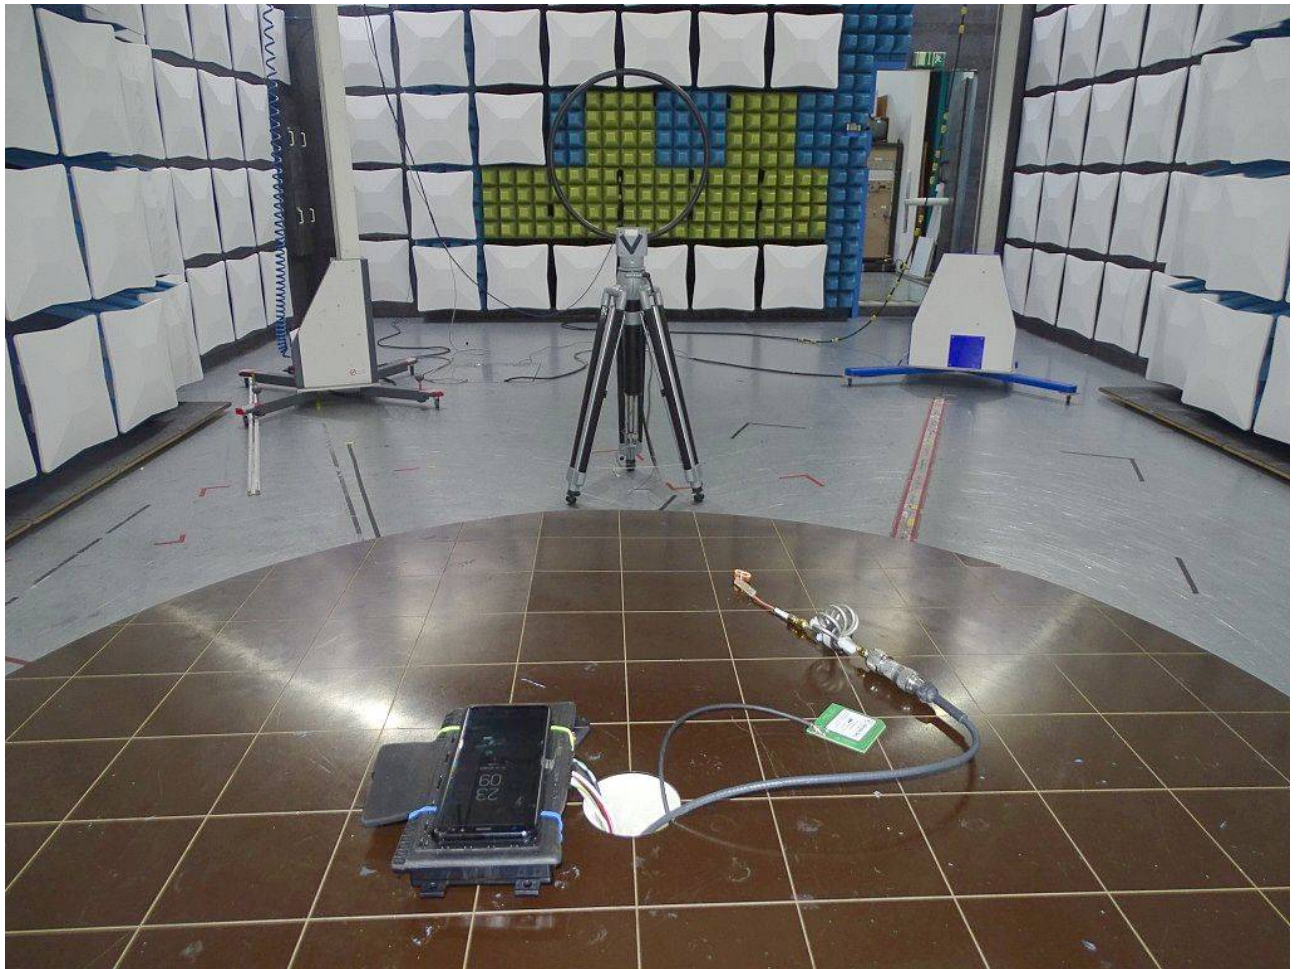
**Photo 4:** Test setup for radiated measurements (Enclosure, semi-anechoic chamber, 9 kHz to 30 MHz, intentional radiator §15, ANSI C63.10)  
EUT horizontal,  
NFC, integral antenna

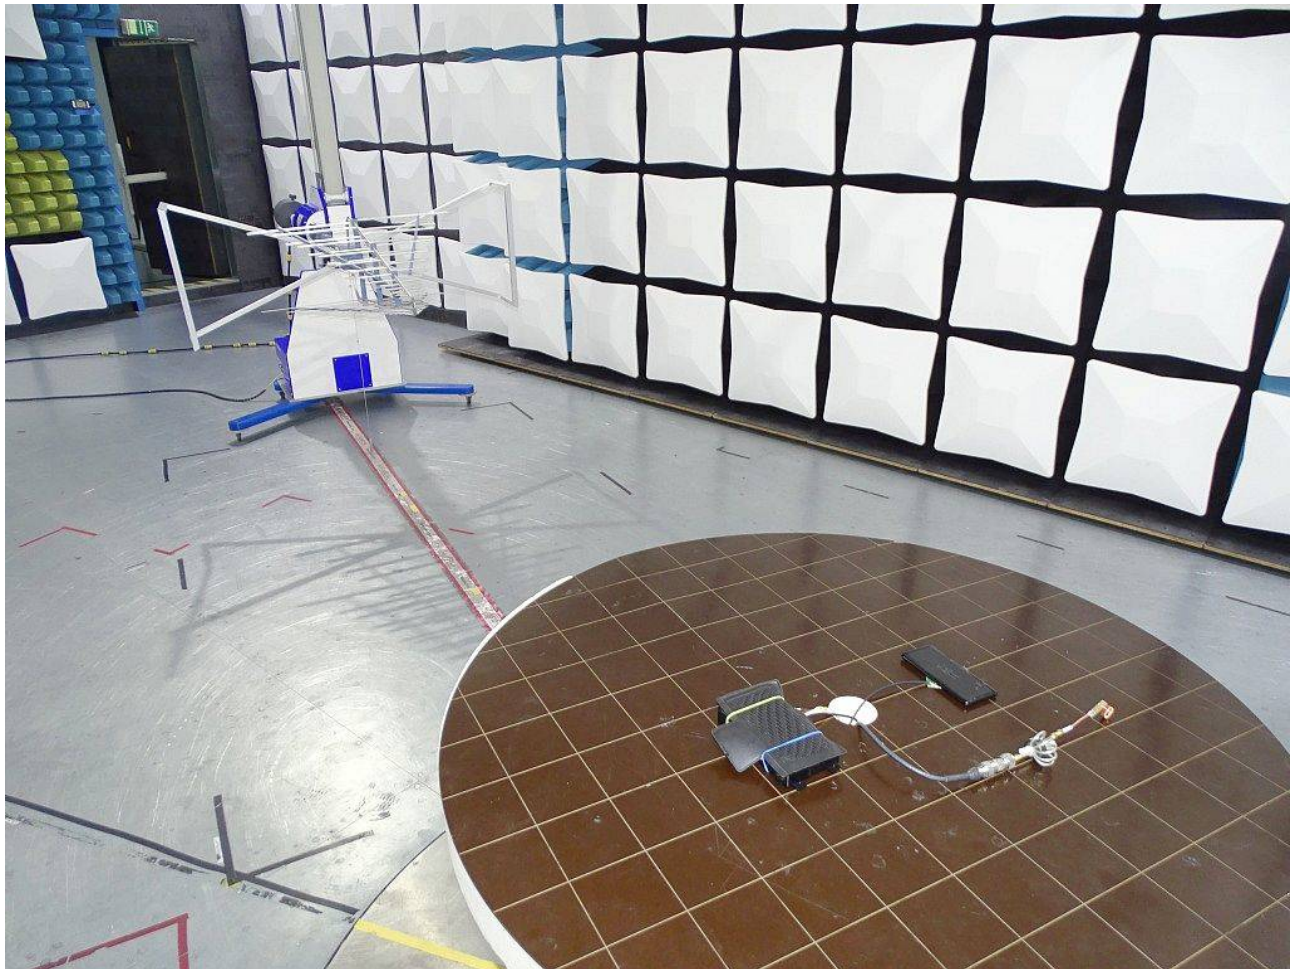
**Photo 5:** Test setup for radiated measurements (Enclosure, semi-anechoic chamber, 30 MHz to 1 GHz, intentional radiator §15, ANSI C63.10) NFC

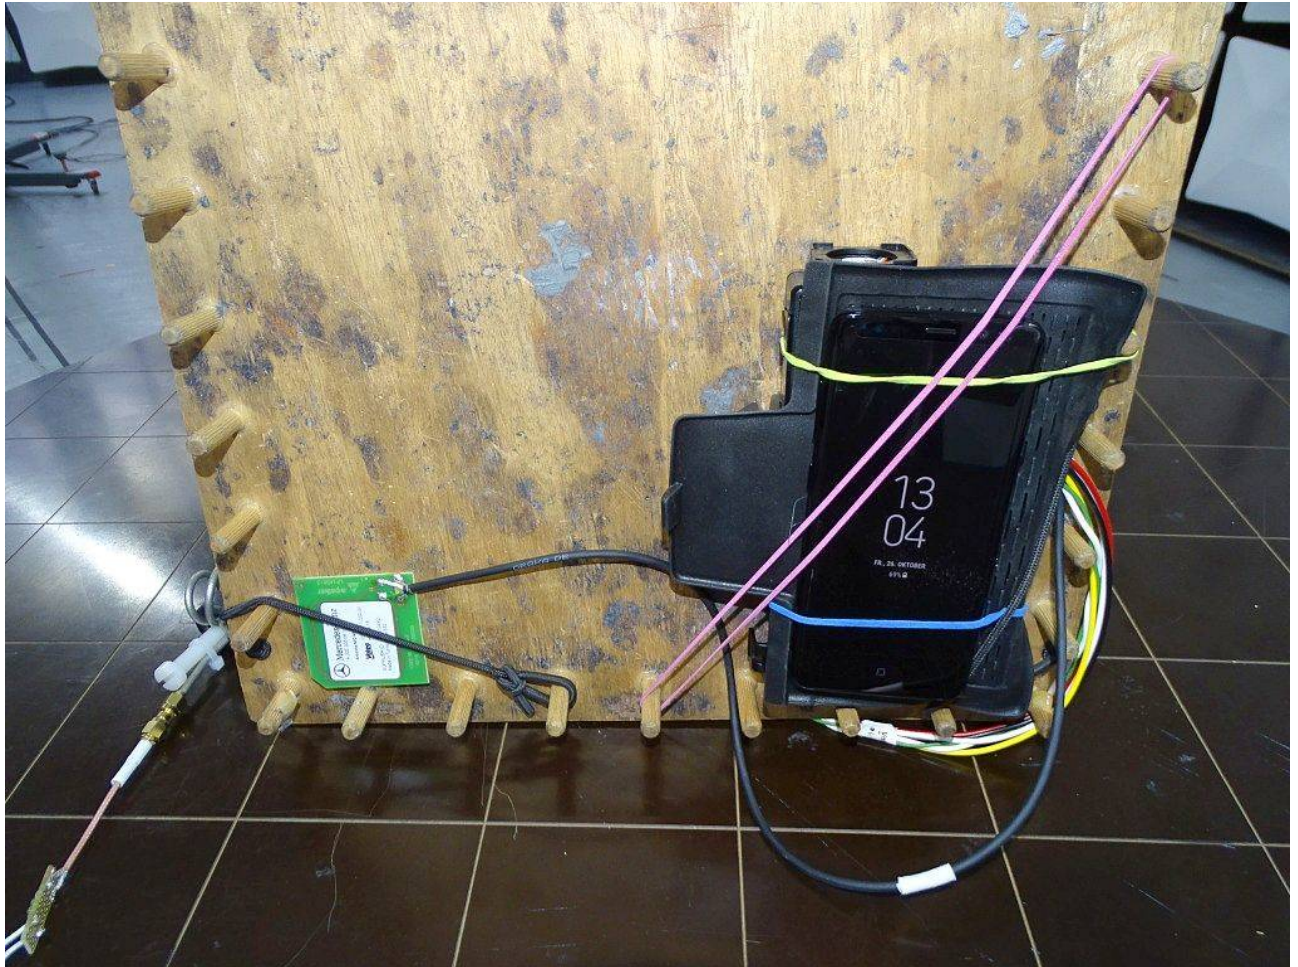
**Photo 6:** Test setup for radiated measurements (Enclosure, semi-anechoic chamber, NFC integral antenna, detail)

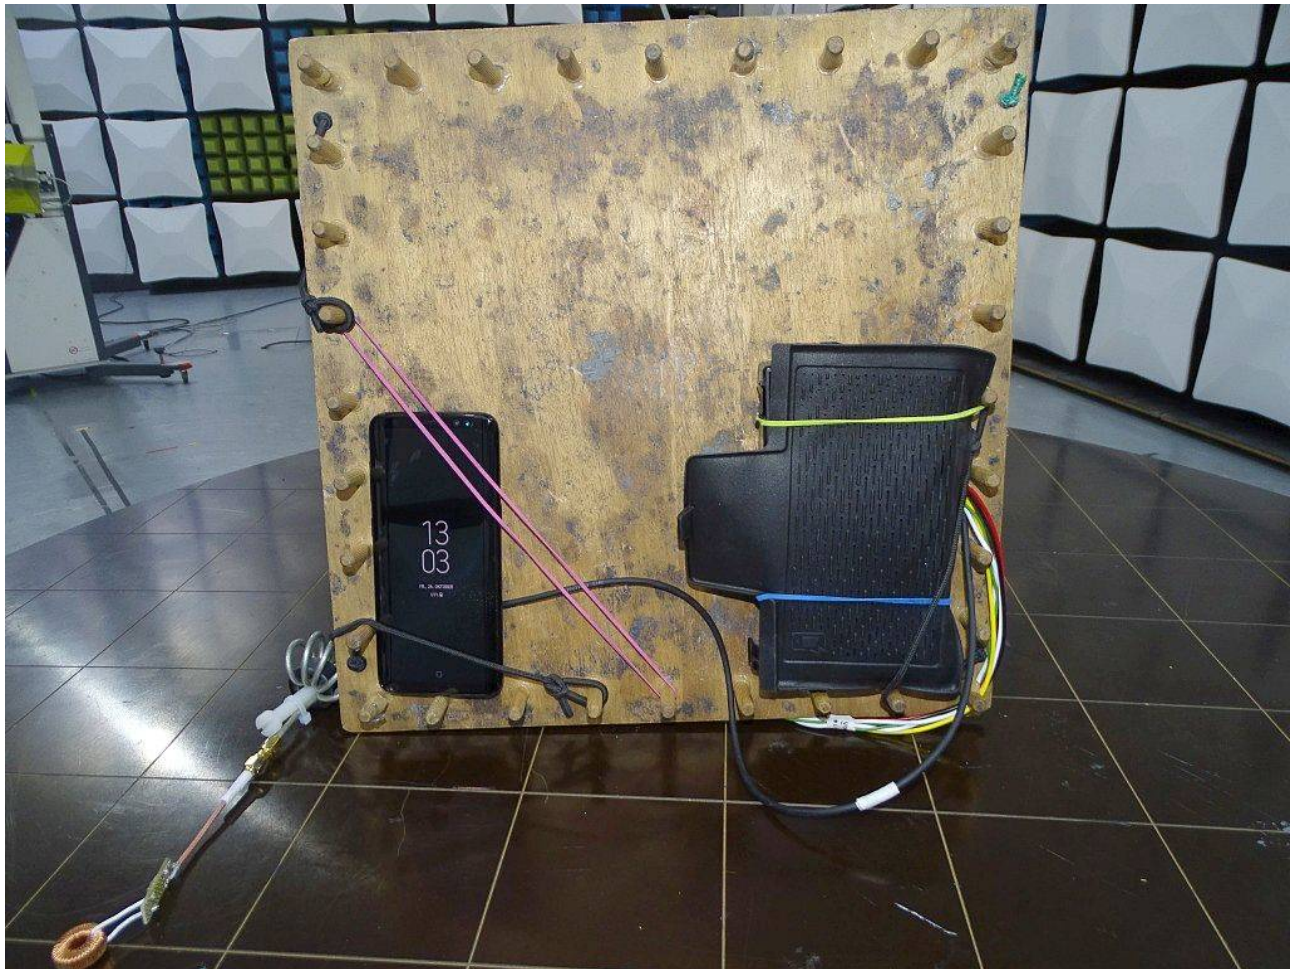
**Photo 7:** Test setup for radiated measurements (Enclosure, semi-anechoic chamber, NFC external antenna, detail)
