## Annex C Photo documentation

Appendix to Test Report No.: 1-8238/19-01-60-A

**CTC advanced GmbH**

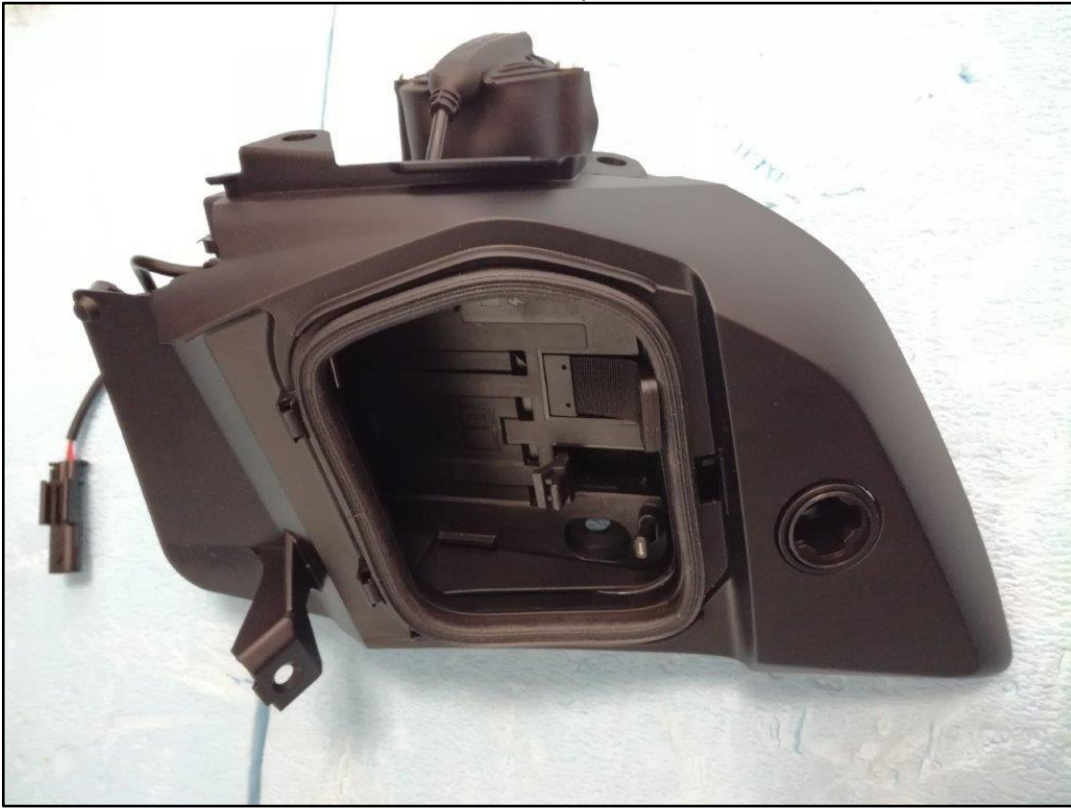
Photo 1: DUT - Top side view

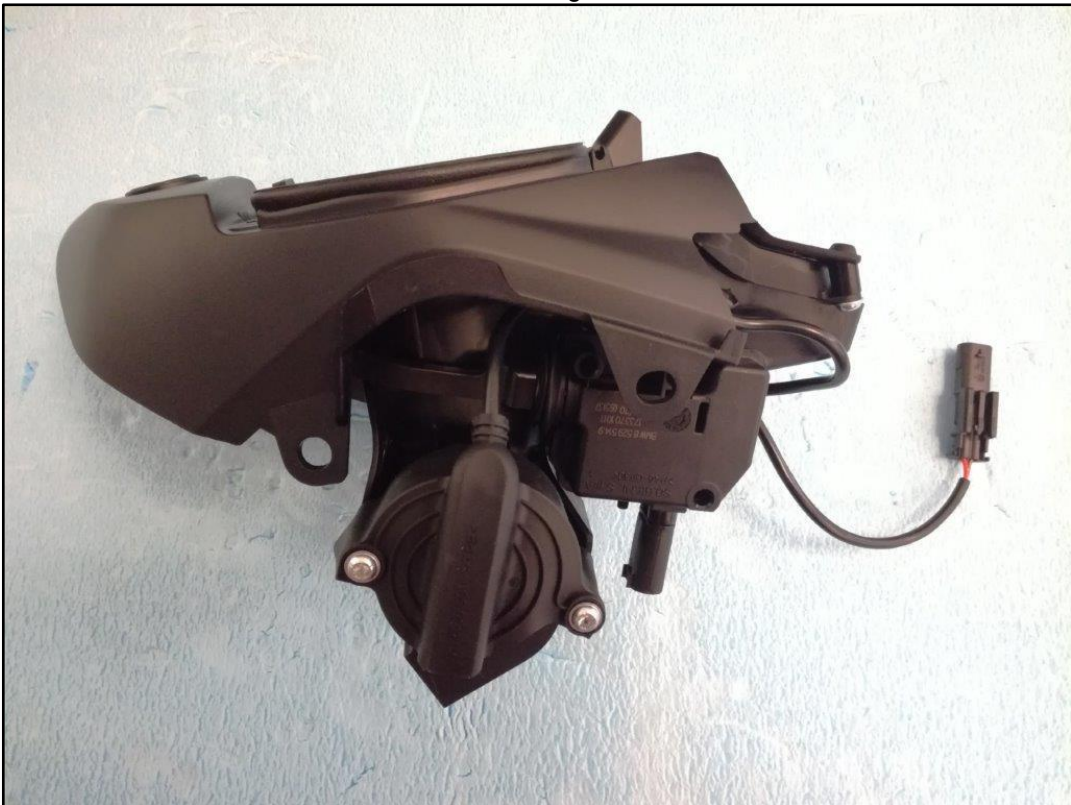
Photo 2: DUT - Right side view

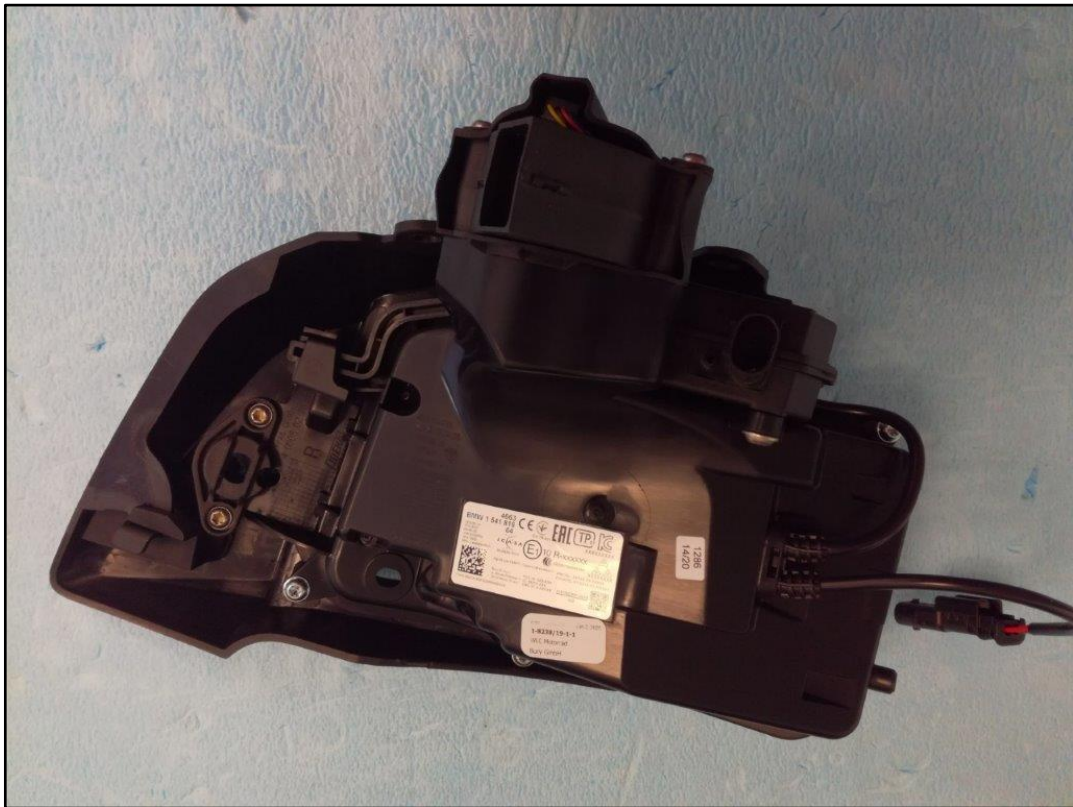
Photo 3: DUT - Bottom side view

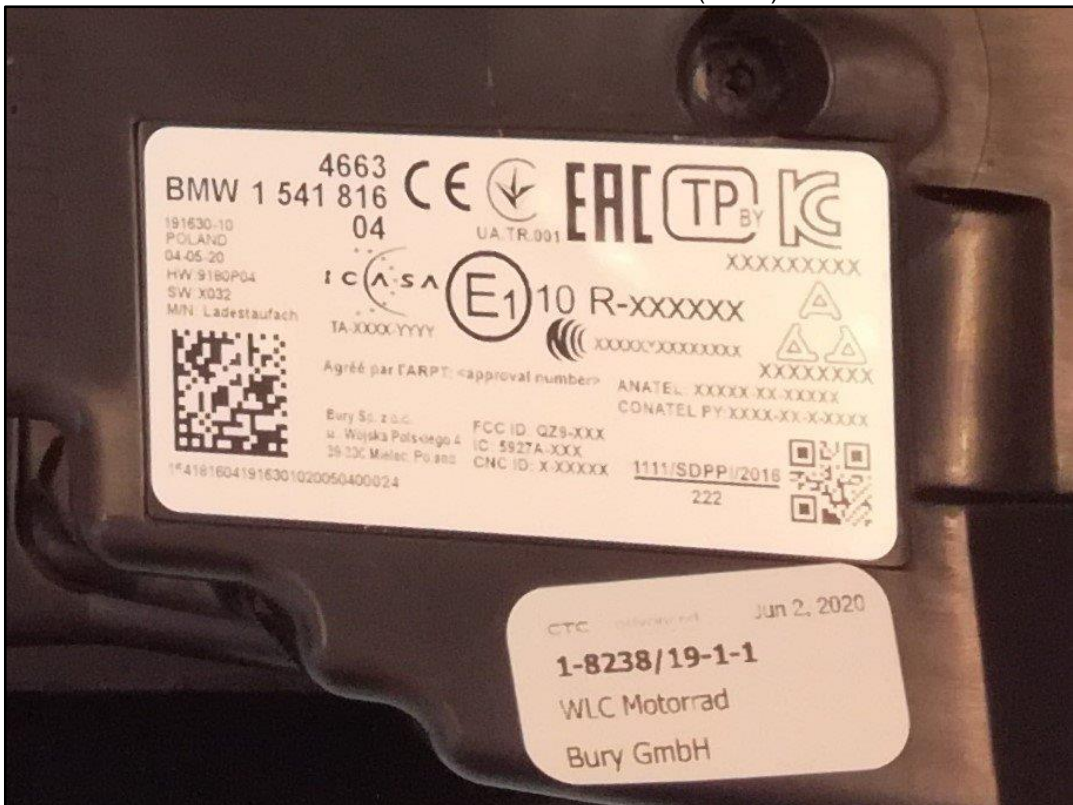
Photo 4: DUT - Bottom side view (Label)

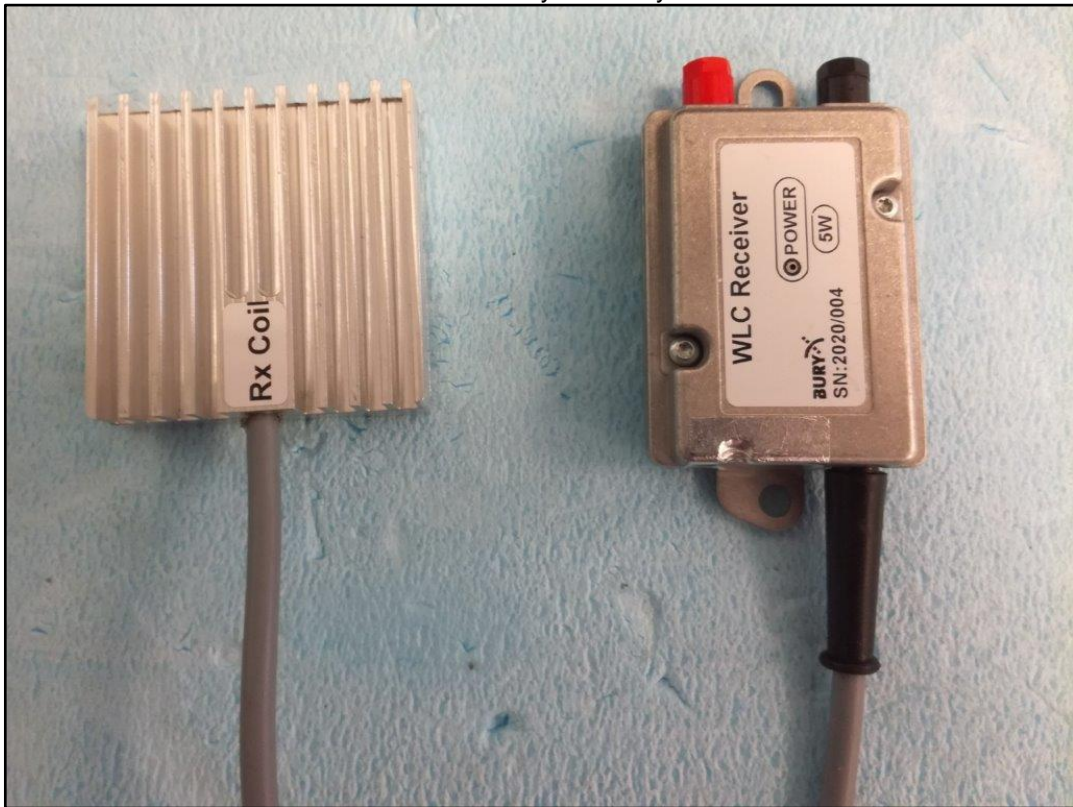
Photo 5: Auxiliary - Dummy Load

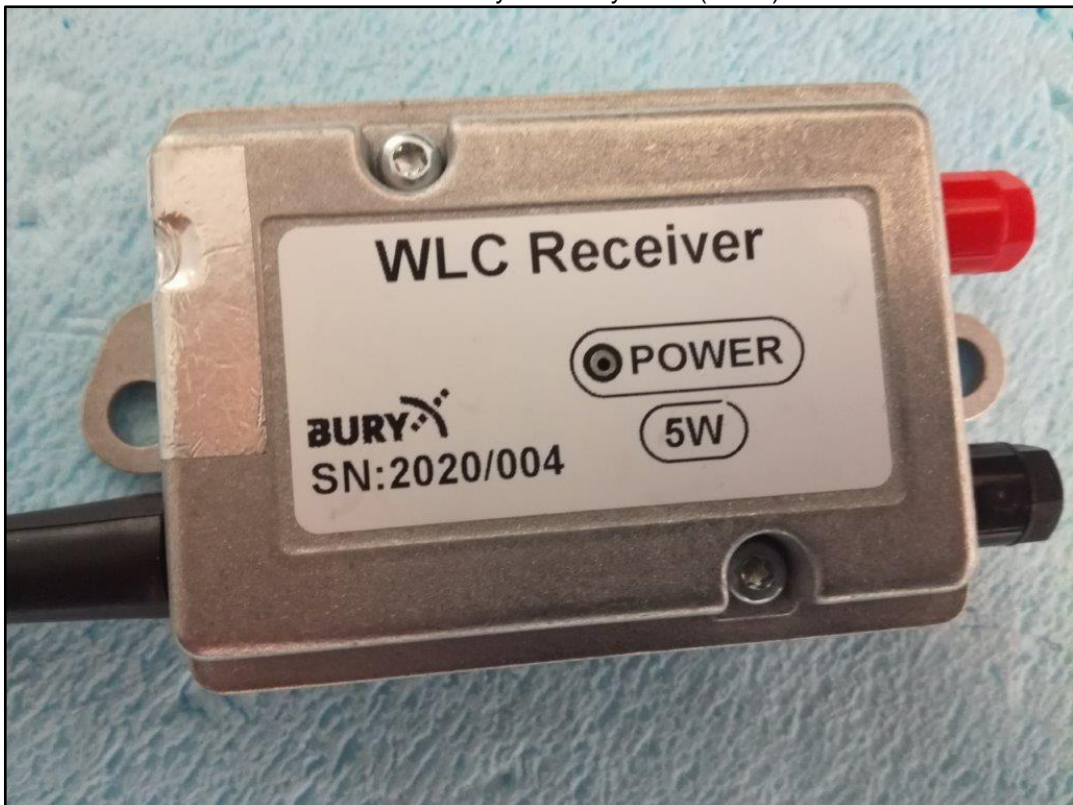
Photo 6: Auxiliary - Dummy Load (Label)

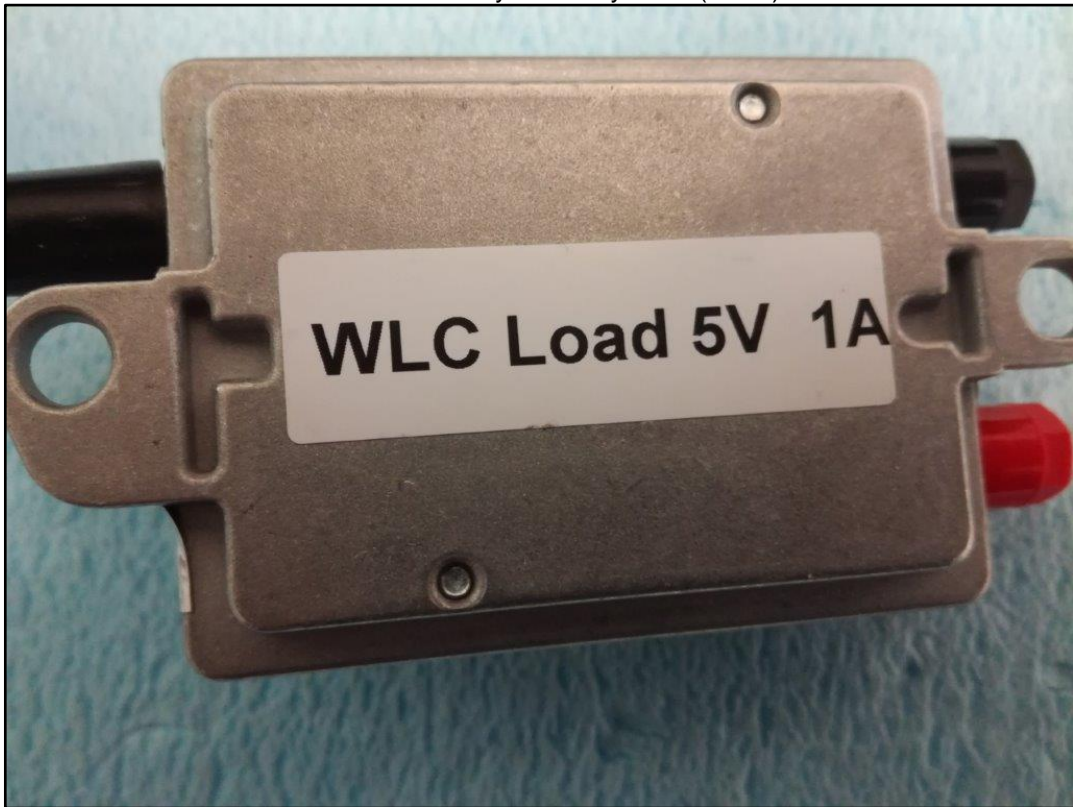
Photo 7: Auxiliary - Dummy Load (Label)

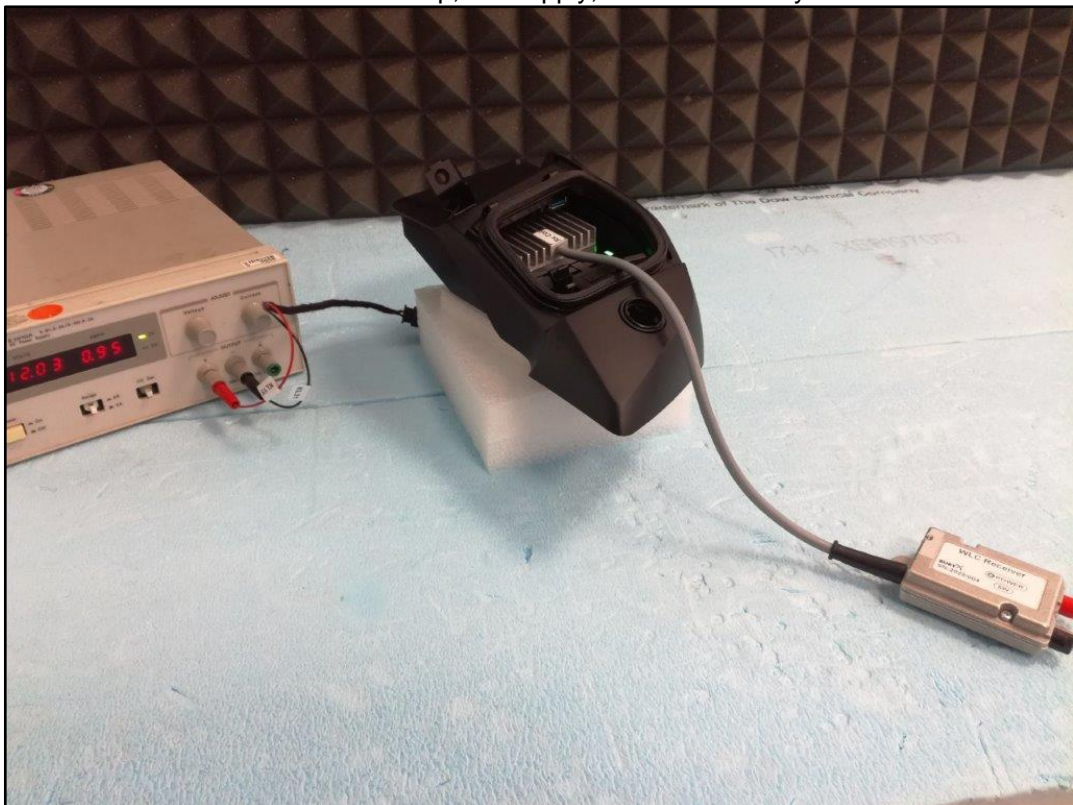
Photo 8: Test Setup, DC supply, DUT and dummy load

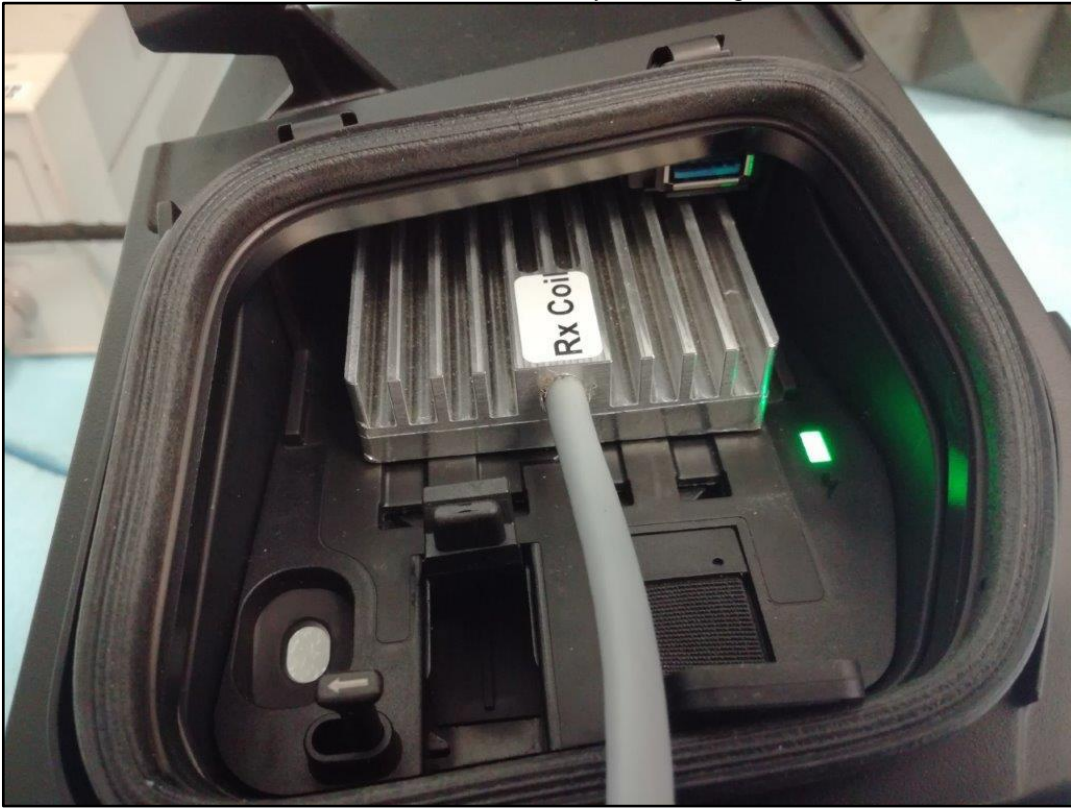
Photo 9: Position of dummy load during test

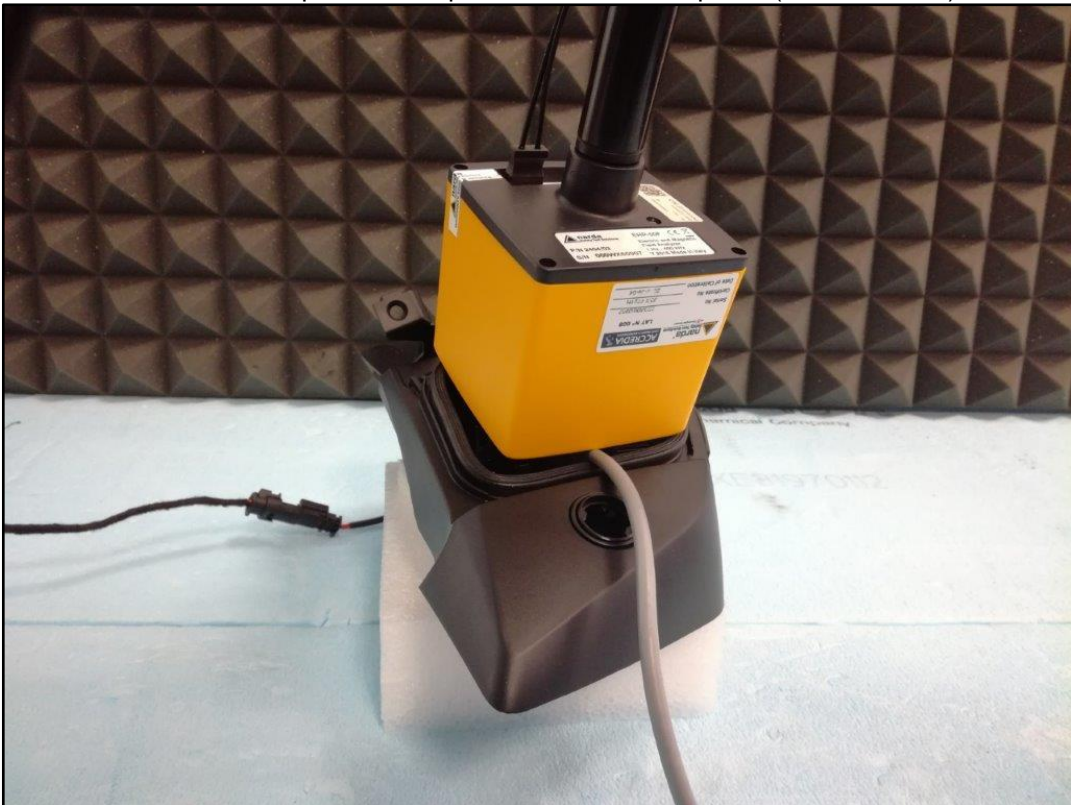
Photo 10: Test position - Top side with EHP 50F probe (0mm distance)

The device was positioned as close as possible towards the dummy load (the cover was removed to get closer towards the dummy load).

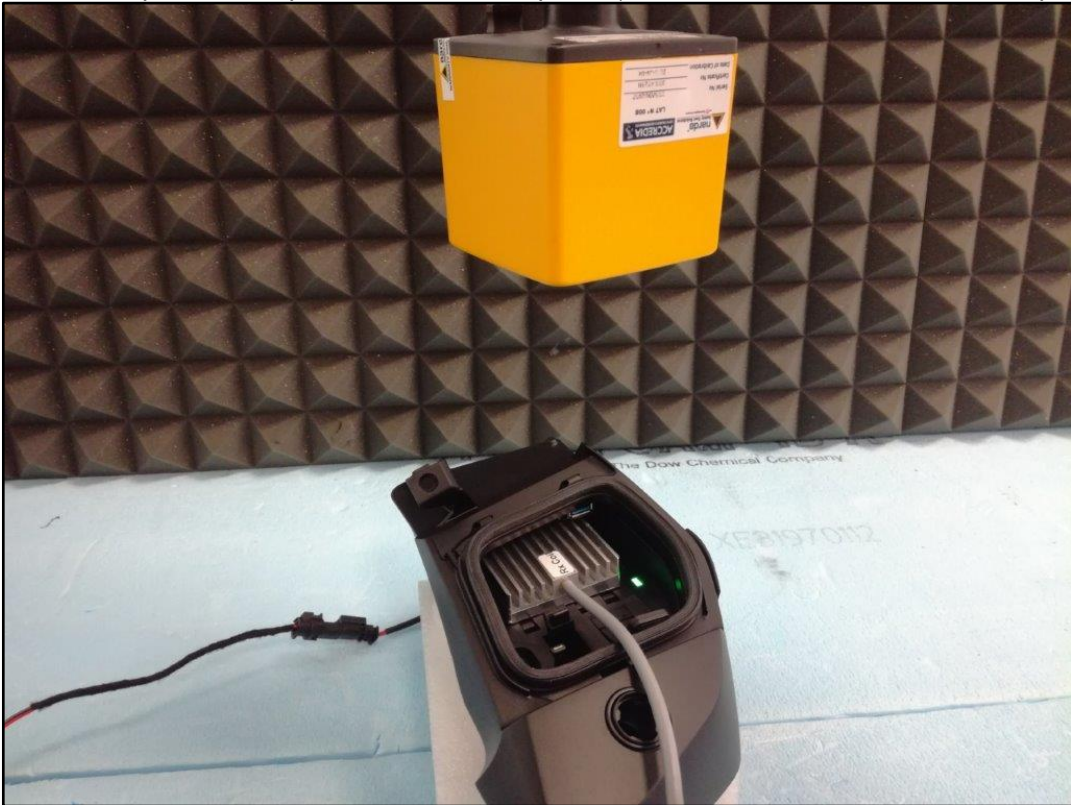
Photo 11: Test position - Top side with EHP 50F probe (20 cm distance to the centre of the probe)

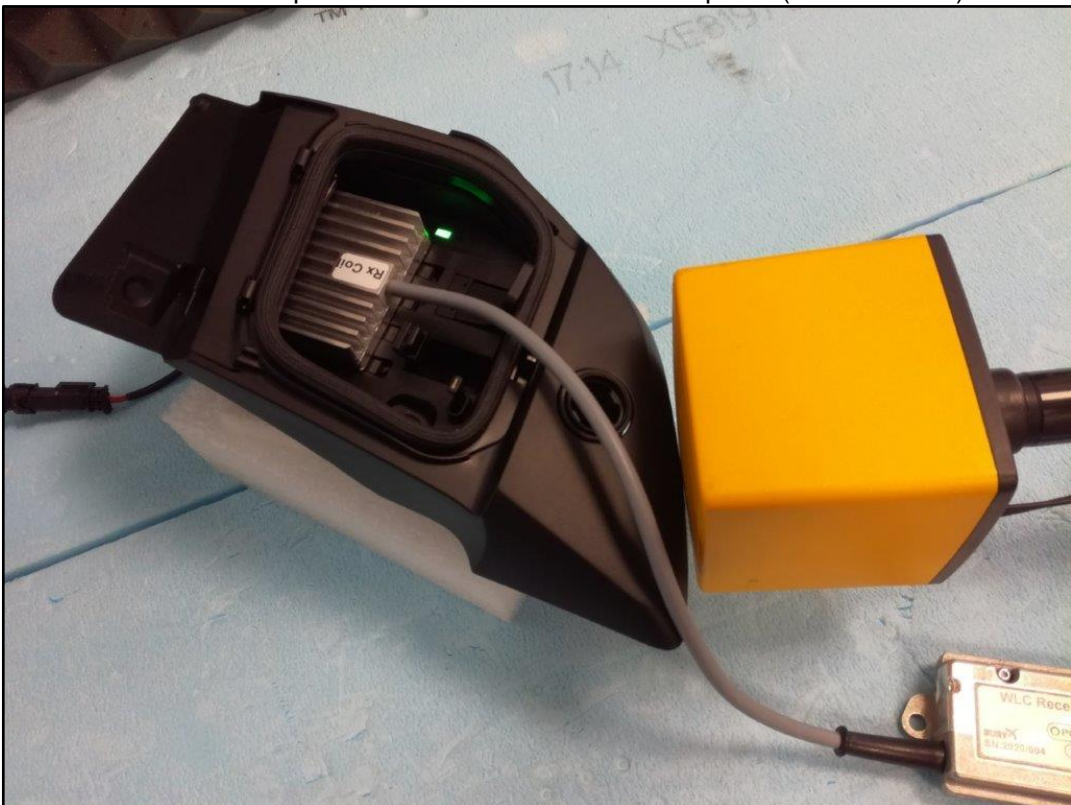
Photo 12: Test position - Front side with EHP 50F probe (0mm distance)

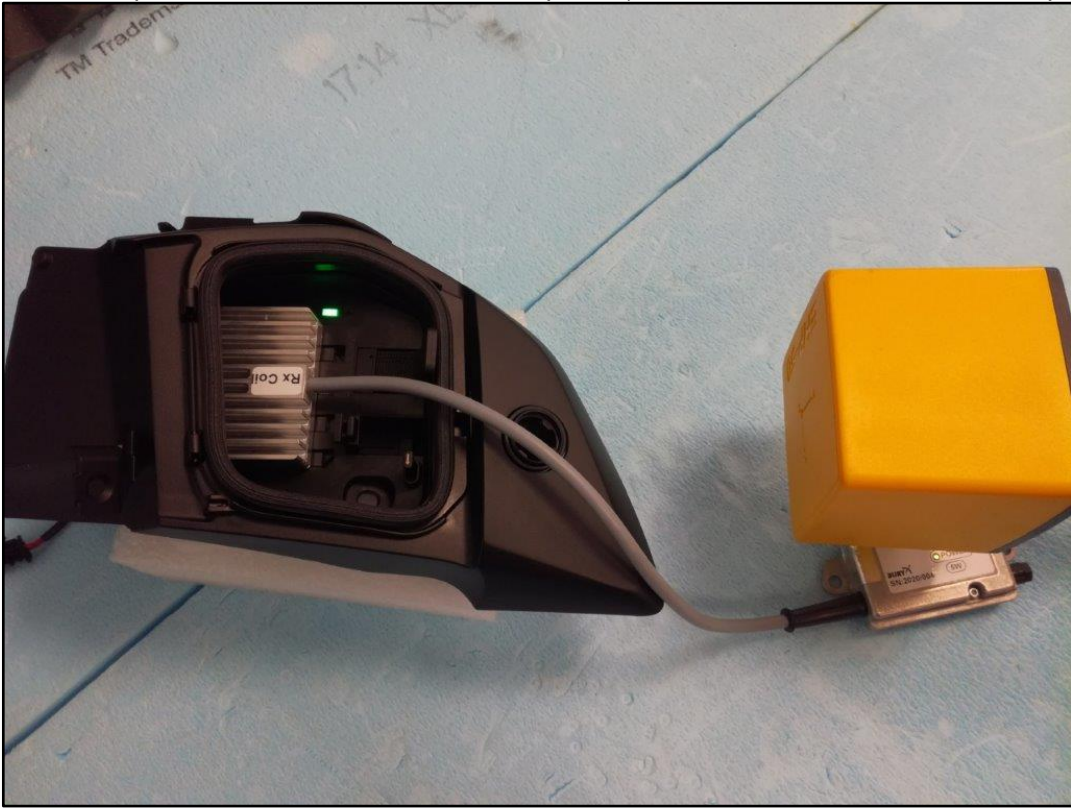
Photo 13: Test position - Front side with EHP 50F probe (15 cm distance to the centre of the probe)

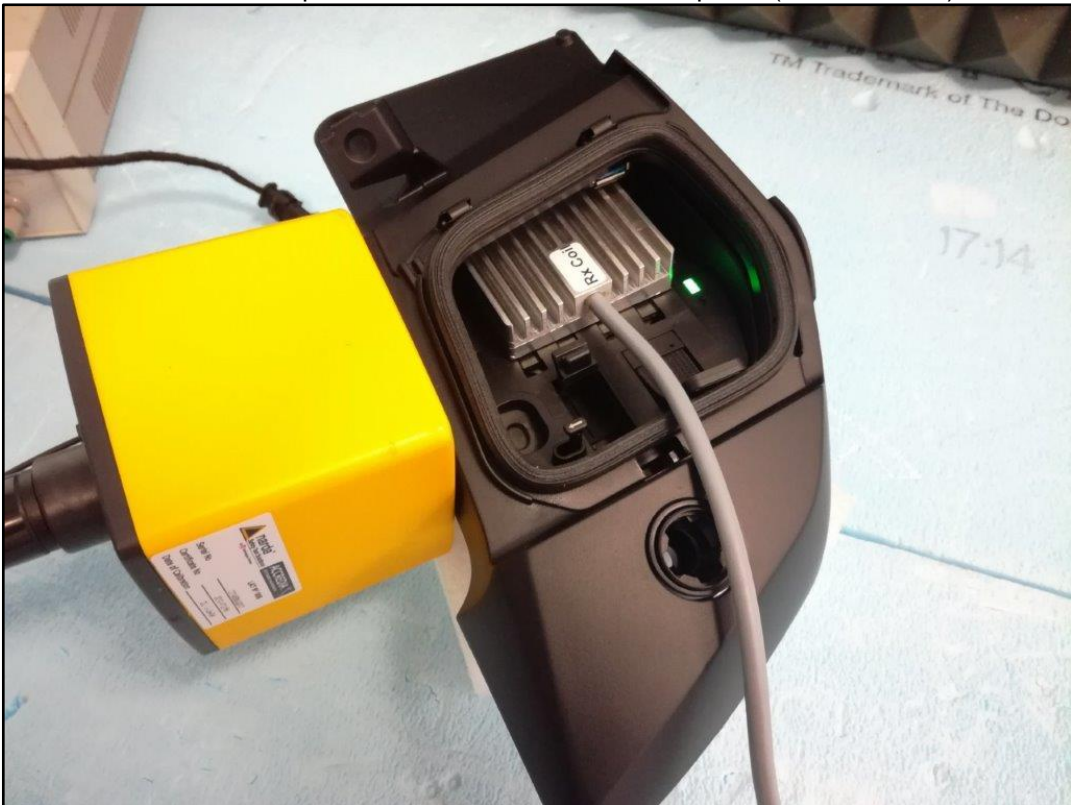
Photo 14: Test position - Left side with EHP 50F probe (0mm distance)

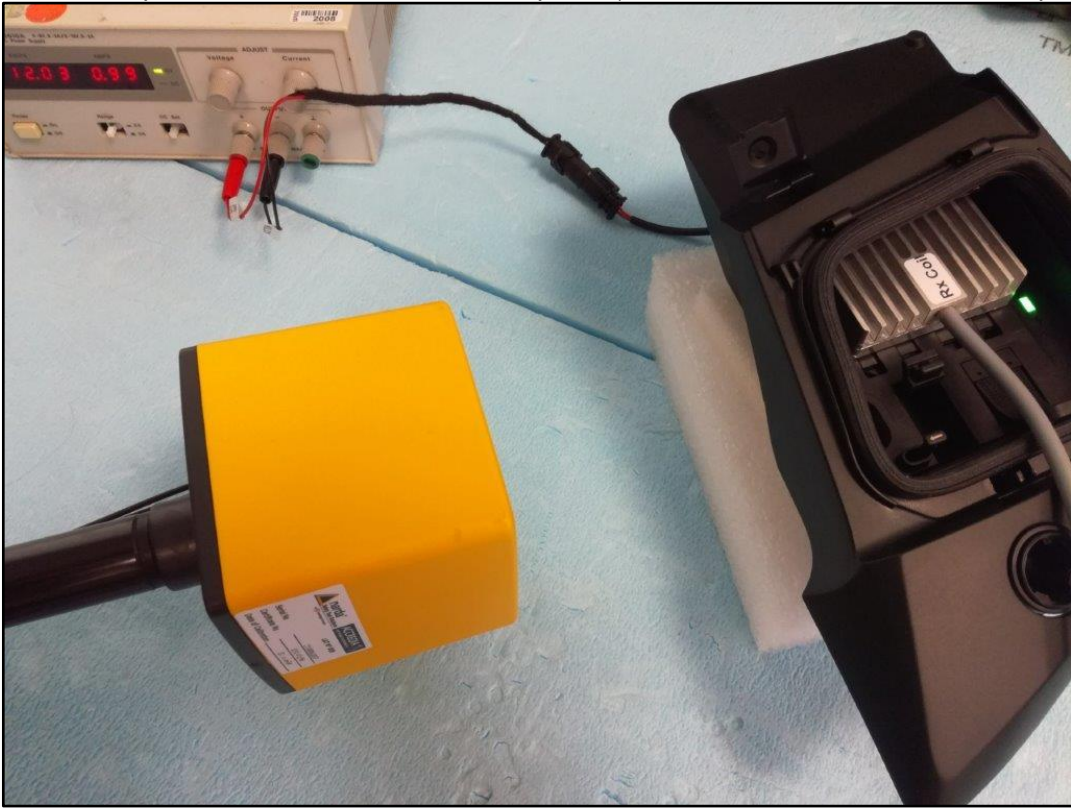
Photo 15: Test position - Left side with EHP 50F probe (15 cm distance to the centre of the probe)

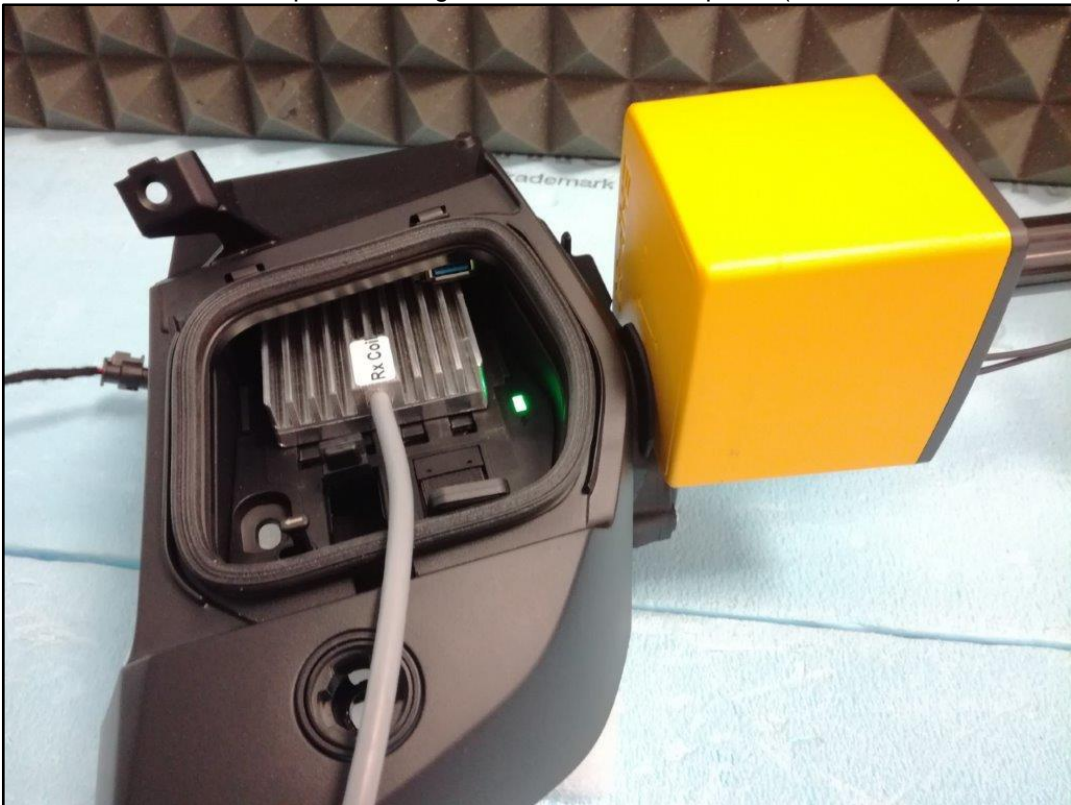
Photo 16: Test position - Right side with EHP 50F probe (0mm distance)

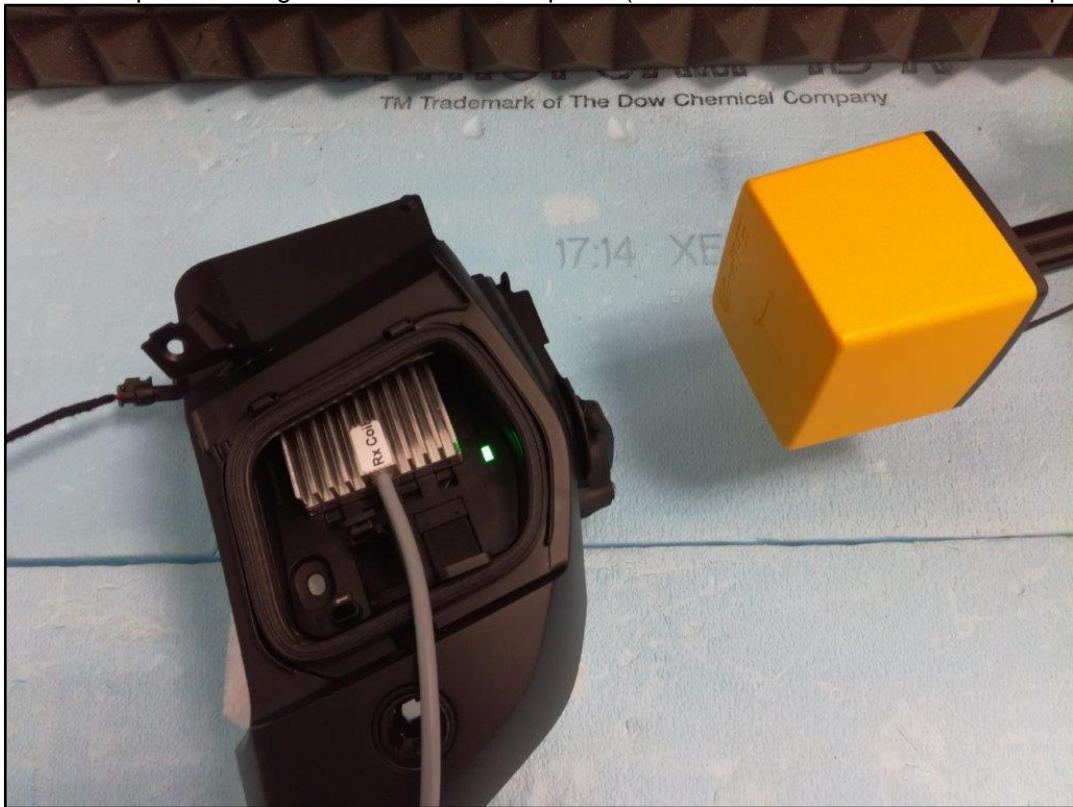
Photo 17: Test position - Right side with EHP 50F probe (15 cm distance to the centre of the probe)
