## 10.7 APPENDIXH: CONDUCTED SPURIOUS EMISSION

### Test Result

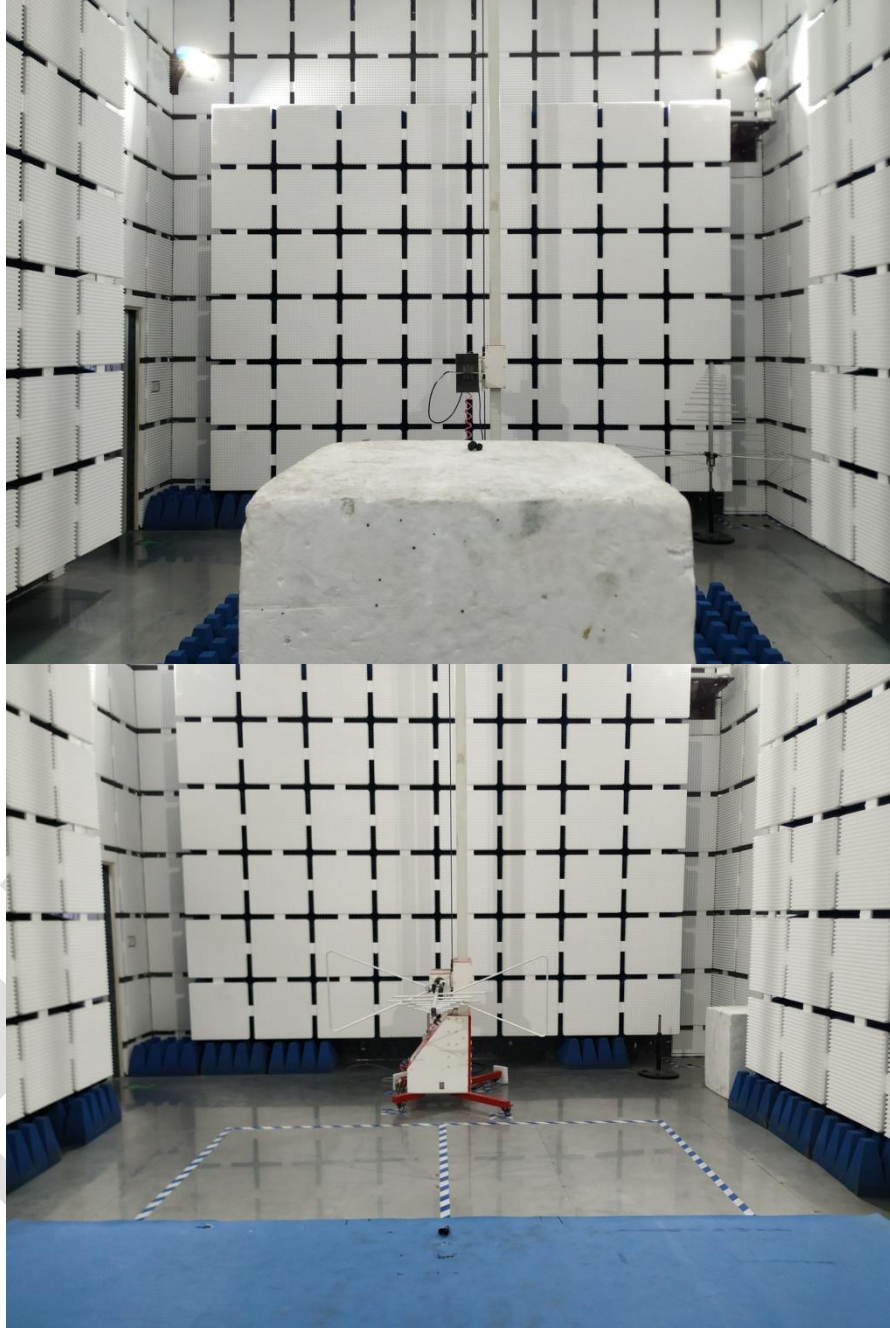
**Radiated Spurious Emissions**
