**Application for Certification
For an RF amplifier**

RF amplifier

FCC ID: RFK-LMSWDJHNEX

REPORT # RV58031A-000

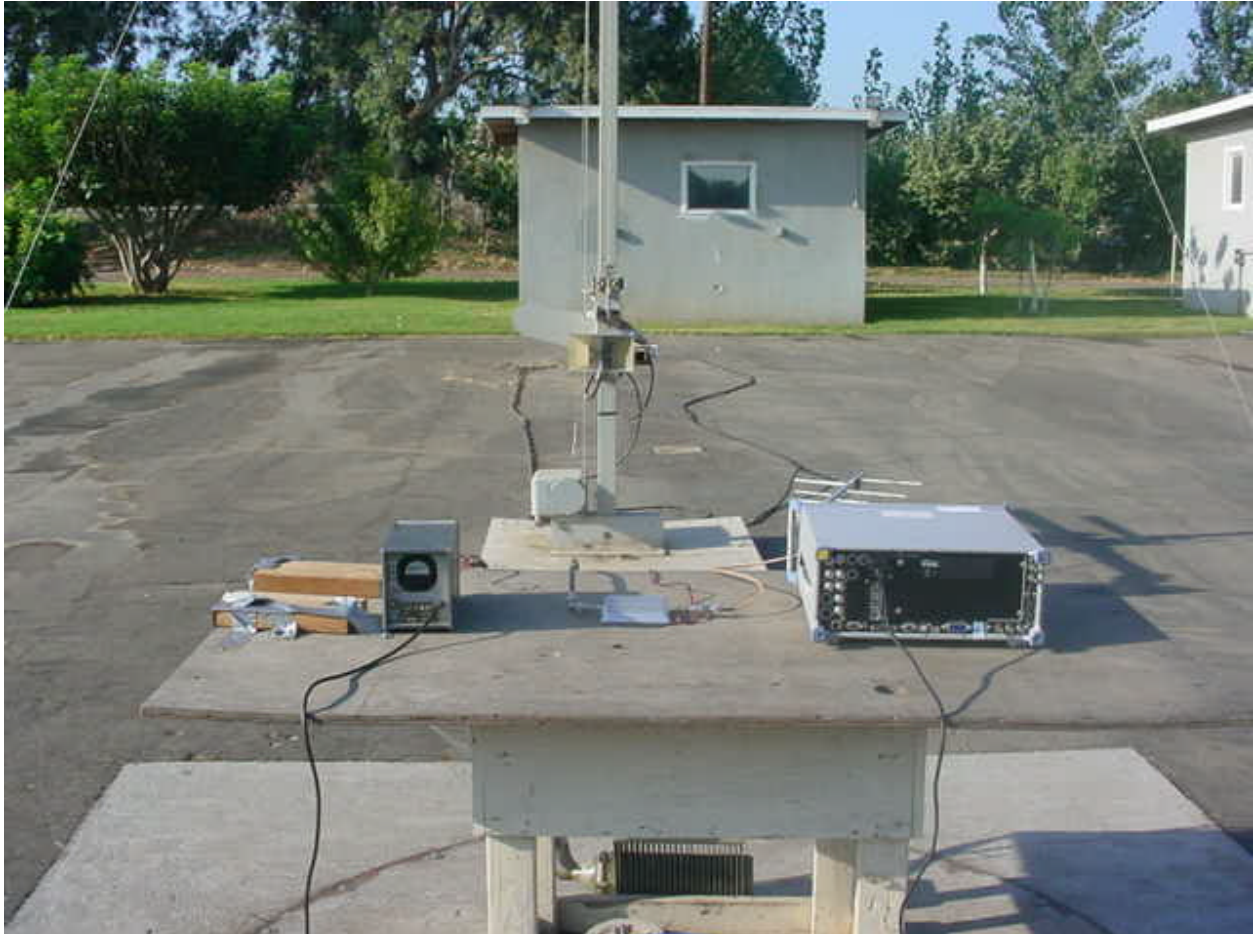
**PHOTO: RF POWER OUTPUT, EMISSIONS LIMITATIONS
GSM/TDMA, OCCUPIED BANDWIDTH
GSM/TDMA, CONDUCTED SPURIOUS
EMISSIONS AT ANTENNA TERMINALS**
